A CASE HISTORY - WHOSE RESPONSIBILITY?

G.R. Astbury

Avecia Limited, P.O. Box 42, Blackley Manchester M9 8ZS

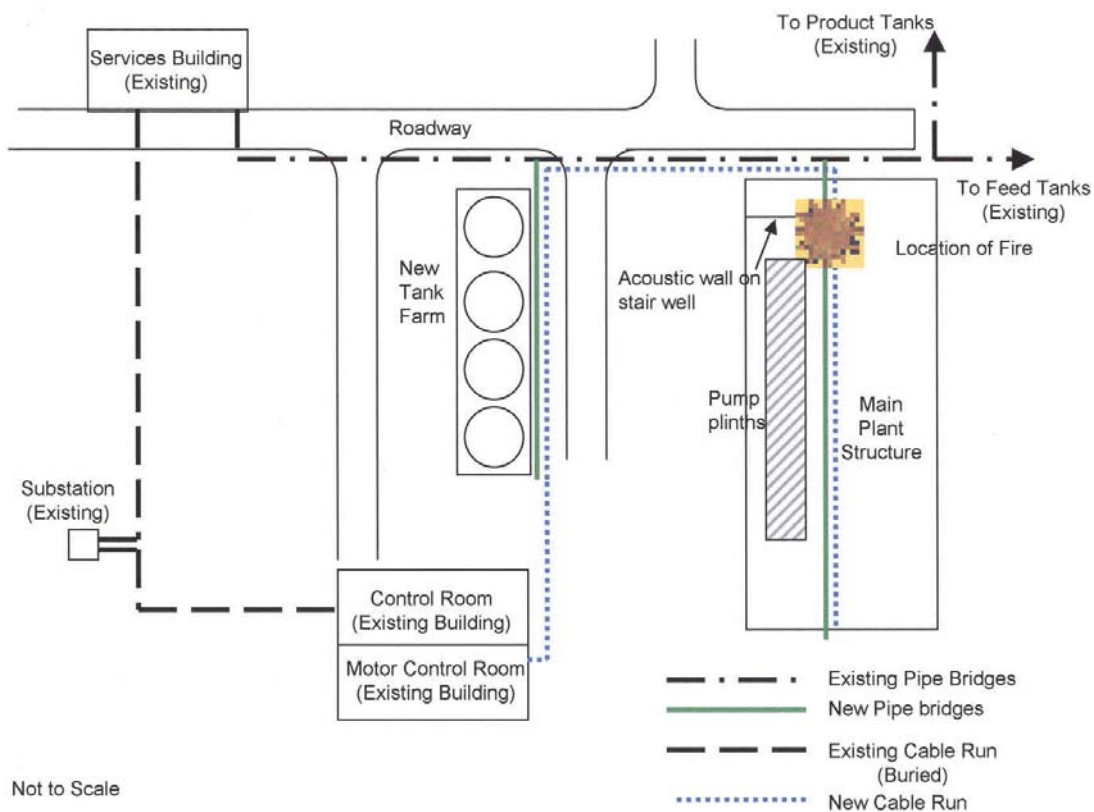
Figure 1.

After a short period of normal production, it was apparent that the hot oil system was not performing correctly, since the main circulation pump was cavitating, and the heat transfer was not being achieved at the correct operating bulk temperature. The oil temperature had been increased marginally, but this had not improved the Plant performance. It was also apparent that there was some cavitation at the control valve on the largest heat exchanger. This was thought to be due to degradation of the hot oil by producing light ends which were flashing off in the pump and after the control valve. This was the reason for the requirement to sample the oil. The risk of poor performance was not entirely unexpected as the design of the heater had been significantly altered to a non-standard design with an unusually low pressure drop to minimise pumping power. The design for the hot oil system had been altered during the design phase because of the layout of the plant in the existing buildings, in order to save capital costs. The main plant location was constrained by a number of reasons, but the position of the Services Building, electricity Substation and the Control Room were fixed as these were existing buildings, served by existing cables. The Site plan is shown in Figure 1 below.

The existing cable supplying the Services Building from the substation was of a small capacity, and was buried along its entire length and passed under the main access road for the Plant. The installation of a new steam boiler, the hot-oil heater and circulating pumps, and a new air-compressor gave an electrical loading which exceeded the capacity of the existing cable. As all the loads were continuous, there was no possibility of applying diversity, so either the cable had to be replaced or the loads reduced.
