REFINERY FIRE INCIDENT:

A CASE STUDY OF A MULTIPLE FATALITY INCIDENT AT THE TOSCO AVON REFINERY, MARTINEZ, CALIFORNIA¹

Donald Holmstrom, Stephen Selk, Stephen Wallace, and Isadore Rosenthal, U.S. Chemical Safety and Hazard Investigation Board, 2175 K St., N.W., Suite 400, Washington, D.C. 20037

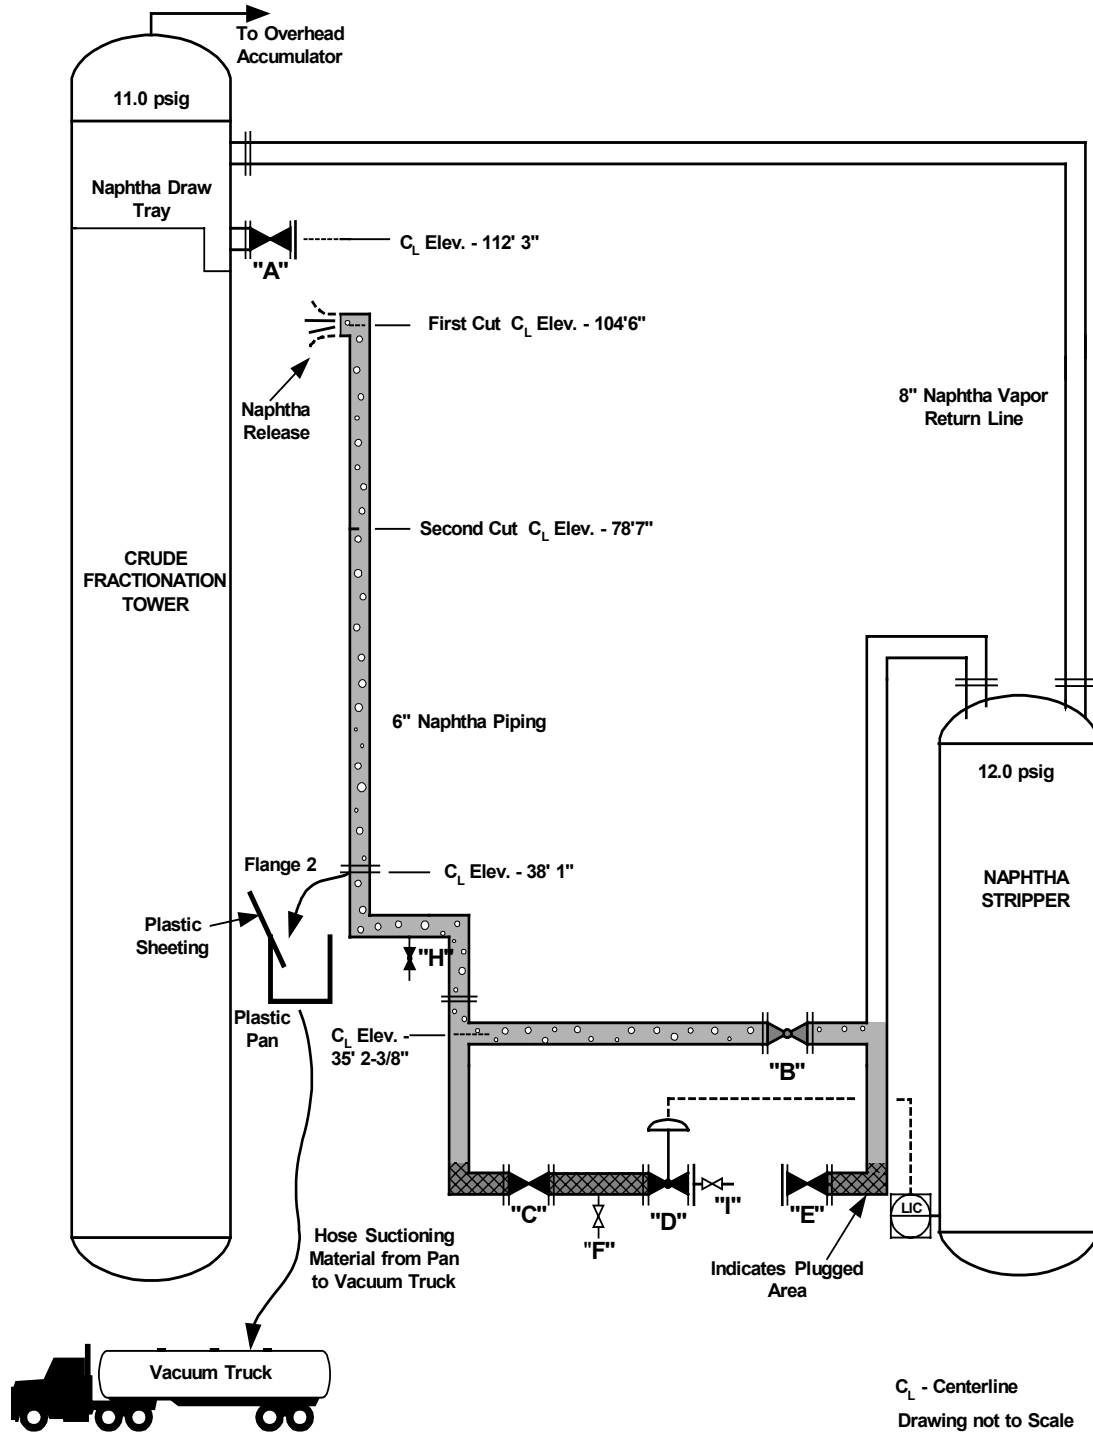
Figure 1

On February 10, 1999, a pinhole leak was discovered in the crude unit on the inside of the top elbow of the naphtha piping, near where it was attached to the fractionator (Figure 1) at 112 feet above grade.⁴ Tosco personnel responded immediately, closing four valves in an attempt to isolate the piping. The unit remained in operation.
