**PUBLIC REPORT OF
THE FIRE AND EXPLOSION AT
THE CONOCOPHILLIPS
HUMBER REFINERY
ON 16 APRIL 2001**

Prepared by the Health and Safety Executive

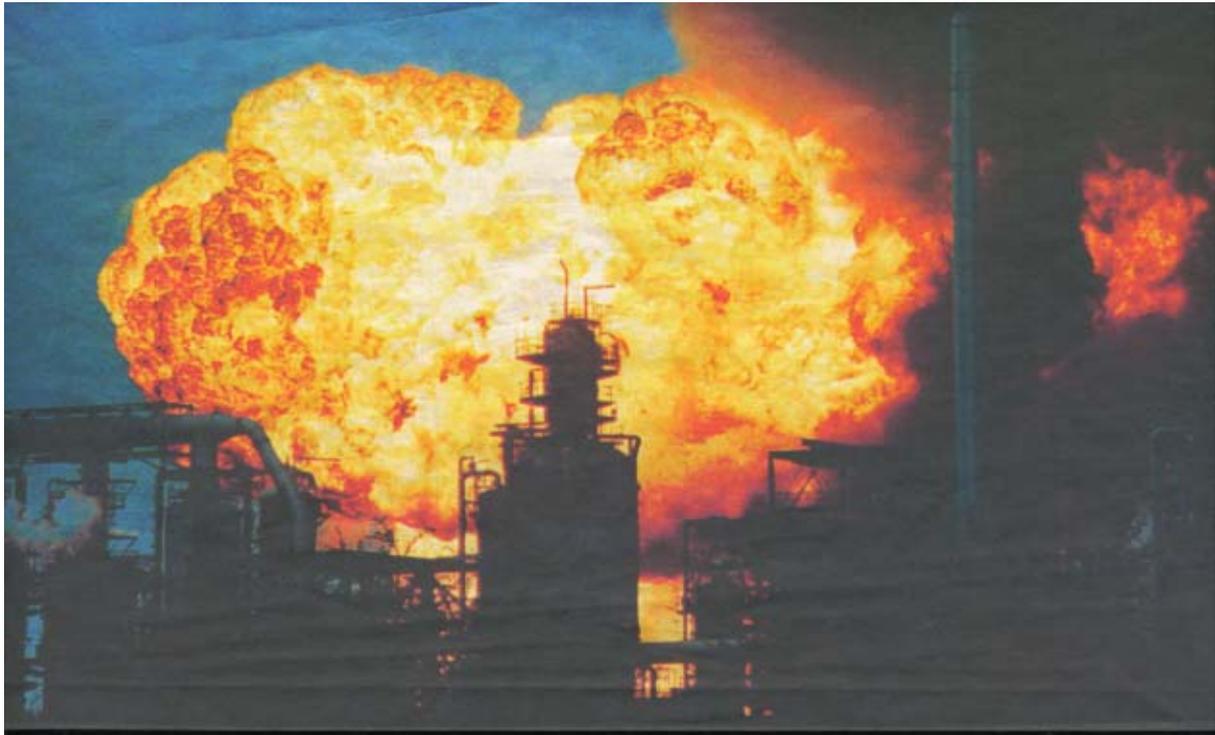
At approximately **14.20 hrs** a catastrophic failure of a section of pipework on the SGP plant occurred at an elbow just downstream of a water-into-gas injection point. The six inch diameter pipe P4363, (the overhead line carrying flammable gas under high pressure),

ruptured releasing a huge cloud containing around 90% ethane/propane/butane. About 20-30 seconds later the gas cloud ignited. As a result a massive explosion and fire followed.

Figure 2 –The fire and secondary fireball - photo courtesy of Andy Trott

As the fire burned, the overheating caused a number of failures of other pressurised pipework from loss of strength. These contributed further quantities of fuel to the fire resulting in another fireball about 15 minutes later, subsequent smaller fireballs also followed.

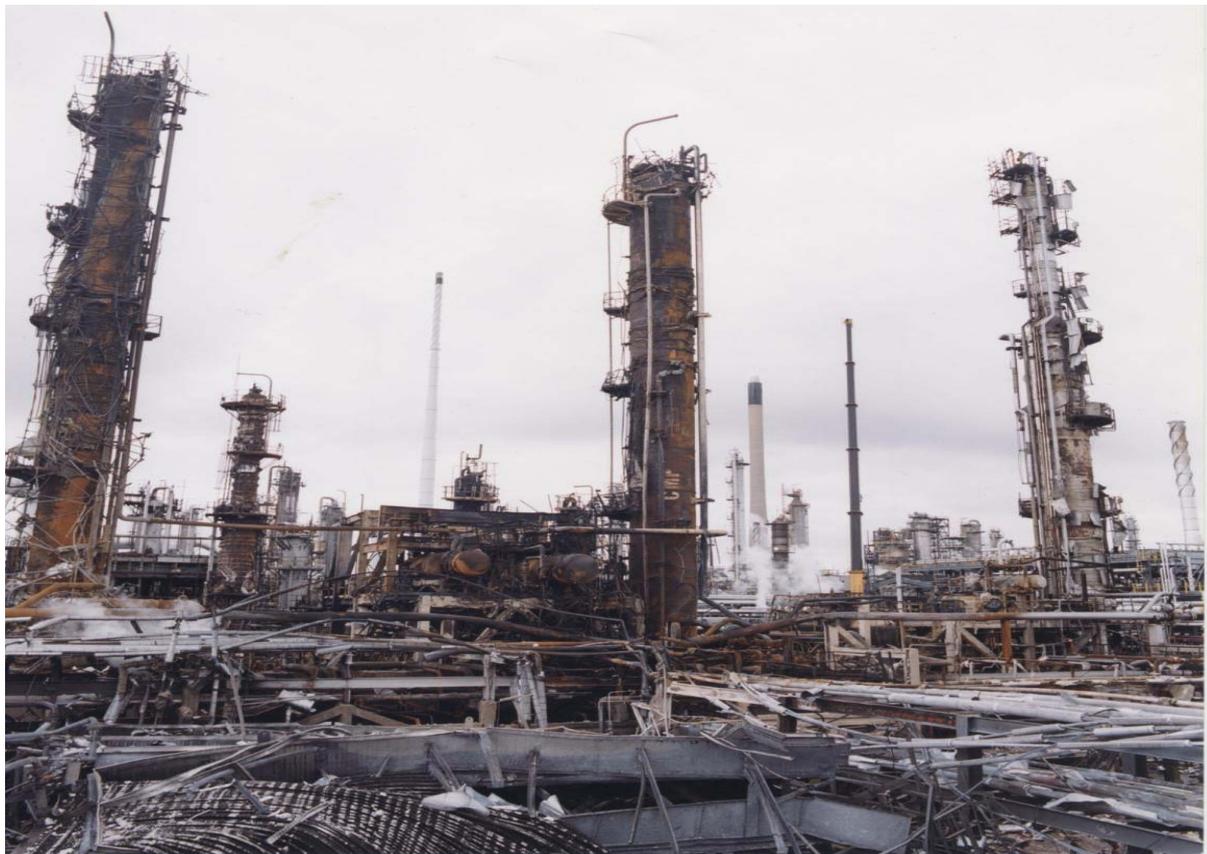
The SGP suffered very heavy damage as a result of the force of the blast. Fortunately, no one had been in the direct path of the estimated 175 metres by 80 metres gas cloud when it had exploded. The resultant fire caused further and substantial damage to the SGP.

Figure 3 – Damage to the SGP after the explosion (W413 column to the right)

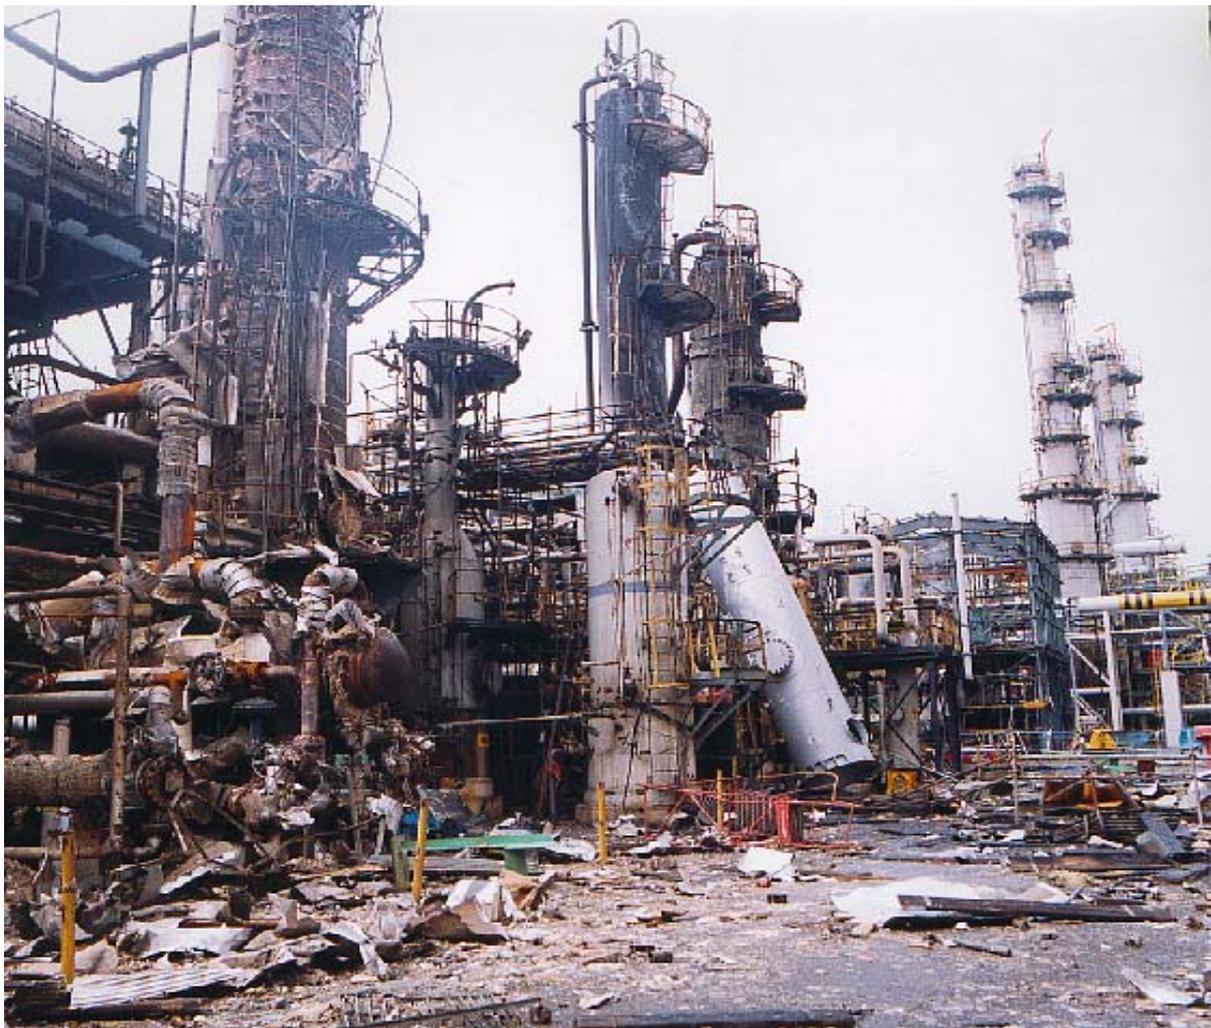
In addition buildings normally occupied on the Refinery, up to 400 metres away from the source of the explosion, were badly damaged. The contractor's canteen building suffered severe damage, had it been occupied at the time of the explosion people could have been severely injured by the flying glass. The staff canteen, the inspection services building and the toilet block suffered blast damage with windows blown in, doors and ceilings damaged and some cracking and displacement of brickwork.

Figure 4 – Damage to adjacent Plant

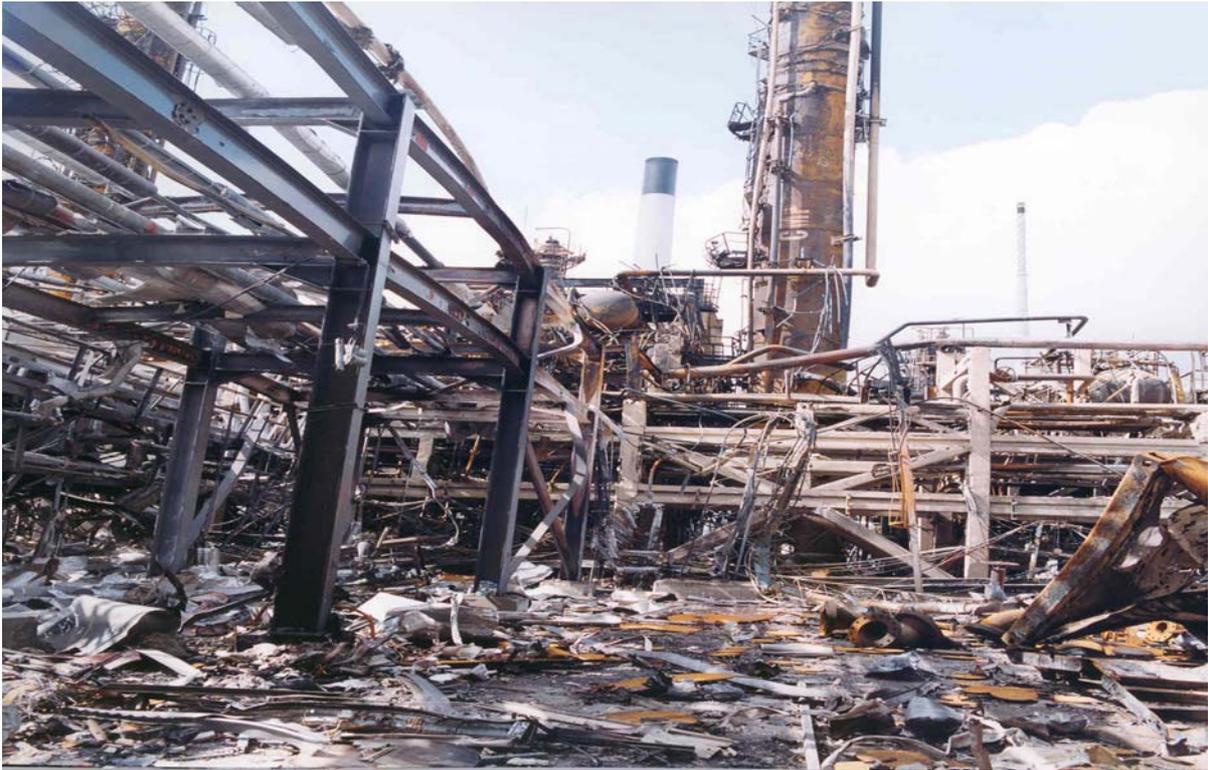
Figure 5 – Close up views of damage to the SGP

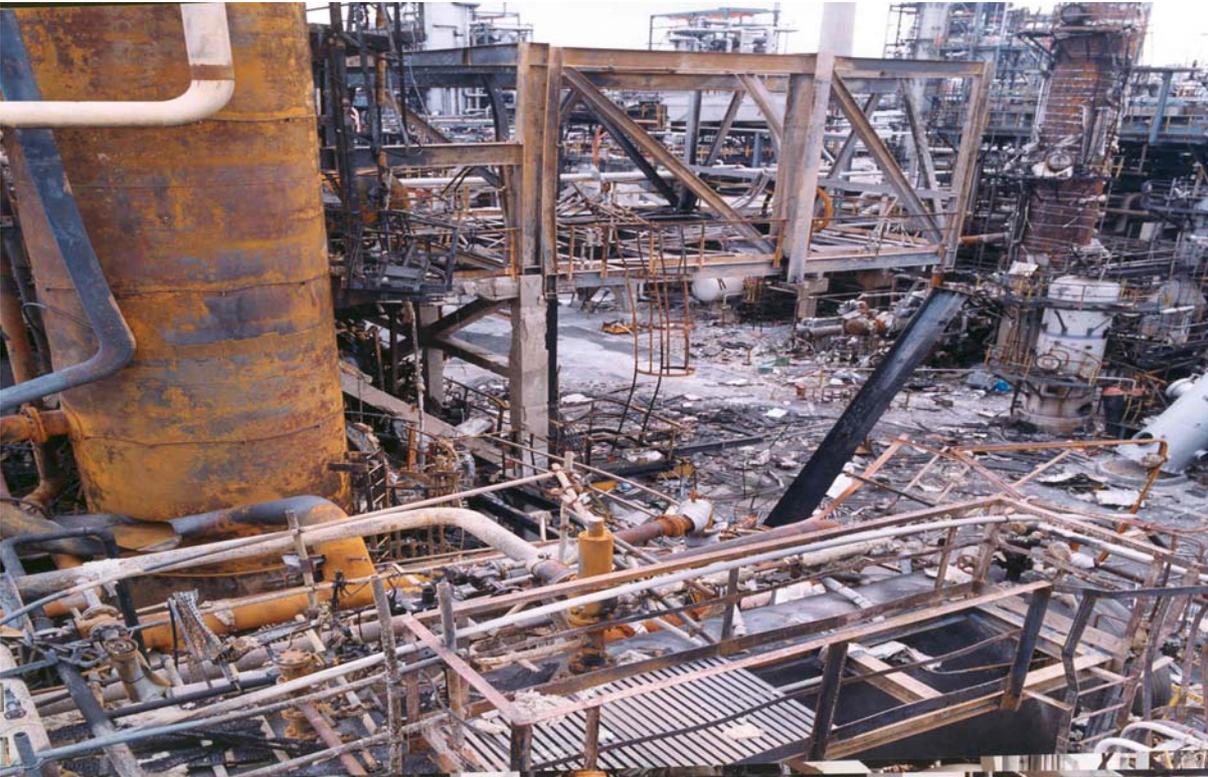
Figure 6 – Close up views of damage to the SGP

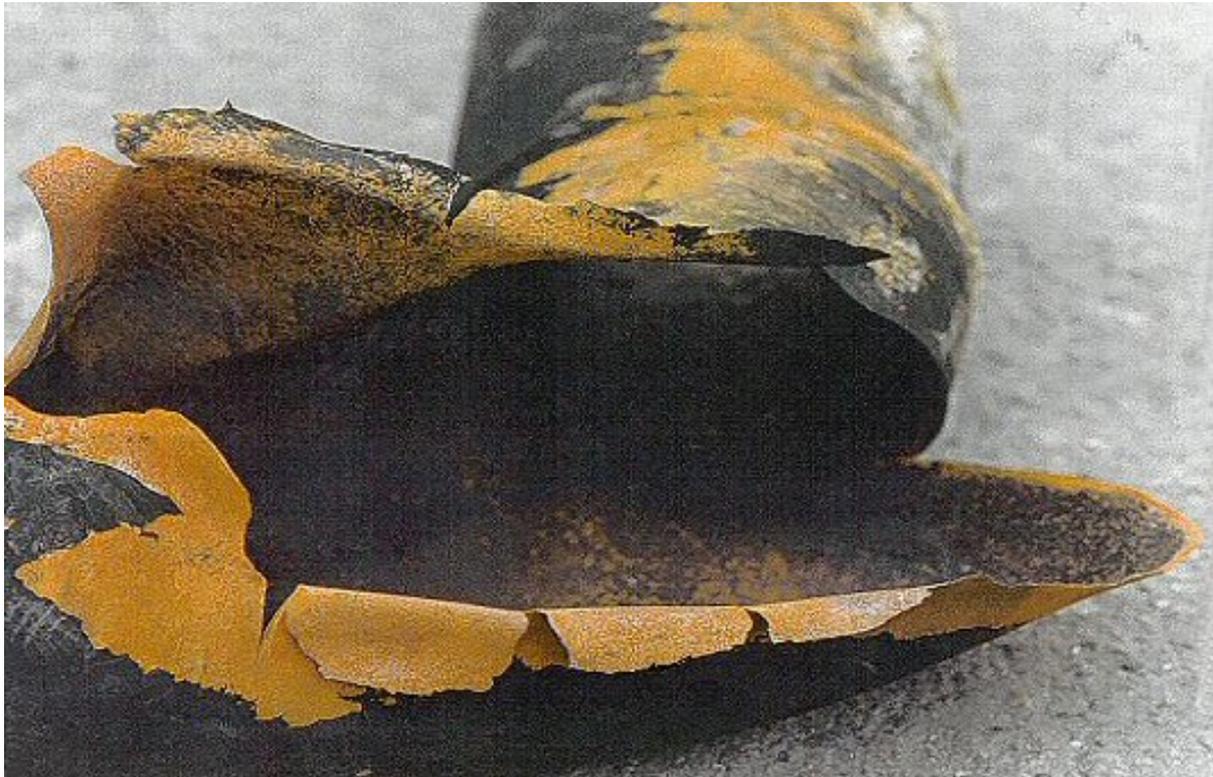
The pipework section containing the failed elbow was recovered from the damage site and metallurgically examined. This section of pipe also contained the water injection point, which was positioned 670 mm upstream of the failed elbow.

The examination showed that the elbow had failed owing to an 'erosion-corrosion' damage mechanism which, over time, had reduced the wall thickness at the outside of the elbow to such an extent that the wall could no longer withstand the internal pressure within. The wall thickness at the point of failure had been reduced from around 7-8 mm to a minimum of 0.3 mm. When the pipe failed it burst open catastrophically (see Figure 7), causing a 'full bore' type of release of the pipe's contents.

The extent of the thinning was mapped and shown to be localised to the elbow and to a slight degree the neighbouring sections of pipe. The pattern of thinning appeared to be directly associated with the water injection position and the downstream flow path of the water from the injection point and around the outside of the elbow. The metallurgical examination revealed that the uncorroded sections of the pipe were internally coated with black iron sulphide. This is known as a 'passivation' layer and once it has formed it serves to protect the carbon steel wall material from further corrosion. However, when the water

injection was in operation it washed away the protective coating leaving it open to attack by corrosive agents in the gas stream. Hence the elbow was subject to erosion/corrosion, a process that resulted in the thinning of the pipe wall and eventual failure.

Figure 7 – The failed elbow recovered from the plant

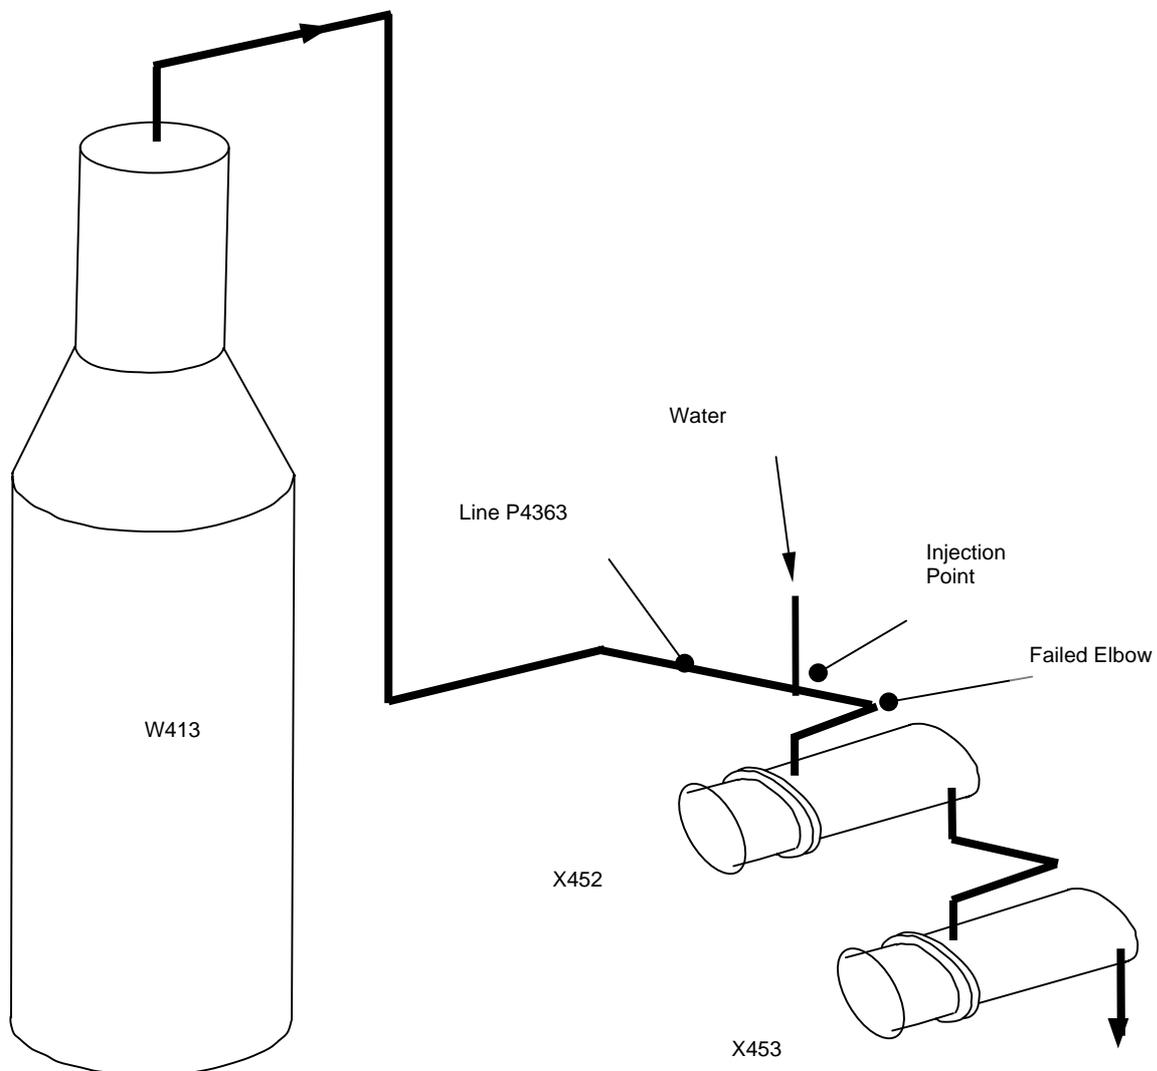
An injection point was created in P4363 by piping water to an existing 1" vent point on the pipe, 670 mm upstream of a right angle bend. At this point P4363 was 9 metres above ground level. No injection quill or other dispersal device was fitted and the water entered as a free jet.

Figure 8 – Diagram of the pipework

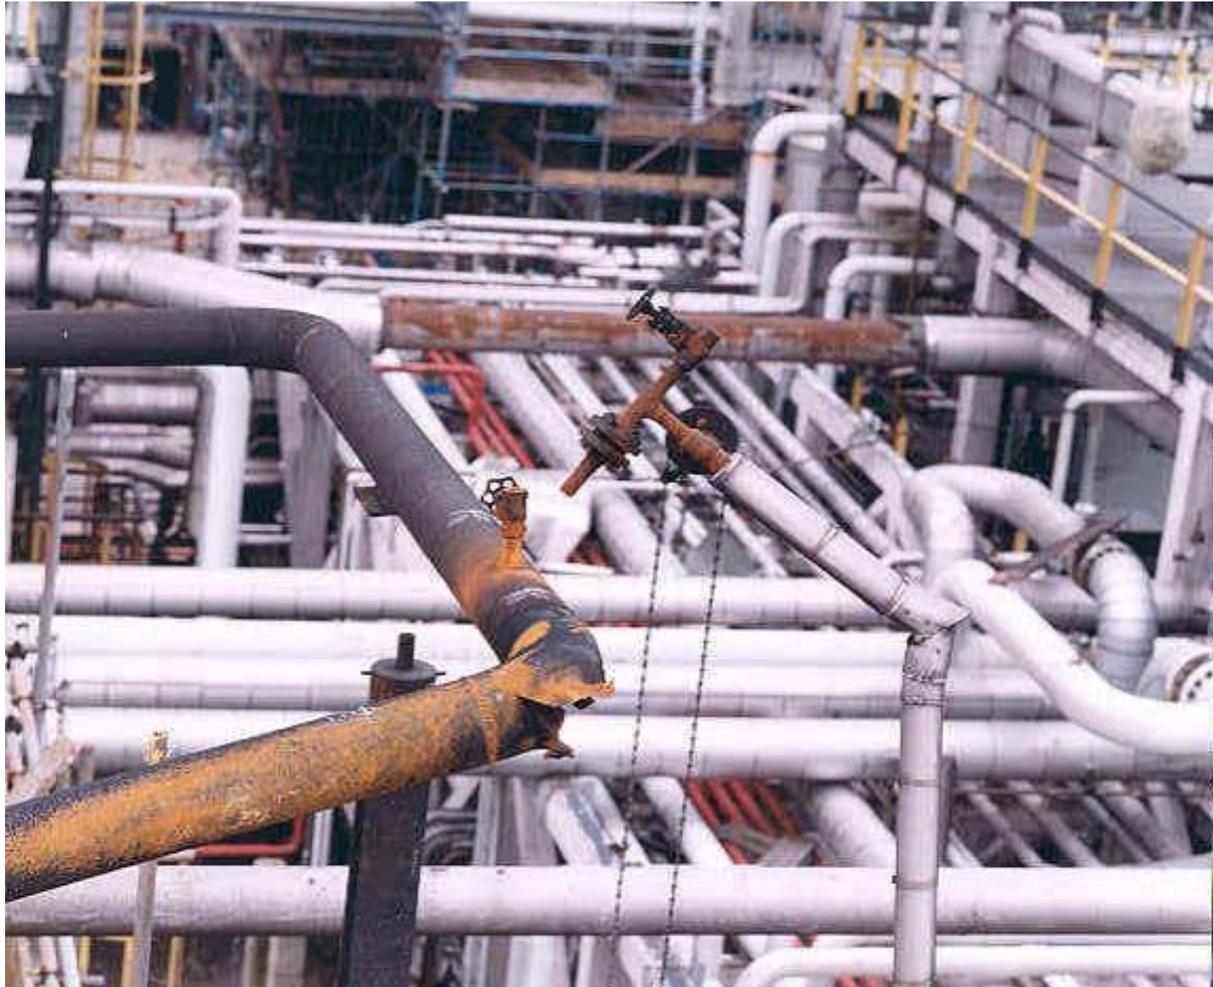
Figure 9 – In-situ failed elbow and injection pipework connection (broken off)

The modification had the hallmarks of a ‘quick fix’ to solve the symptoms of the immediate problem of fouling. Using an existing vent valve to connect the water into P4363 was expedient, and meant that there would have been little or no downtime required for this modification.

The continual flow of water from a jet into a pipe with a potentially corrosive environment should have alerted engineers to consider the influence of the erosion on the whole of the pipe. The position of the water injection point into P4363 was a major contributory factor to the subsequent failure of the pipe.
