# IMPERIAL CHEMICAL INDUSTRIES HEAVY ORGANICS DIVISION

## SAFETY NEWSLETTER NUMBER 8

By Trevor Kletz

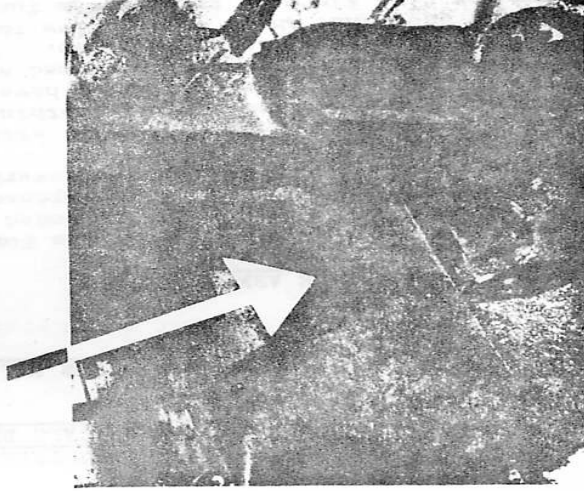
The attached poster was circulated widely a few years ago and various times since. Almost the same incident has now occurred twice more, once on the original Works, and once on a different Works.

A MAN'S FOOT SLIPPED THROUGH  
THIS GAP AND WAS SCALDED

Two similar incidents  
have caused LOST-  
TIME ACCIDENTS

**REPORT defective  
or missing duct  
covers PROMPTLY**
