IMPERIAL CHEMICAL INDUSTRIES HEAVY ORGANICS DIVISION

SAFETY NEWSLETTER NUMBER 11

By Trevor Kletz

2nd July 1969

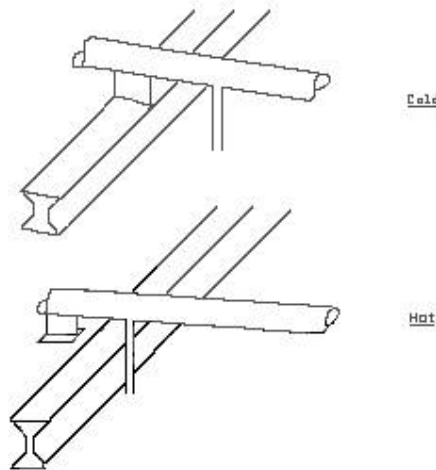
11/8 RUPTURE OF A PIPE-LINE CAUSES A FIRE

Another Company have reported a serious fire which resulted from the rupture of a pipeline carrying hot oil at 300°C. The pipeline, which was 10 ins ID, was fitted with a $\frac{3}{4}$ in branch on the underside $4\frac{3}{4}$ in from a girder on which the pipe rested. Then the pipe was put into service and heated up to 300°C. The expansion of the pipe was sufficient to bring the branch into contact with the girder and knock it off. Calculations later showed that the expansion of the pipe, which was 120 ft. long would result in the branch moving $6\frac{1}{4}$ ins.
