IMPERIAL CHEMICAL INDUSTRIES LIMITED

PETROCHEMICALS DIVISION

SAFETY NEWSLETTER No. 60

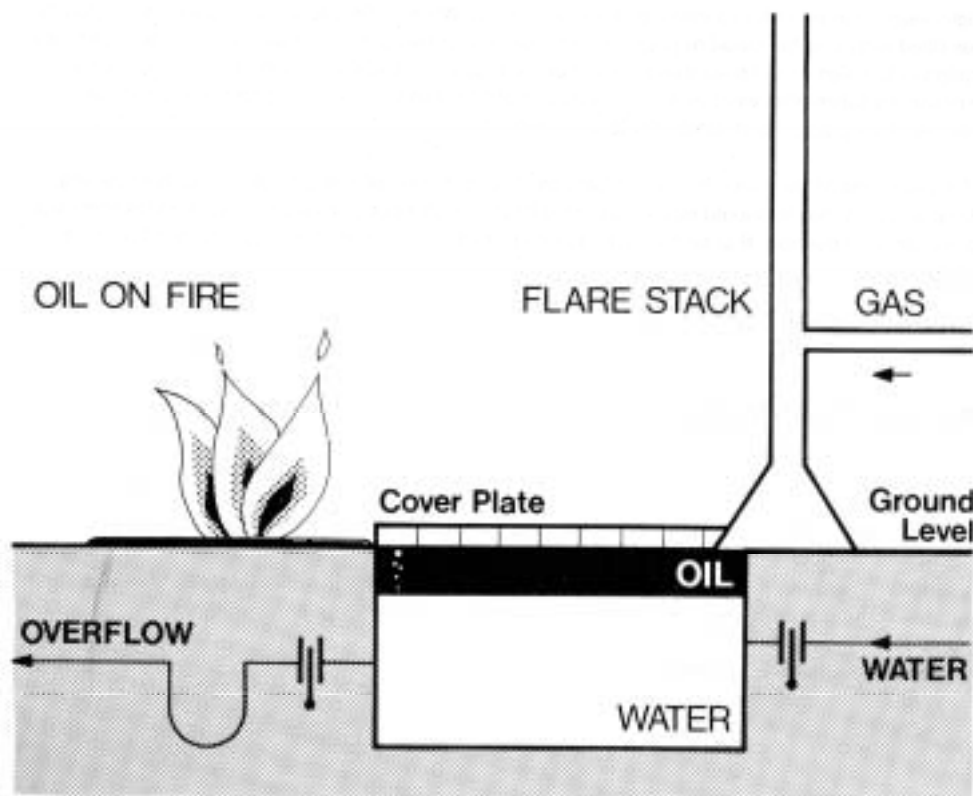
The incident occurred on a flare-stack which sits on top of a concrete sump. The sump was originally fitted with a water inlet line and overflow to drain to wash out any liquid which collected. These were both blanked off when the stack was changed onto a "dry" duty. Some oil nevertheless collected on top of a layer of water, dissolved the bitumen which sealed the sump cover plates and overflowed onto the surrounding ground where it was ignited by a spark from the stack.

The overflow line has now been brought back into use.
