# **IMPERIAL CHEMICAL INDUSTRIES LIMITED** **PETROCHEMICALS DIVISION**

## **SAFETY NEWSLETTER No. 62**

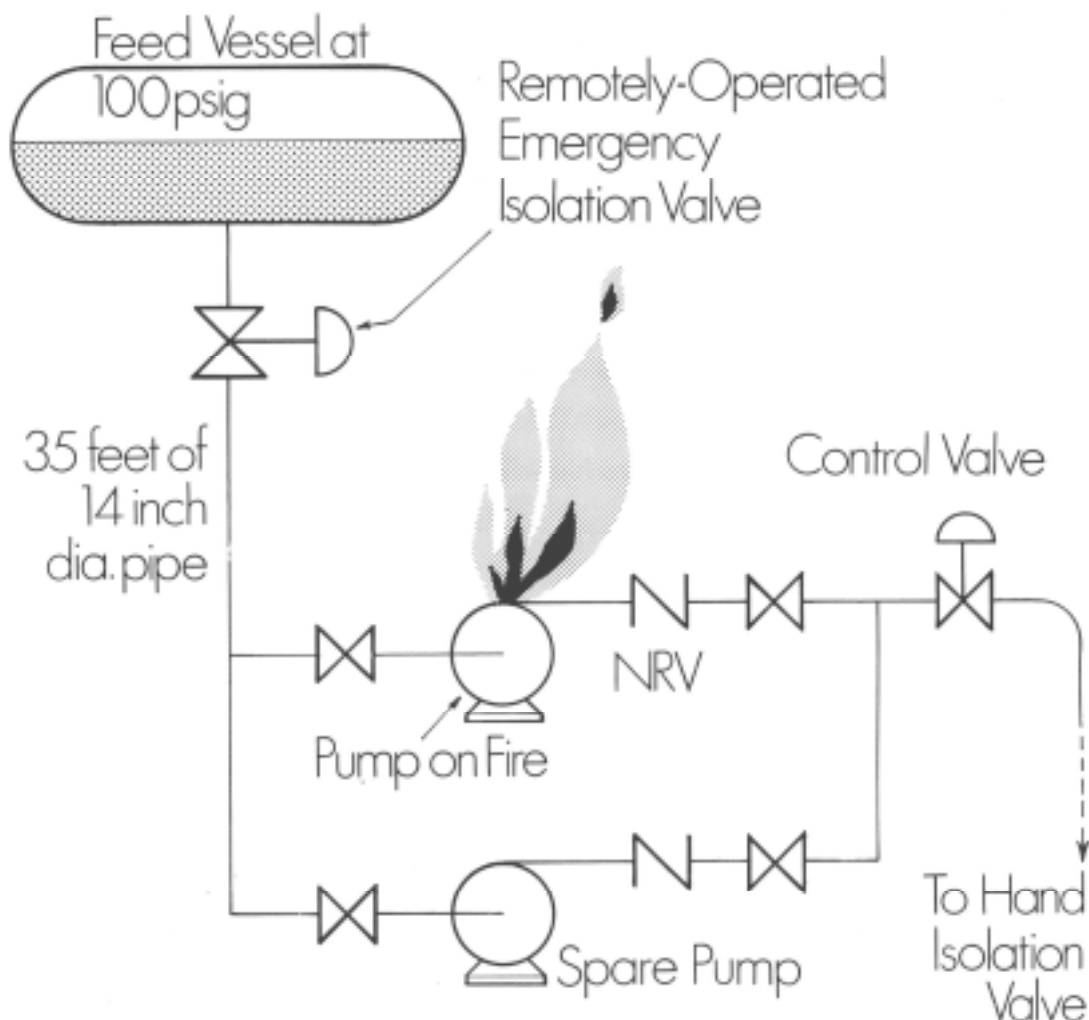
A leak of light hydrocarbon from a pump caught fire. The flames were 30 feet high. From the control room, the operator closed a remotely-operated valve in the pump suction line. The flames soon died

down and the fire burned itself out in twenty minutes. It would have been impossible to have closed a hand-operated valve in the same position and if the emergency valve had not been provided the fire would have burned for many hours. The emergency valve had been tested regularly; it could not be fully closed during testing but was closed part-way.

Back-flow from the delivery side of the pump was prevented by a non-return valve, by closing a control valve and by closing a hand valve well away from the fire.
