IMPERIAL CHEMICAL INDUSTRIES LIMITED
PETROCHEMICALS DIVISION

SAFETY NEWSLETTER No.74

74/1 MORE ABOUT BELLOWS

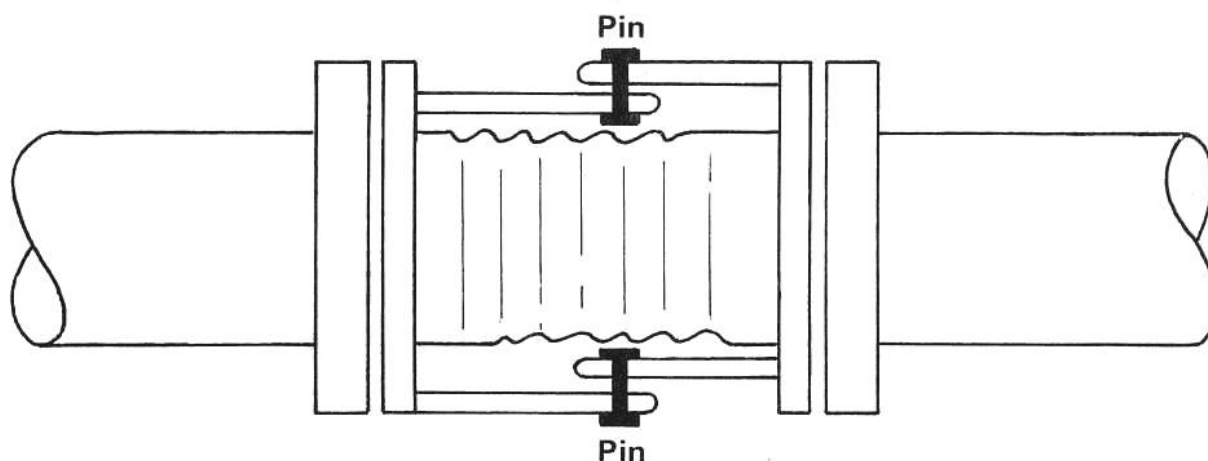
In another incident, a bellows in a 6 inch diameter line was mounted between a pair of flanges hinged together to carry the pressure end load; lugs on the flanges were connected by pins. Two pins failed by fatigue and the bellows became distorted, fortunately without leaking.

If there are any hinged bellows on your plant you should consider if stronger pins are necessary, or if they should be inspected regularly. Bill Jones (P2335 or B3240) may be able to help you.

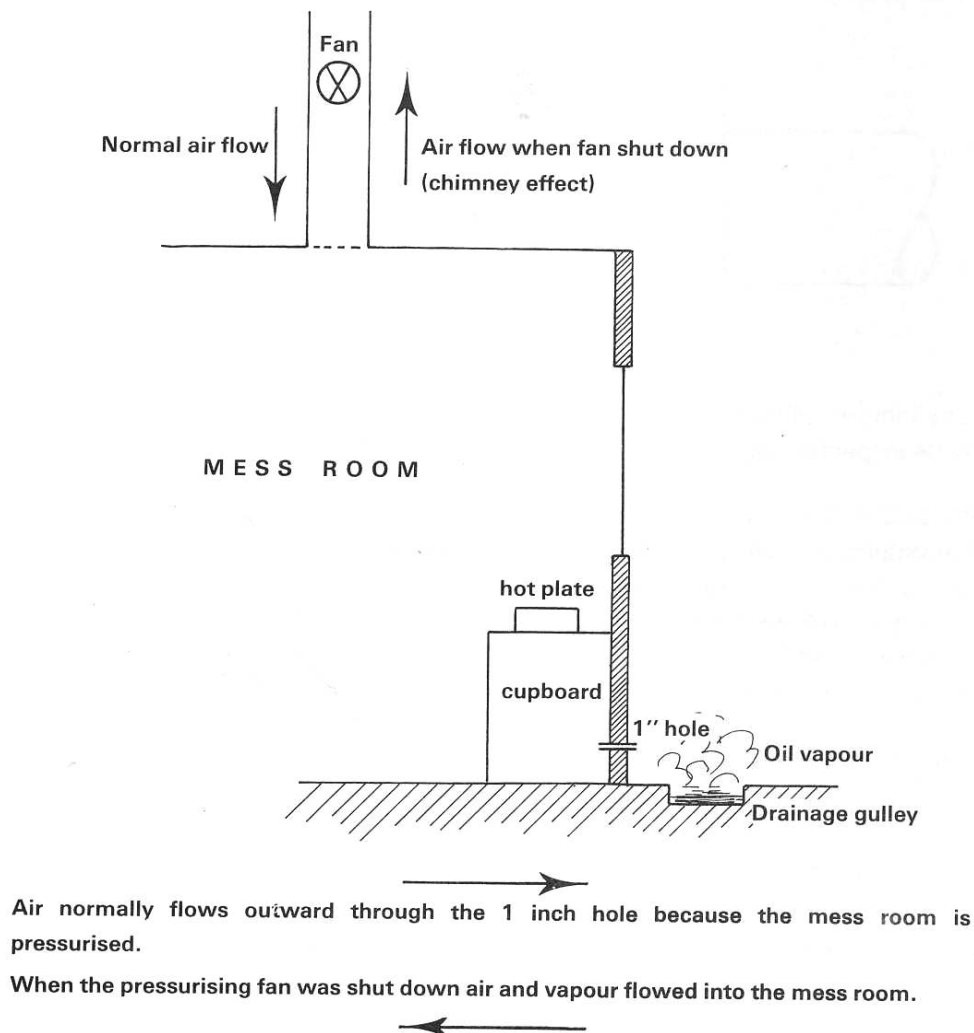
A drainage gully ran alongside the outside wall of the mess-room. When the pressurising fans were

shut down for a few days for repair, vapour from the drainage gully entered the mess-room through a 1 inch hole in the wall. The vapour may have been sucked in by a chimney effect caused by the flow of warm air up the ventilation inlet pipe. At one time a drain pipe had gone through the hole but when the pipe was removed the hole was not blocked up. The vapour accumulated in a cupboard under a sink.

While the pressurising fans were shut down, smoking was stopped in the mess-room and the electric equipment was not used. The explosion occurred 7 hours after the pressurising was restored and was ignited by a hot-plate. The cupboard had not been opened and the vapour had not dispersed.

- (1) All pressurised buildings in areas where flammable materials are handled should be examined carefully to make sure there are no openings which have been overlooked and through which vapour can enter. This examination should be repeated every year.
- (2) If the pressurising fan has been shut down, when it is started up again and before smoking etc. is permitted, the nooks and crannies in the building should be checked with an explosimeter.
- (3) On new plants obvious sources of vapour, such as drainage gullies, should be located away from pressurised buildings.

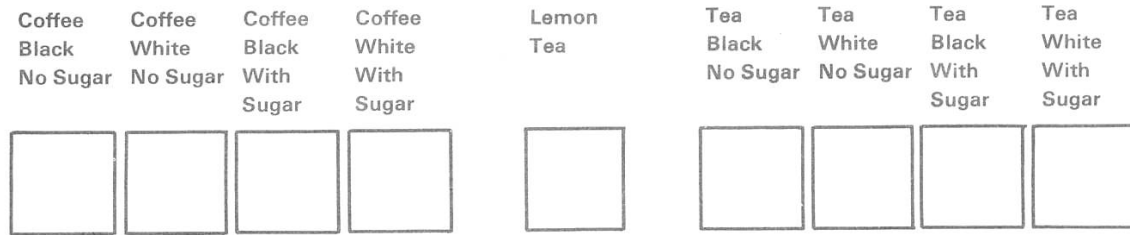
Fig 1

I have been drinking lemon tea. I felt sure I would not make mistakes in future as the lemon tea button is on its own, apart from the other buttons.

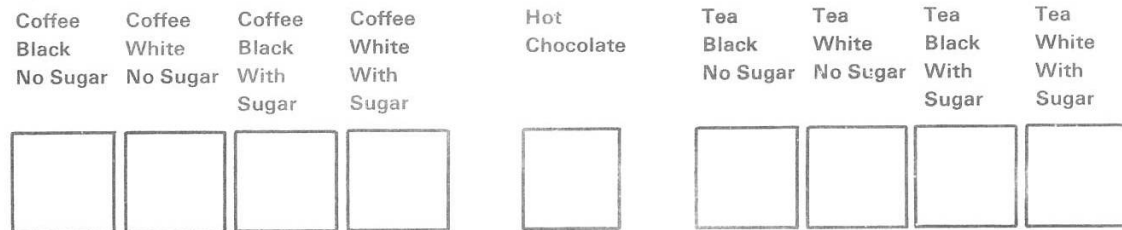
Fig 2

Nevertheless, after a few weeks I did make a mistake and got the wrong drink. I was on the floor below the machine I usually use. I pressed the centre button and I got hot chocolate I

I was so used to pressing the centre button that I did not stop to read the lettering and did not notice that it was different from that on my usual machine.

This is a good example of a situation which sets a trap for the operator. Again, it does not matter very much in this case, but a similar situation on the plant might have serious consequences. If you have more than one unit in the control room with a separate panel for each, and the panels are slightly different, you are setting a trap for the operator and you cannot blame him if he presses the wrong button. The panels should be identical or they should be entirely different. If they are slightly different and cannot be altered then a striking notice or a change of colour is needed to draw people's attention to the difference.
