IMPERIAL CHEMICAL INDUSTRIES LIMITED

PETROCHEMICALS DIVISION

SAFETY NEWSLETTER No.88

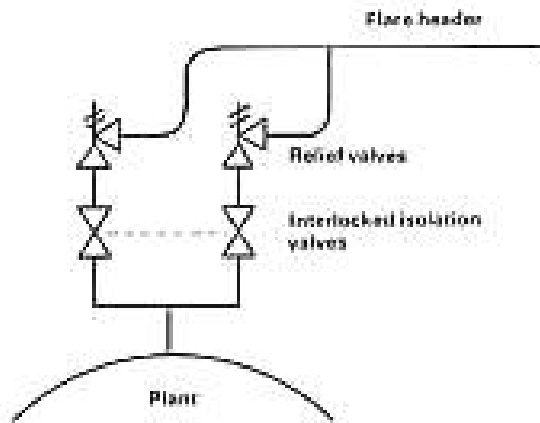
Recently, while an 8 inch relief valve was being replaced, the on-line relief valve lifted and a considerable quantity of warm petrol came out of the open end. Fortunately, it did not ignite and all the men on the job were able to scramble to safety.

The plant instructions state that before a relief valve is removed or replaced on a plant which is on-line, the people concerned must make sure that the plant is steady and that a relief valve is unlikely to lift. Unfortunately, with the passage of time, this procedure had lapsed. Changing relief valves had become a routine job and more attention was given to the danger of air getting in than to the danger of petrol getting out; previous incidents, such as the one described, were remembered. There were also several other jobs in progress and they demanded attention from the operating team.

The best way to change a relief valve with a plant on-line is to use the special sealing plate shown below (and originally described in Newsletter 1 0/7).

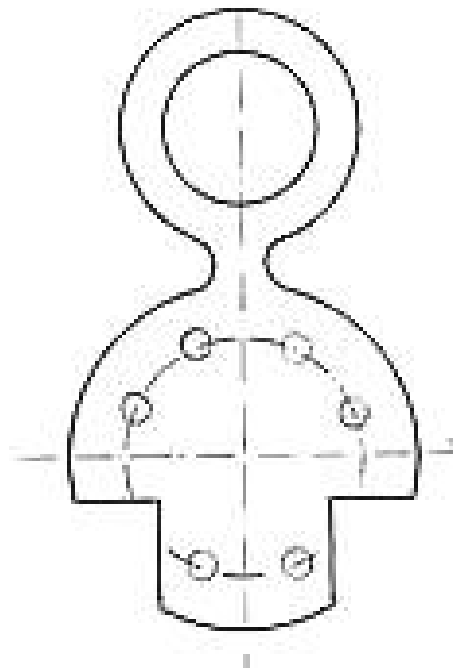
All but two of the bolts joining the relief valve to the flare header are removed; the sealing plate is then inserted and secured by special bolts with small heads that pass through the bolt holes in the relief valve flange, but not through the holes in the sealing plate. The last two bolts can then be removed and the relief valve removed. To replace the relief valve, the procedure is reversed. For details see Engineering Standard TDB 2411.

This system is recommended when changing relief valves on lines greater than four inches bore. On some plants, flanges are provided in the flare lines so that ordinary slip-plates can be inserted. **This system is not recommended as the slip-plates may be left in by mistake. The sealing plate cannot be left in by mistake.**
