IMPERIAL CHEMICAL INDUSTRIES LIMITED
PETROCHEMICALS DIVISION

SAFETY NEWSLETTER No.96

February 1977

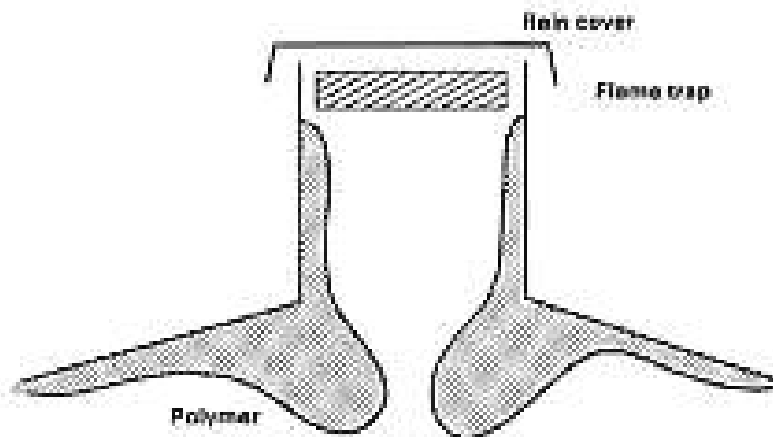
Previous Newsletters (78/8, 77/2, 47/5b, 42/1 and the supplement to 56) have described how tanks were sucked in or overpressured because the vents were choked. Another incident nearly occurred in the Division in a tank containing a hydrocarbon which is liable to polymerise and which is therefore always doped with an inhibitor. The hydrocarbon has a boiling point of 145° C and is stored at atmospheric temperature. When there is a fall in atmospheric temperature some vapour condenses on the roof of the tank; since the liquid formed in this way is not inhibited, it polymerises and a plug of polymer almost bridged across the bottom of the vent pipe as shown below.

The vent pipe is inspected regularly by removing the cover and flame trap and looking through the vent pipe to see that it is clear. The man doing this could not see the build-up of transparent polymer.

The build-up of polymer was discovered when the plant manager, carrying out a personal inspection of the vents, noticed a thin coating of polymer on the inside of the vent pipe. He had the pipe removed for cleaning and the build-up was then discovered.

Now, as well as looking through the vent pipe, they push a wooden rod through it to make sure it is clear.

WARNING: If you do the same, make sure there is something on the end of the rod to prevent it falling into the tank.
