No. 103

**IMPERIAL CHEMICAL INDUSTRIES LIMITED
PETROCHEMICALS DIVISION**

103/1 AN EMERGENCY ISOLATION VALVE STOPS A FIRE

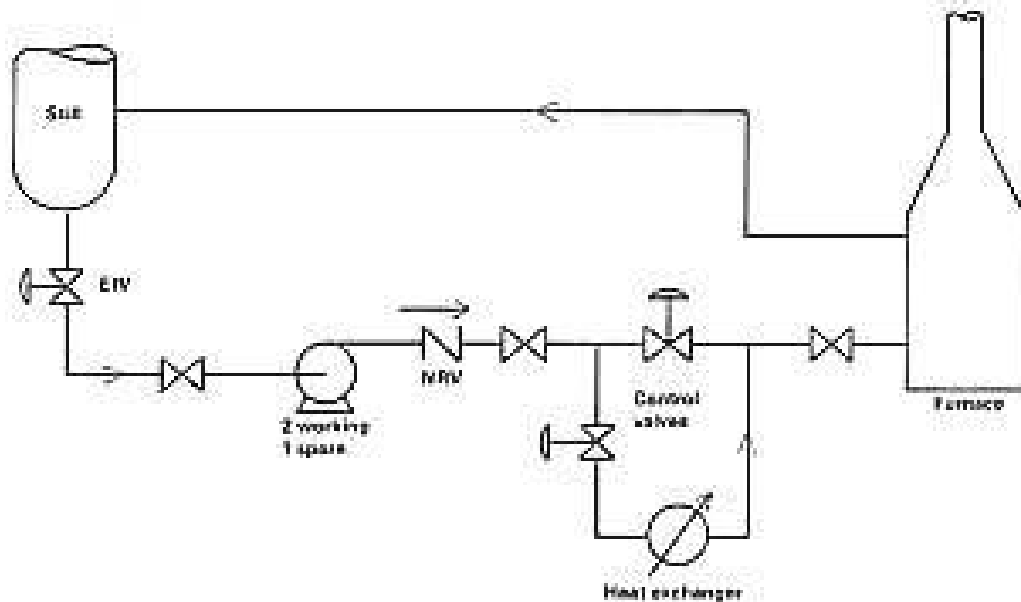
The fire was due to a bearing failure on a pump handling hot light hydrocarbon — actually the feed pump from a still to a reboiler furnace.

The electrically-operated emergency isolation valve (EIV) on the pump suction line was closed by pressing a button. (The valve is tested regularly).

The control valve in the delivery line to the furnace was also closed. Unfortunately this valve is bypassed by the line through the heat exchanger and in the heat of the moment no-one remembered to close the valve in the by-pass line. In addition the non-return valve did not hold. The flow of oil backwards from the furnace was stopped by closing a hand valve next to the furnace which was about 100 feet from the fire.

The non-return valves on all three pumps were out-of-order. On one the seat had become unscrewed, on another the fulcrum pin was badly worn and on the third the pin was worn right through and the flap was loose. The valves had not been inspected since the plant was built. As mentioned in Newsletter 61/6, when failure of a non-return valve can affect the safety of the plant, it should be scheduled for regular inspection.

The report on the fire recommends that another emergency isolation valve is installed in the pump delivery line.

Although the EIV was not affected by the fire, the report nevertheless recommends a critical look at the standard of fire protection of EIV's and their impulse lines — many such valves are not fire-protected at all. Rotork can supply a fire-resistant sack to put over the valves and this is being tested.

If control valves are used for emergency isolation a special switch may be necessary to close them in an emergency, so that operators do not have to go to the control room to alter the set-points on the controllers.

The operation of an emergency isolation valve should automatically shut down any pump in the line and trip the fuel supply to any furnace.

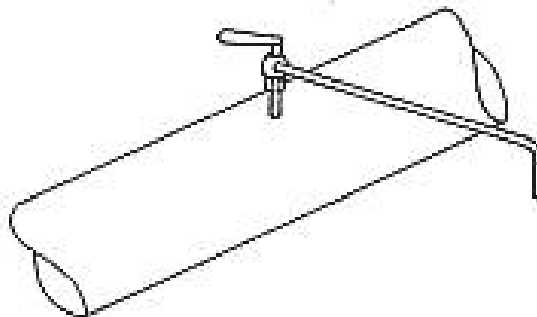
a) Commenting on Newsletter 100/2, a reader points out that if a right-angled cock had to be used it should have been installed as shown below
