No. 110

IMPERIAL CHEMICAL INDUSTRIES LIMITED

PETROCHEMICALS DIVISION

110/1 ANOTHER FIRE CAUSED BY MIXING WATER AND HOT OIL

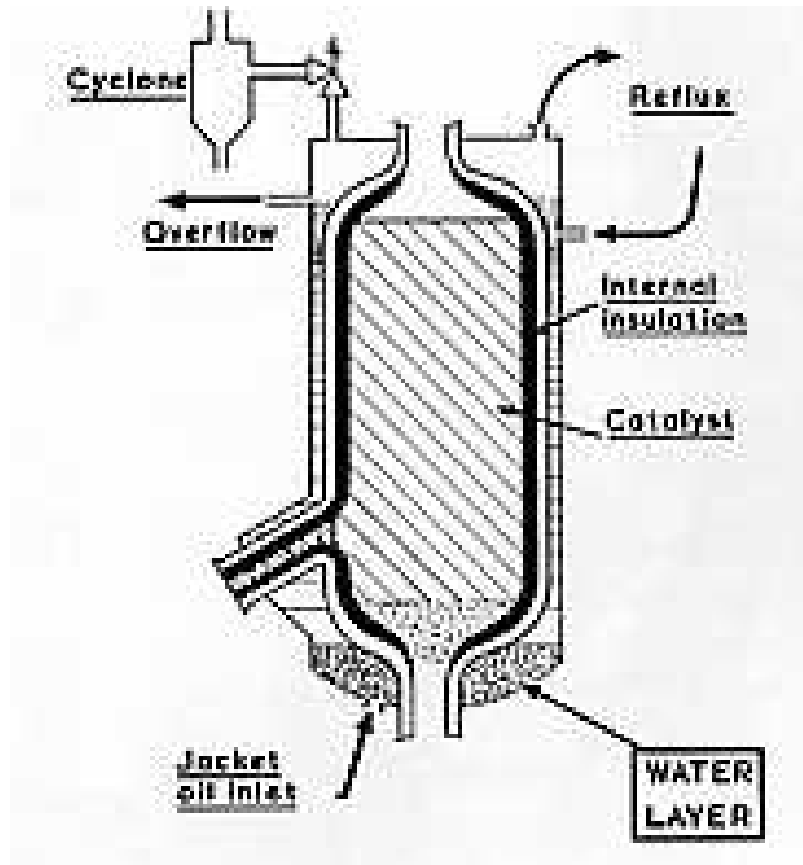
A carbon steel reactor is insulated internally. Cracks in the insulation and channelling in the catalyst could cause hot spots to develop on the steel shell and these might exceed the safe working temperature. The reactor is therefore surrounded by a jacket containing a heat transfer liquid.

Originally water was used but it was found that temperatures above 100°C were needed. Water under pressure could not be used as the jacket was not strong enough, so oil was used instead. A by-product of the process, boiling point 170°C, was found to be suitable and was used. To avoid degradation, there is a continuous make-up at the bottom of the jacket and overflow from the top. The oil enters at about 120°C and oil vapour from the top of the jacket is condensed and returned.

As the result of an upset in the plant the by-product oil became contaminated with water which settled out in the base of the reactor. The water did not boil immediately as the hydrostatic pressure in the jacket raised its boiling point to about 120° C, the temperature of the incoming oil. However, when a minor disturbance caused some mixing of the oil and the water, some of it flashed and blew some of the oil out of the jacket relief valve. A cyclone had been provided after the relief valve but it was not designed for such a high flow and some oil escaped to atmosphere. It was ignited by a neighbouring furnace and, although all the oil that came out burnt in five minutes, damage to instruments and electric cables was extensive.

All hot oil systems should be critically examined in order to identify ways in which water might enter. Precautions should then be taken to prevent water entering and to detect and remove any that does enter.

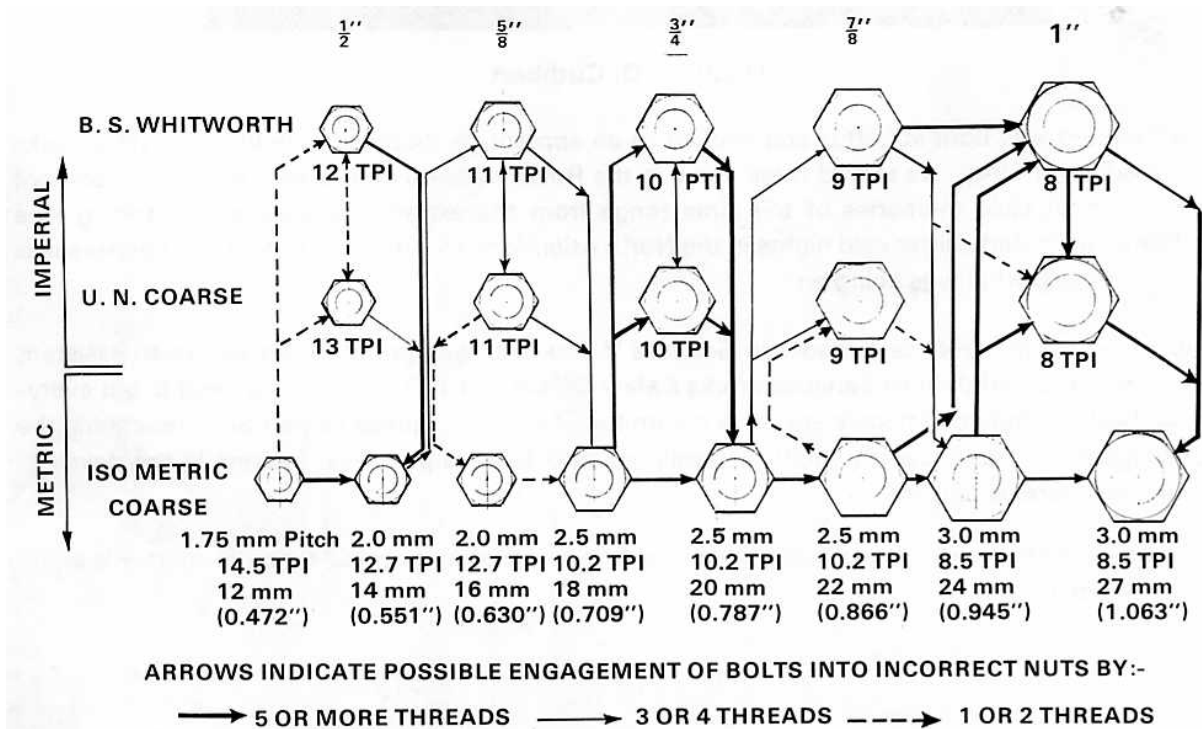
Interchangeability between the three main thread systems is illustrated on the accompanying chart (BSF and UNF ignored) which shows that thread engagement can vary from full engagement of a loose nature of incorrect nuts from another thread system, through misleading apparently correct

engagement, to a tight fit of perhaps only two or three threads which could tempt the user to apply force suspecting a burr, dirt or other cause of tightness.

Proper segregation in stores helps keep the problem under control together with an awareness of error potential on the part of all users. Marking systems can help where manufacturers and/or users have applied these. Whitworth nuts and bolts carry no identification, Unified bolts have a shallow circular recess on the head with nuts stamped on one flat with circles (000) or a circular groove of semi-circular section in the non-bearing face, ISO Metric bolts have the symbols ISOM or M stamped or embossed on the head with nuts stamped with an M on one flat. ICI Standard Sheet 08-0200 gives all the details.
