CASEBOOK NEWSPAPER

No. 112

SOME PIPE AND VESSEL FAILURES

IMPERIAL CHEMICAL INDUSTRIES LIMITED

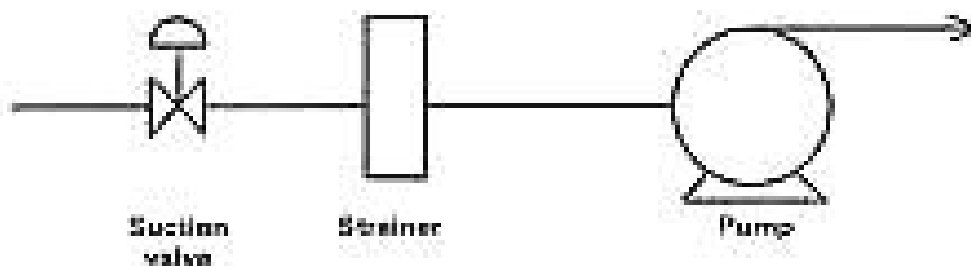
The control room operator switched No 1 pump suction valve into the manual position so that the maintenance crew could close the valve in the pump room. **He did not put any lock or warning on the switch.** He started up No 2 pump in place of No. 1.

The maintenance crew closed the suction valve and started work on the strainer.

Ten minutes later No 2 pump gave trouble and had to be shut down. The operator forgot that the maintenance crew were working on No 1 pump and decided to start it up. He switched the suction valve into the normal automatic position and the valve started to open. Crude oil at 235 psig came out of the open top of the strainer, hit the ceiling and deluged the entire pump room. An explosion blew off the roof and blew down the walls. One man was killed and five injured. The source of ignition may have been the lights which were damaged by the oil jet.

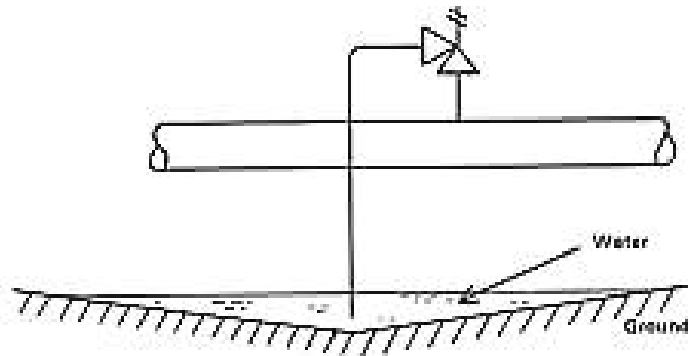
A line carrying liquefied gas (in another Company) was protected by a small relief valve, but nevertheless a high pressure developed in the line and damaged a pressure transmitter.

It was then found that the tail pipe from the relief valve came down to ground level in an area that was prone to flooding. The water rose above the end of the tail pipe and froze.

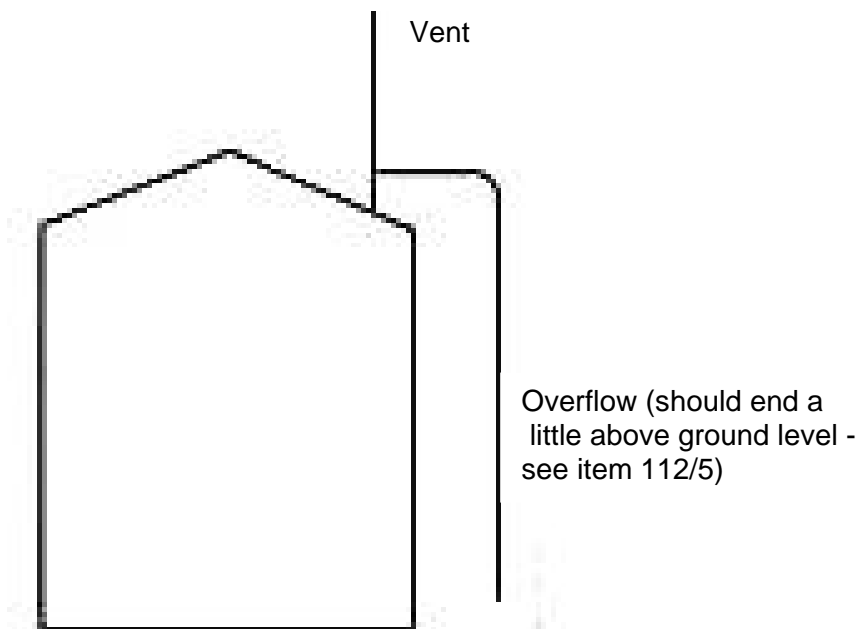
An explosion occurred in a tank containing sulphuric acid. The vertical tank split round the bottom weld, rose 50 feet into the air, went through the roof of the building and fell into a clear space close by, just missing other tanks. Fortunately, nobody was seriously injured but if the tank had fallen on the other side of the building it would have descended into a busy street.

Slight corrosion of the tank had produced hydrogen. As the tank was provided with an overflow pipe leading down to ground level rather than a vent, the hydrogen could not escape and accumulated at the top of the tank (as in the incident described in Newsletter 59/6). The tank had not been made with a weak seam roof, presumably because the possibility of an explosion had not been foreseen. The hydrogen was ignited by welders working nearby.

The report recommends that acid tanks should have a vertical vent pipe as well as an overflow pipe, as shown below, so that hydrogen can escape, or an explosion vent in the roof or a weak seam roof.
