No. 119

SOME INSTRUMENTS WHICH CANNOT DO WHAT WE WANT THEM TO DO

IMPERIAL CHEMICAL INDUSTRIES LIMITED
PETROCHEMICALS DIVISION

January 1979

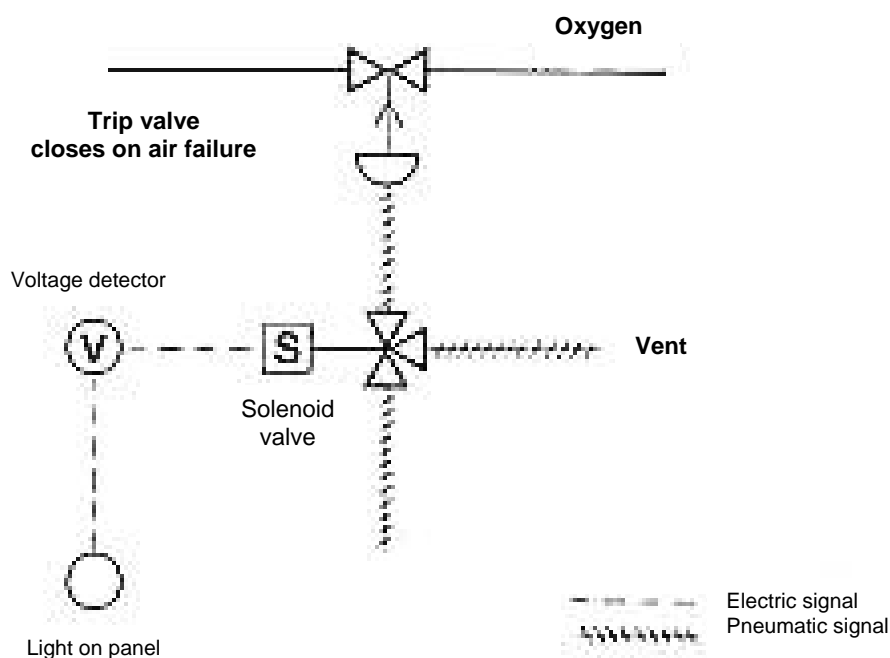
The light shows that the solenoid is de-energised, not that the oxygen flow has stopped

The trip valve was closed by venting the air supply to the valve diaphragm, via a solenoid valve. The light on the panel merely said that the solenoid valve had been de-energised. Even though the solenoid valve is de-energised the oxygen flow may continue because:-

- The solenoid valve fails to open.
- The air fails to vent.
- The trip valve fails to move.
- With some designs of trip valve, even though the spindle moves, the valve may not close (See Newsletter 117/4).

Actually (b) happened; the vent line on the air supply was choked by a wasp's nest. It seems incredible that a wasp's nest could do this, but the incident occurred in Texas where the wasps are, no doubt, bigger than elsewhere. (See "A Survey of Fires and Explosions in Hydrocarbon Oxidation Plants", available on request).

We should always try to measure directly the property we wish to know, not some other property from which it can be inferred.

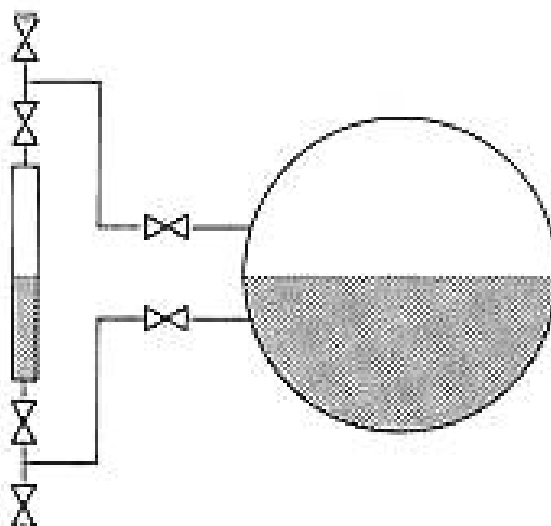
A manager found a level glass four feet long connected to vessel branches two feet apart.

The level glass will indicate the correct level only when the liquid level in the vessel is between the two branches.

Reminder: We do not like sight-glasses on flashing flammable or toxic liquids. See our Safety Note 72/20.

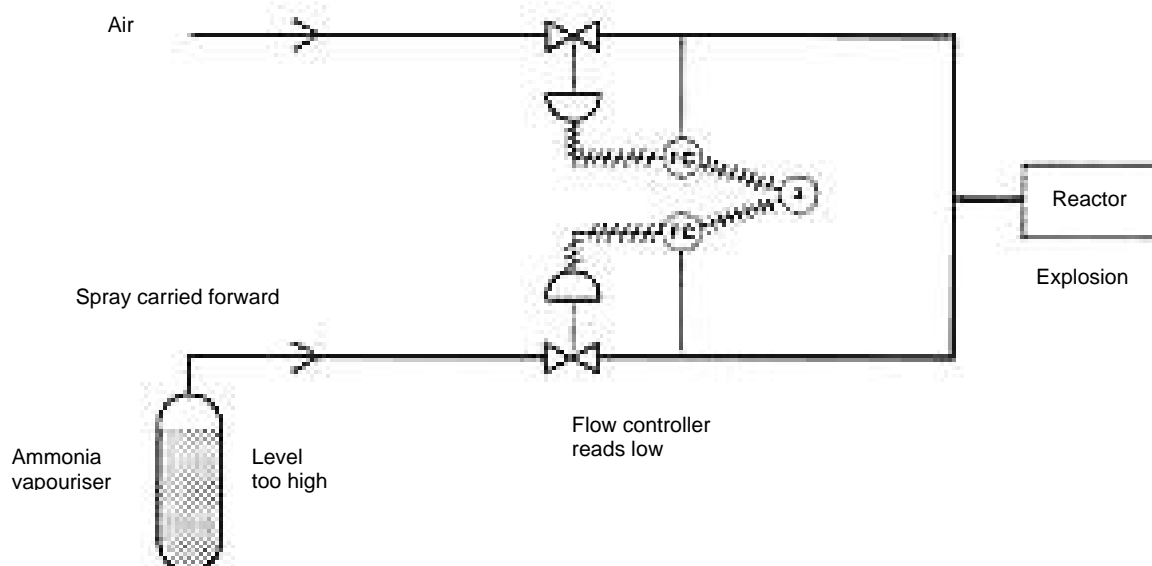
The vaporiser level controller was out of order and the level of ammonia was on hand control. The level got too high and droplets of ammonia were carried forward. These were not picked up by the flow ratio controller and an explosion occurred.

All flow measurements are inaccurate when spray is present; the error depends on the detailed design. If the spray increases the density of the gas by 50% then the flow of vapour and liquid could be 25% higher than the flowmeter reading.
