**No. 166
BOOBY TRAPS**

**IMPERIAL CHEMICAL INDUSTRIES LIMITED
PETROCHEMICALS DIVISION**

166/7 — AND DO NOT PUT HOLES WHERE THEY SHOULD NOT BE

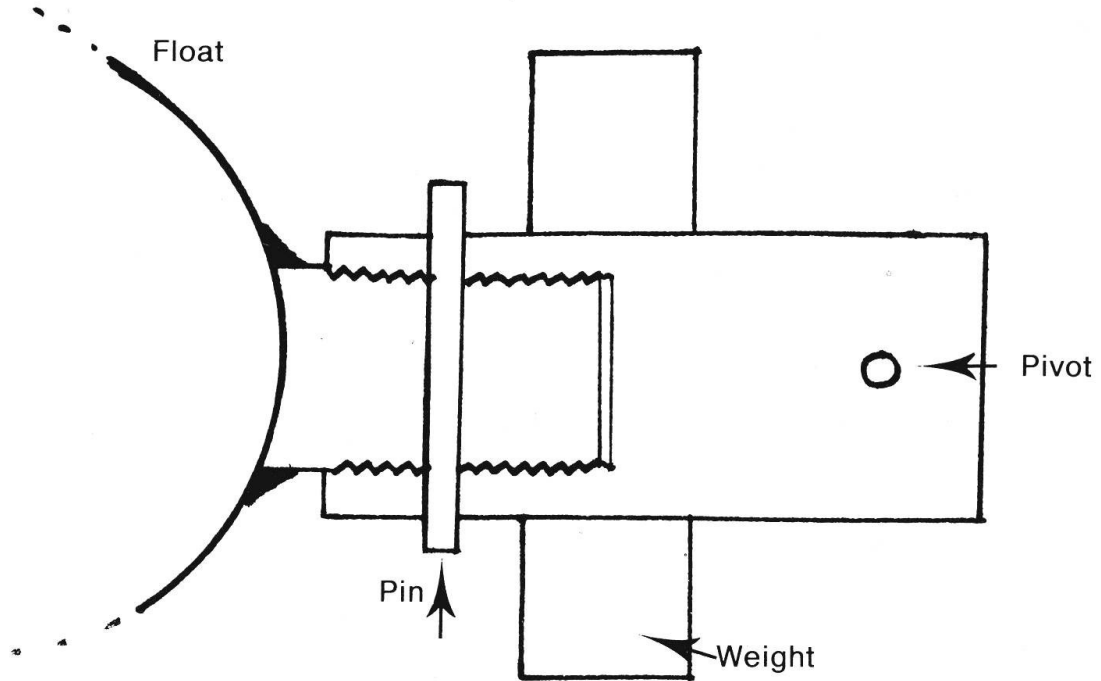
Originally, the float for a liquid level instrument was made like this:

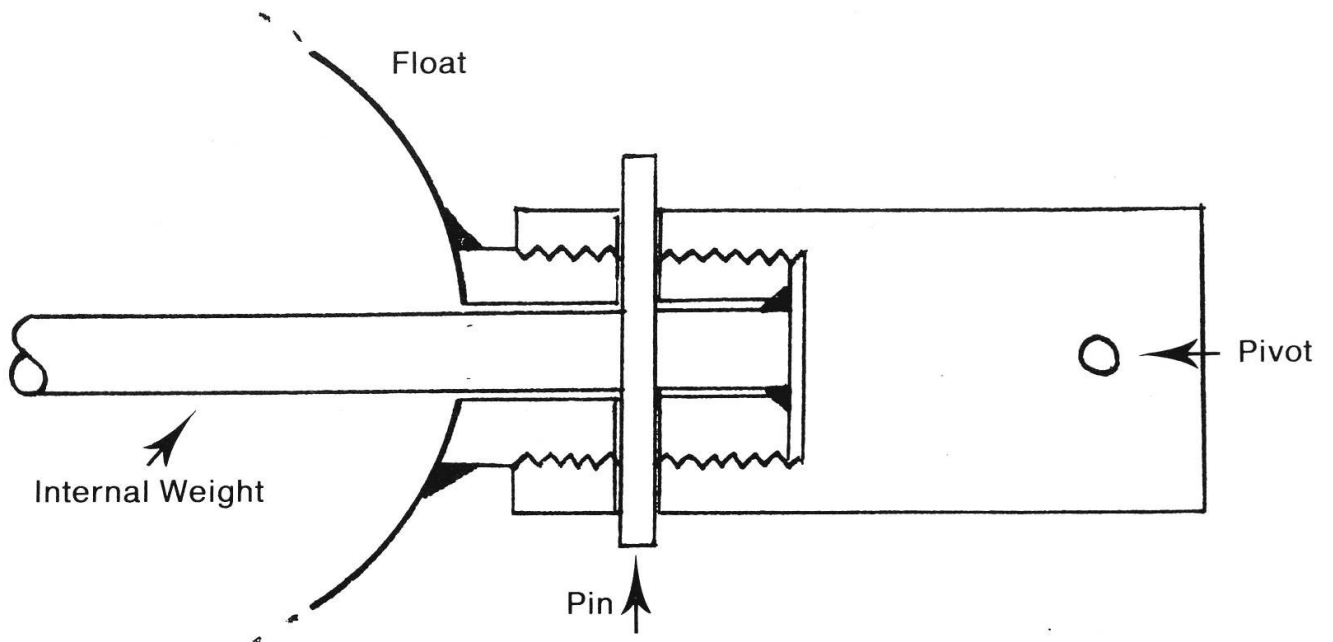
After some time, the design was altered to put the balance weight inside the float

After a while it was noticed that an encrustation of salt was building up round the securing pins. When the floats were completely dismantled brine came out from inside.

It was then realised that although the ends of the new weights had been sealed, small gaps had been formed between the pins and their holes. Brine seeping down these had entered the floats and caused false readings.

When the design was altered, the manufacturer had not altered the ordering code so no one on the plant was alerted to the change and the need to check.
