# **CATASTROPHIC INCIDENTS**

## **No. 132 ROT STARTS AT THE EDGES**

**IMPERIAL CHEMICAL INDUSTRIES LIMITED  
PETROCHEMICALS DIVISION**

## **132/1 ROT STARTS AT THE EDGES, NOT IN THE MIDDLE**

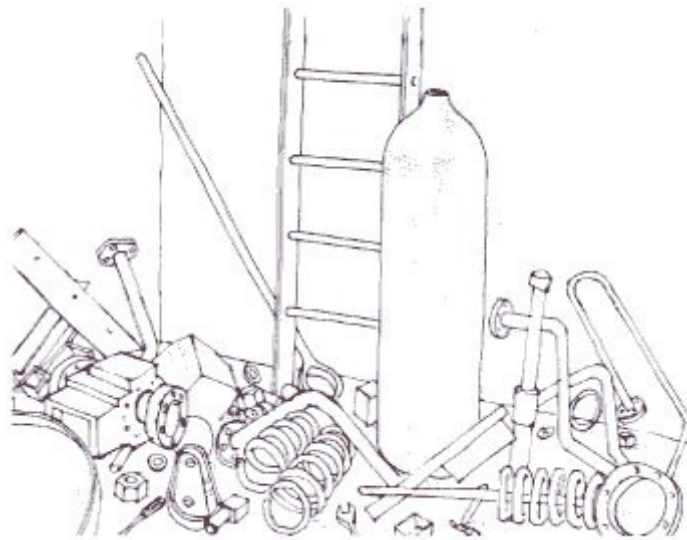
When I used to carry out safety and good housekeeping inspections, if I knew from experience that the mainstream plants would be shipshape, I used to look to the edges of the plant where horrible sights could often be seen. The drawing shows one from my collection of photographs — a little-used ladder in a little-used store.

### **Fringe areas and activities must get their fair share of attention.**

Operators and managers should visit them regularly and should keep an eye on the relevant readings.
