## Incident

# The sugar dust explosions and fire at Imperial Sugar Company, Georgia

Tony Fishwick

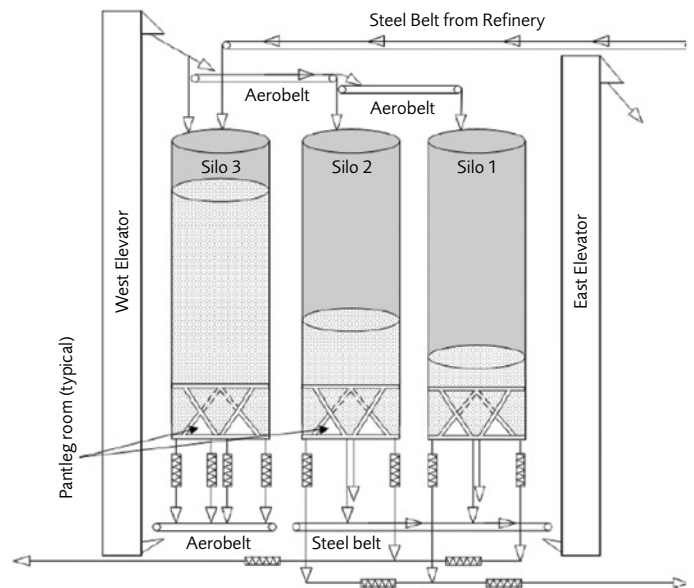
The first explosion initiated in the enclosed steel belt conveyor below the sugar silos (Figure 1) and was the result of explosive accumulations of sugar dust inside the enclosure. Poor housekeeping was a major contributory factor, and this is a feature that has relevance to any facility dealing with finely divided substances that might accumulate and be a source of explosion – due to static discharge or other reason(s). Severe damage was caused to plant equipment and buildings in addition to the loss of, or impairment to, life. The circumstances are described in detail in the CSB report into the accident<sup>1</sup> and summarised in this article.

Figure 1: Sugar flow into and out of the silo

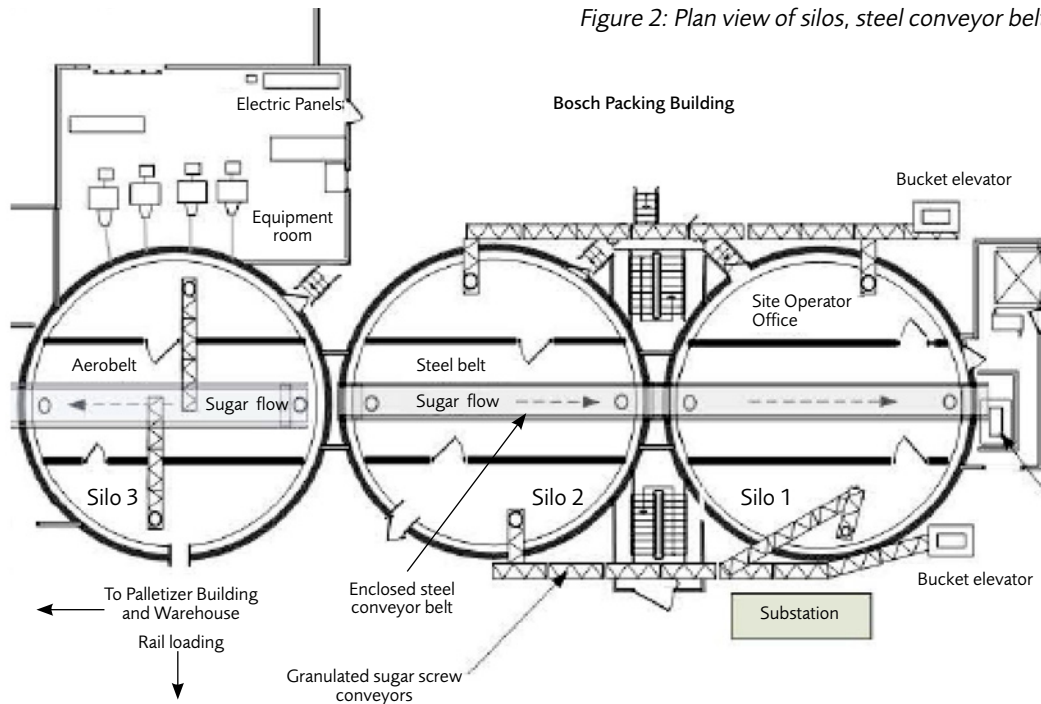
Figure 2: Plan view of silos, steel conveyor belt and other items

panel had been blown off the tunnel support frame. There was major damage at the east end of the silo tunnel (Figure 2) with all equipment deflections eastwards away from the tunnel. The equipment under Silo 3, and outside the west of the tunnel, had damage patterns indicative of a pressure wave travelling west out of the tunnel. The wooden walls and doors were blown off both the east and west entrances of the tunnel. Mangled steel belt cover panels were blown off and the brick wall to the south was blown into the south packing area.

The primary explosion sent overpressure waves out into the first floor of the Bosch Building (Figure 2). Brick walls were blown from the silo area into the packing area. Fireballs were fuelled by sugar dust dislodged from overhead equipment and thrown into the air by the advancing pressure waves. Concrete floors were violently heaved upwards throughout the south packing building. Workers in the packing buildings had little or no warning as walls, equipment and furniture were thrown into the air. Escape routes were hampered by dense, dark smoke. Intense fireballs advanced through the entire north and south packing and palletizer buildings. Fires were ignited in the refinery and bulk sugar building hundreds of feet away from the seat of the incident. The secondary explosions and fires most probably caused the fourteen fatalities.

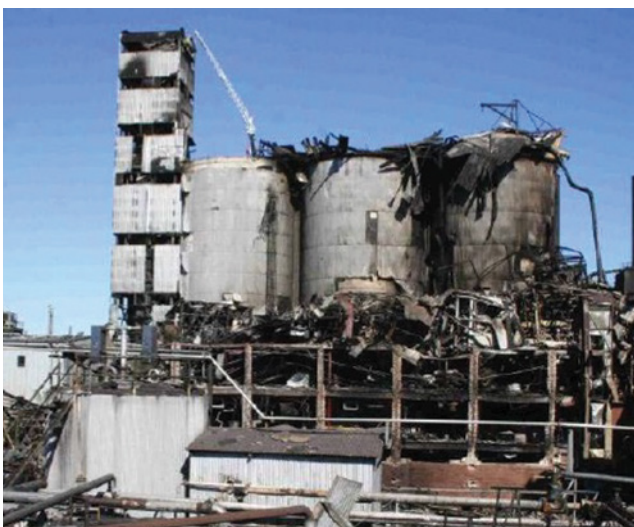
and powdered sugar packing buildings, bulk sugar loading buildings and the raw sugar refinery. Three-inch (75mm) thick floors buckled from the force of the explosions, the roof of the palletizer building was shattered and blown into the railcar loading area. Violent fireballs erupted out of the penthouse on top of the silos, the west bucket elevator and surrounding buildings (Figure 2). The damage to the silos and adjacent buildings is shown in Figure 3, and the extent of the devastation to the entire site is illustrated in Figure 4<sup>2</sup>.

Figure 3: The damage to the south packing building and the penthouse

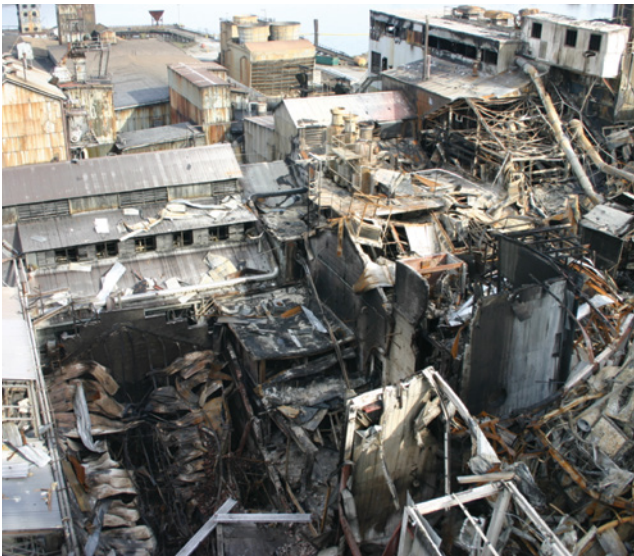
Figure 4: The extensive damage to buildings and equipment
