Chemical Incident Investigation

Millennium Inorganic Chemicals (MIC)

Stallingborough UK, 2010

May 2019

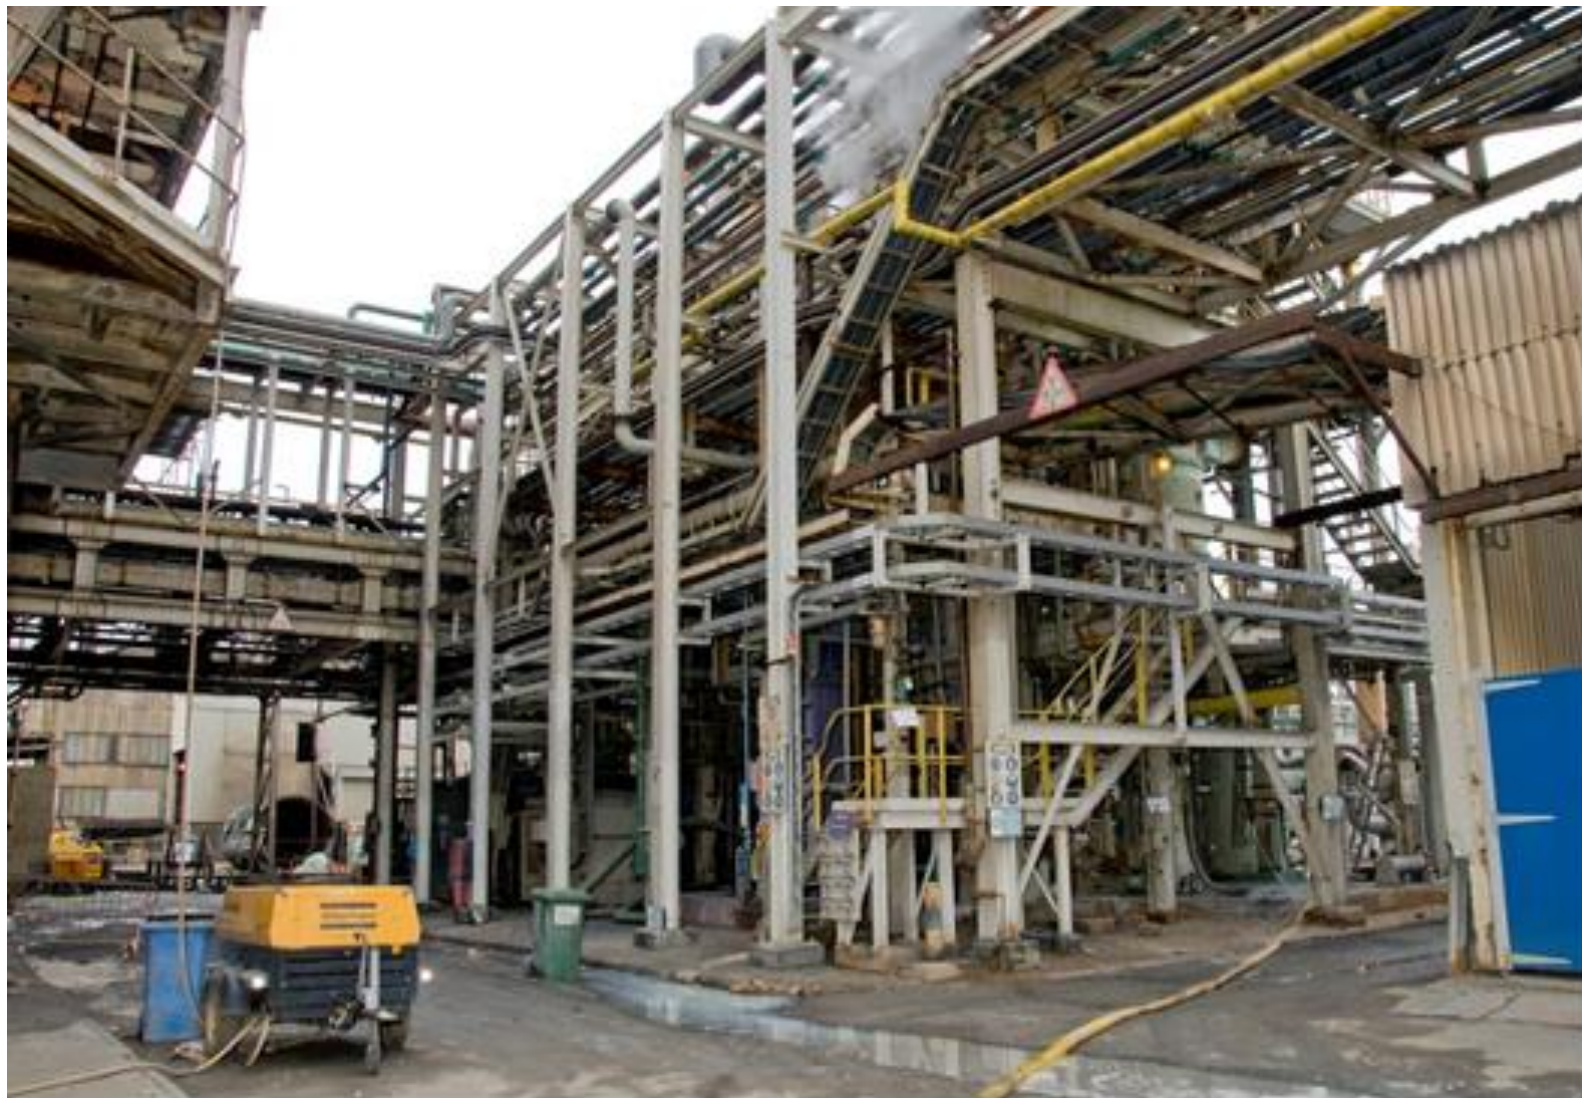
Unit 600: Scene of a Violent Reaction

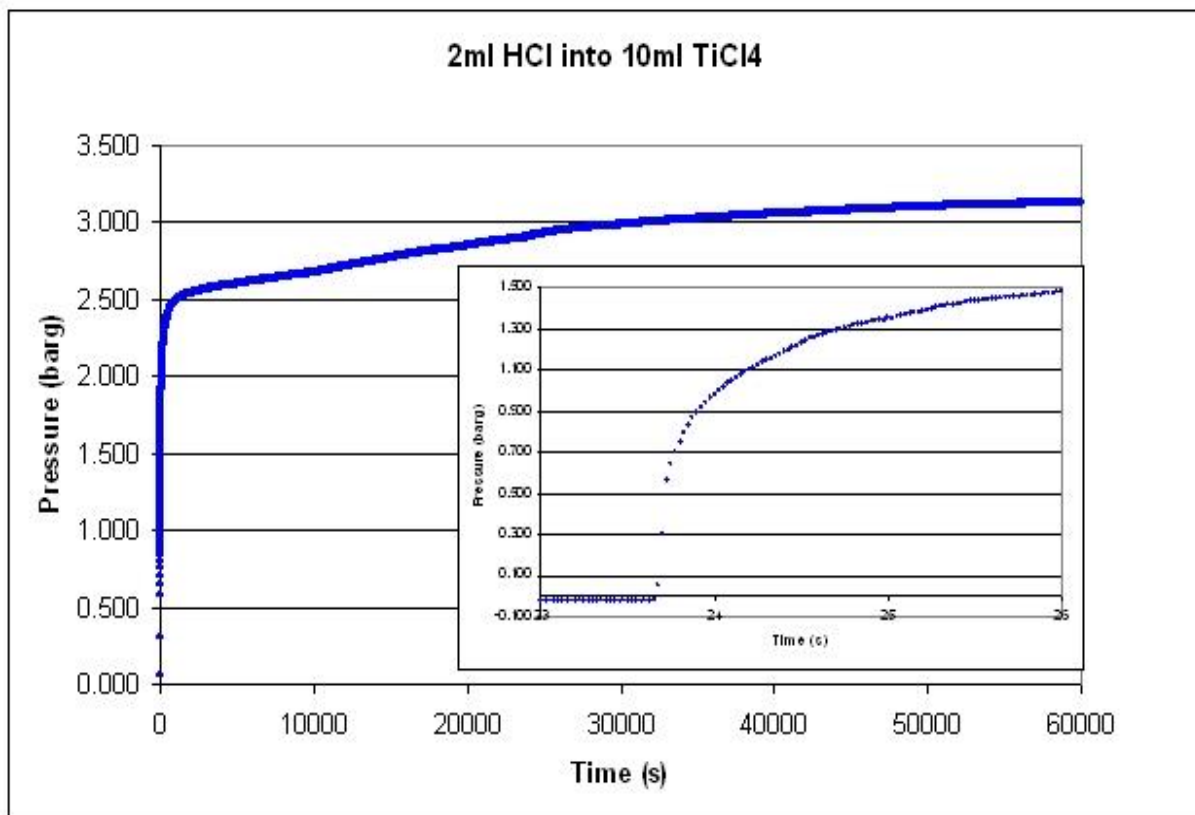
Pressure Increases

- Pressure rise 0-1 bar about 400ms
- Final Pressure 3.13 bar
- 1.3 bar could be from hydrochloric acid

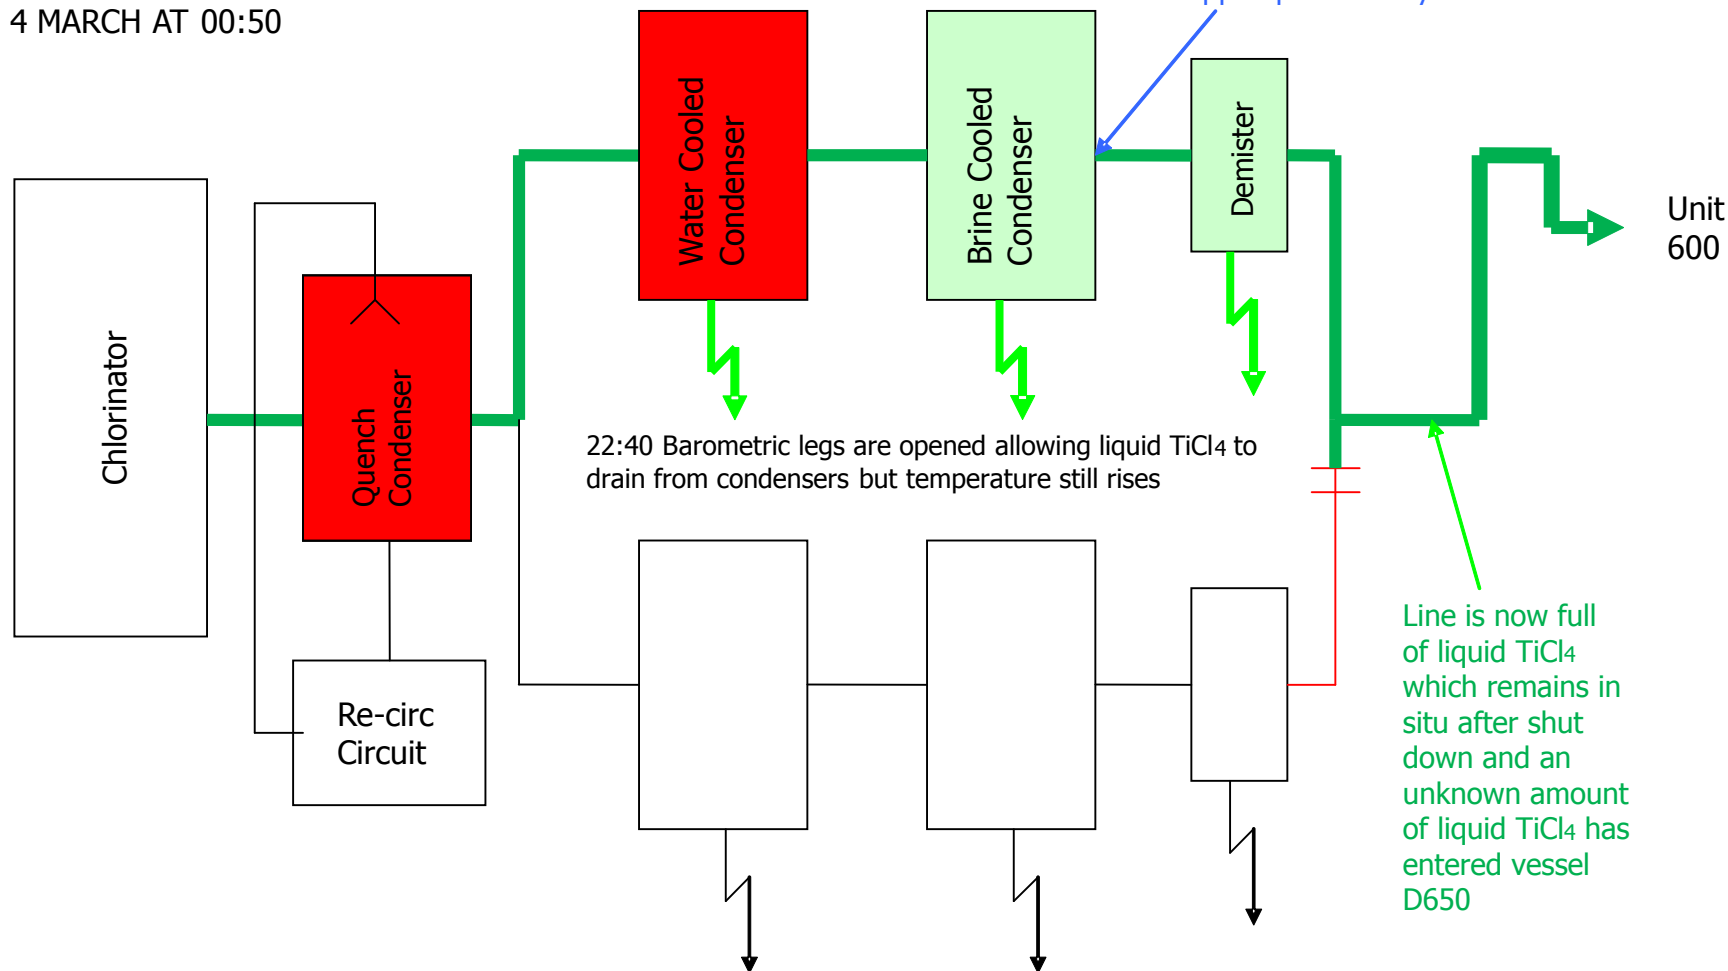
CONDITIONS WHEN WARM UP IS
STOPPED PREMATURELY ON
4 MARCH AT 00:50

New upper operating limit of
-5° is reached and warm up is
stopped prematurely

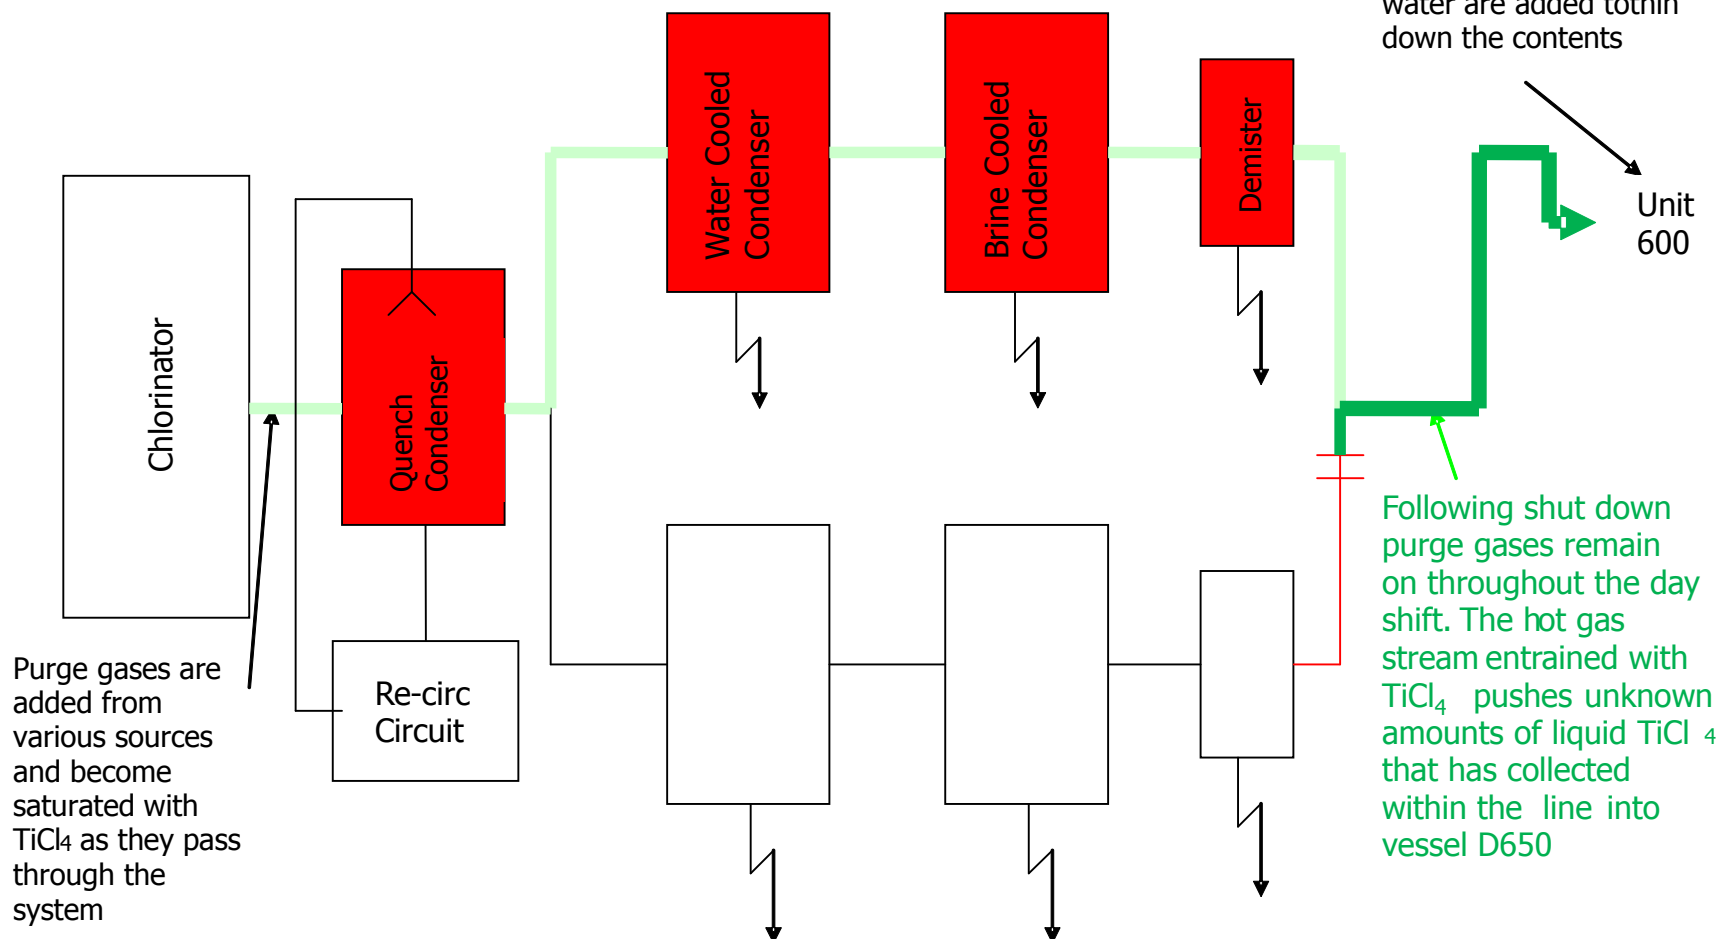
CONDITIONS DURING THE DAY SHIFT 4 MARCH

Water and brine off to enable repair

Significant quantities of $TiCl_4$ enter D650.
Unknown quantities of water are added to thin down the contents
