Lessons learnt from some accidents which resulted in discharges to regulated waters

Chris Dickinson, FIChemE, Regulatory Officer, The Environment Agency, Deanery Road, Bristol, BS1 5AH

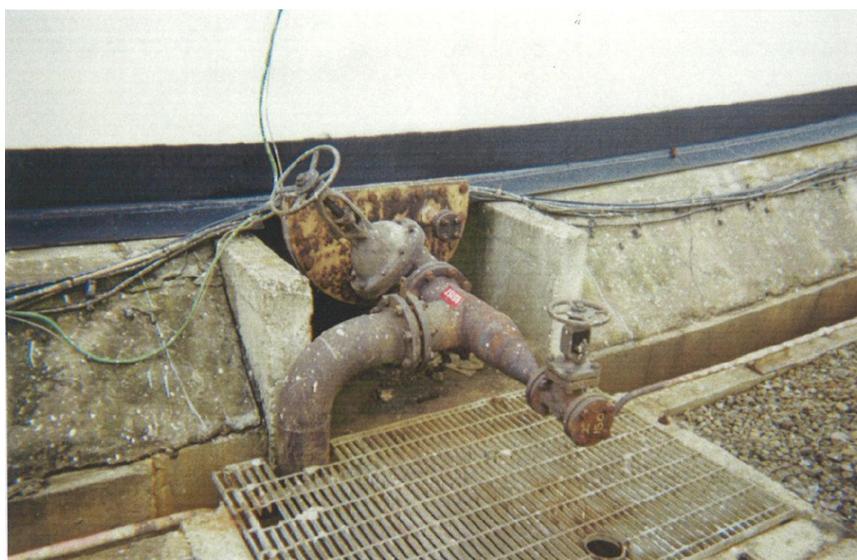
Figure 1 - The Dewatering Valves as reconfigured following the event

The incident first became apparent on a Tuesday following a long Bank Holiday. It had actually started the Thursday before. Water accumulates at the base of the type of the floating roof stock tank involved in this incident, which from time to time has to be removed (dewatering). The incident occurred following a Tank “dewatering” operation. The operation was undertaken by a “Stand-by” man who was on a temporary contract to the operator. He believed he shut the valve at the end of the operation but it became apparent later that he had not. A picture of the valve involved is shown as Figure 1 (note this is the valve as reconfigured after the incident, - the second, smaller valve was fitted after the incident).

- i) The tank dewatering valve was not fully closed after dewatering. Despite the standard set by HSG 176, only a single isolation valve had been provided for the dewatering operation. It should have been obvious to a competent process operator that the valve was passing. The standby man was not a process operator. He was a regular worker normally used as a standby man for safety purposes, fork lift truck driving, general cleaning etc. For the previous couple of weeks prior to the incident, he had been used to dewater large stock tanks similar to the tank involved in this incident. Before commencing this work, he has received some informal training by a regular process operator comprising an explanation of the P&ID's and an introduction on how to use the process logging system to record the dewatering operation. On the first occasion he went out to actually dewater a stock tank he was accompanied by the process operator who had "trained" him. Subsequently, he had been left alone to do the job.

- ii) The slip plate had not been refitted at the conclusion of the dewatering operation. The company reported that following the dewatering operation a slip plate should have been fitted on the dewatering valve as shown in Figure 1. This was the back-up system in the event of the valve failing or being defective or not being fully closed. Despite this there were no clear written procedures in place at the time of the incident on how dewatering operations should be carried out. It was also reported that the slip plate which should have been present prior to this dewatering operation starting was not in fact there. This indicates that it may have been normal practice to leave tanks in that condition

The company stopped using contract “standby” men on all process related tasks immediately after the incident. They also bypassed the defective underground drainage system for dewatering operations and fitted the second isolation valve on the tank dewatering stream – the smaller of the two valves shown in Figure 1. Other operators have chosen to install self closing valves on stock tank dewatering duties, intended to ensure that the operator remains in place throughout the dewatering period since the valve works as a “hold to run” device. Other available risk reduction measures include bund sump leak detection systems.

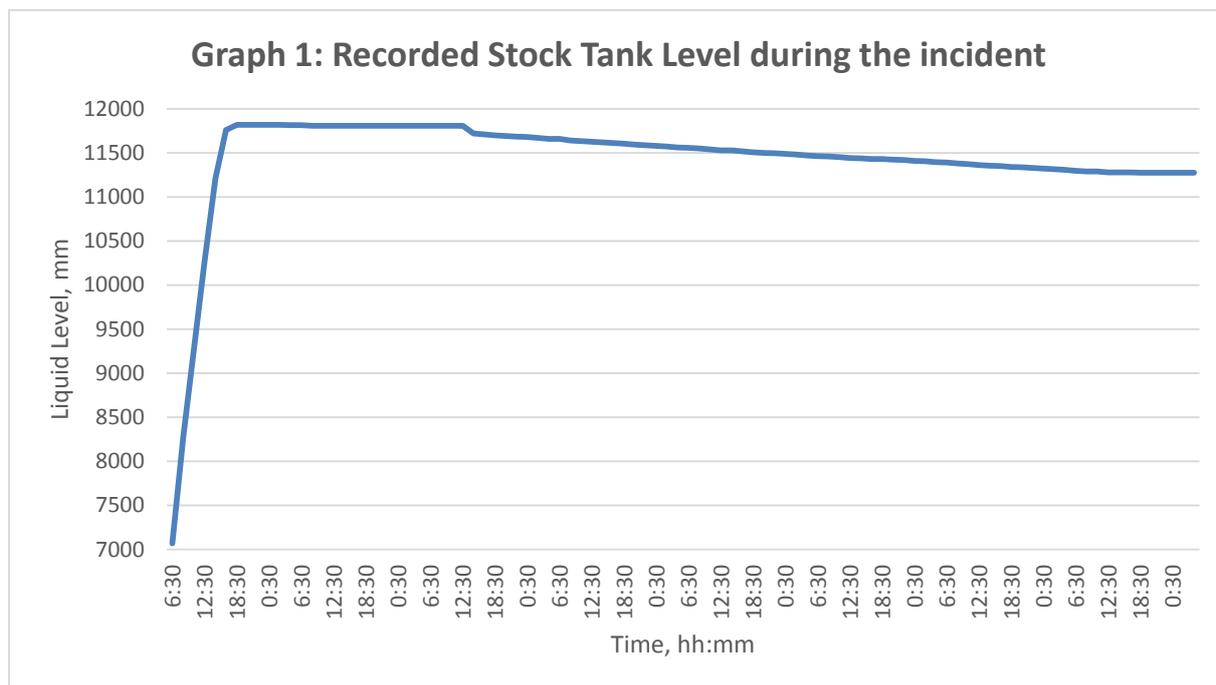
It was standard practice for production technicians in the control room to record the levels of all the stock tanks in use that they were responsible for on a log sheet every two hours. They had 9 stock tanks in use at the time of the incident. The levels that were recorded for the Stock Tank involved in the incident are shown Graph 1 below.

- iv) Despite the regular checks on the levels of the storage tank, the level dropped for three days without any corrective action being taken. Following an instruction to attend to it, the "corrective" action taken was ineffective. The Tank level was allowed to drop for a further 20 hours before the loss of containment became obvious.

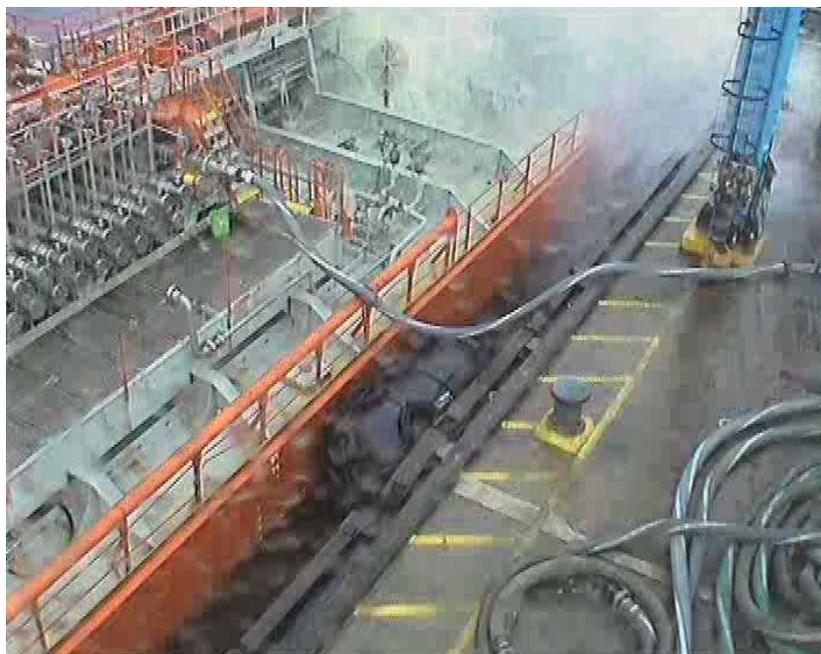
Figure 3 - The Aniline Burst

being filled. The tank's hatch blew off with a loud bang, spraying product over the ship, into the river and onto the Jetty. Figure 3 is a frame captured from the terminal's video surveillance system showing the burst.

There were difficulties in establishing both the quantity of material loaded on to the ship and the amount of material that was lost to the River. Most of the material that was lost was contained on board the ship in the “scuppers”. Some of the material that was released in the “burst” – see figure 3 above – was lost to the River

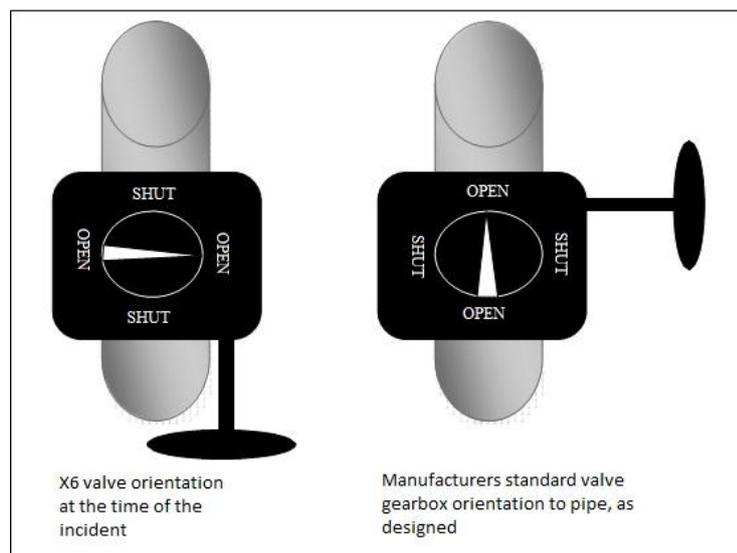
Figure 4 - Orientation of Valve X6

- The operator opened, rather than closed Valve X6 when requested to stop transfer of product to the ship. The valve position should have been changed to make it line up with the other valves on this and the other site jetty.

After the incident, the Terminal found the loading isolation Valve X6 was open. During the discharge, the valve had been gagged back to limit the loading rate to meet the ship’s loading requirement. This use of an isolation valve for control purposes is not good practice. It is clear that the jetty operator had fully opened, rather than closed it, at 07:40. Immediately following the incident, management discovered that the telltale on the top of the valve had been installed incorrectly. It

appears that about 12 to 18 months prior to the event, the valve was replaced after reports of the original valve passing liquid. It is thought that, when the valve was replaced, the gearbox was also replaced with a manufacturers standard design gearbox, which resulted in a gear box orientated incorrectly to the Terminal’s standard, as shown in Figure 4. No records can be found relating to this work.

The Terminal had already been considering simplifying the jetty Emergency shutdown system so all stop buttons stop all jetty supply systems as part of the Work linked to a “Reduced manning on Jetty” project. They brought this part of the project forward following this incident. The Terminal corrected the unhelpful orientation of the indication on Valve X6 following the incident.

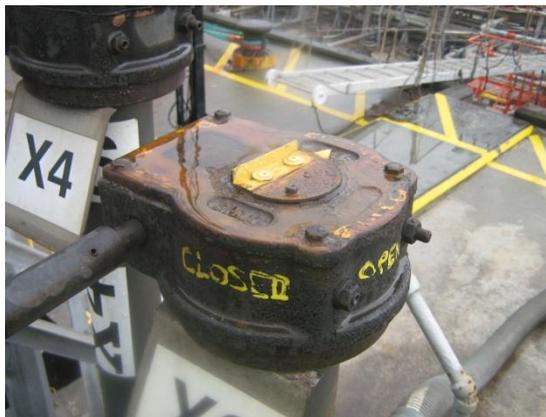
Figure 5 Picture of the Jetty Valve

On all the other valves on the establishment the telltale on the top of the valve shows the open direction of the hole in the ball. In this case, the telltale was at right angles to the direction of flow – so was actually open when the telltale of every other jetty valve shows “closed” and is in fact closed. This anomaly had been previously recognised and the abnormal operation of the valve was clearly indicated on the valve body in yellow paint, as can be seen in the photographs attached as figure 5

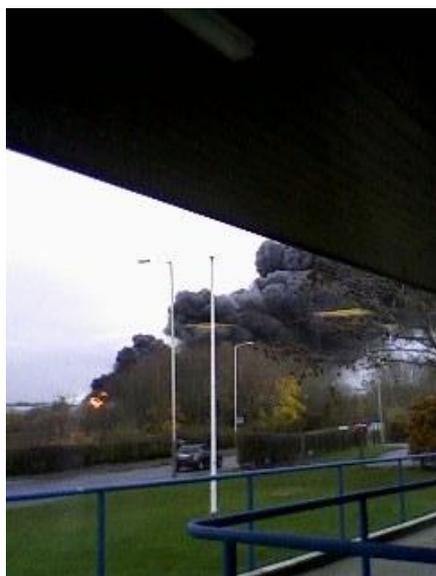
Figure 7 - Photo of the fire

The fire was well established by the time the Fire and Rescue Service (FRS) arrived – Figure 7 shows a photo of the fire taken at about 13:00 hrs by a member of the public and put up anonymously on the web.

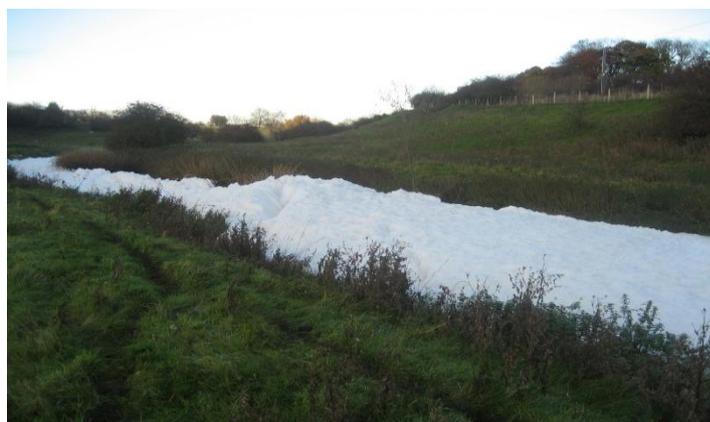
Figure 8 - foaming on the River

During the early phases of the fire, firewater was applied to the warehouse itself and quantities of liquid detergent were picked up in the firewater runoff. This was discharged into the local River, causing extensive foaming along the 7 mile stretch until it meets a larger river. An example of this is shown as Figure 8. The receiving river itself was an “improving” River, slowly recovering from historical Industrial Pollution. It had been restocked with fish some 5 years previous to the incident and prior to the incident surveys indicated that these were doing well with the population increasing. There were initial reports of a few dead fish on the bank on the day of the incident, but nothing was found the following day when the banks were systematically inspected. A Fish Survey by the Environment Agency some months later

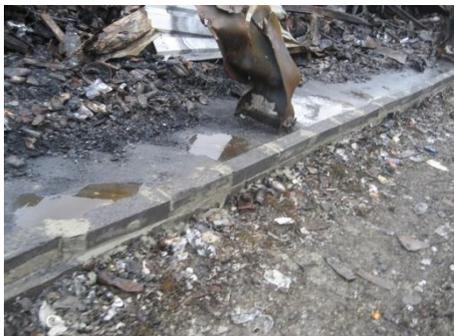
Figure 9- Kerb round warehouse slab

The warehouse was not provided with kerbing at its base. This is standard practice for warehouses containing hazardous materials. During the fire, a lot of liquid was released and the FRS reported that it was 2+ ft deep in places. Immediately after the fire, it was obvious that liquids were seeping out of the fire from compromised packaging from the warehouse slab to ground. Following pressure by the Agency, the operator had a small kerb built round the whole periphery of the warehouse to limit liquid runoff and enable waste liquids to be collected as they became obvious. A small section of this is shown in Figure 9. It was fortunate that there was very little rainfall in the period between the fire and the time the operator had the site completely clean. However, during and immediately after the fire, there were some discharges of contaminated non-hazardous material to ground. The geology of the site indicated that there may have been some leakage paths to the underlying aquifer but monitoring of the groundwater for several years following the event had not shown any signs of contamination.

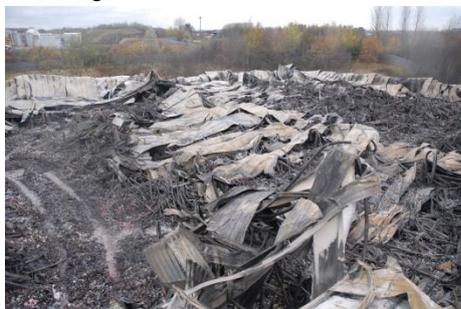
Figure 10 - The Site after the Fire

The destruction (see Figure 10) was so severe that all the investigation teams agreed no forensic evidence could be obtained.
