Application of detonation diagnostics to the Flixborough Explosion

Graham Atkinson¹, Edmund Cowpe² and David Painter²

¹ Health and Safety Laboratory, Harpur Hill, Buxton SK17 9JN.

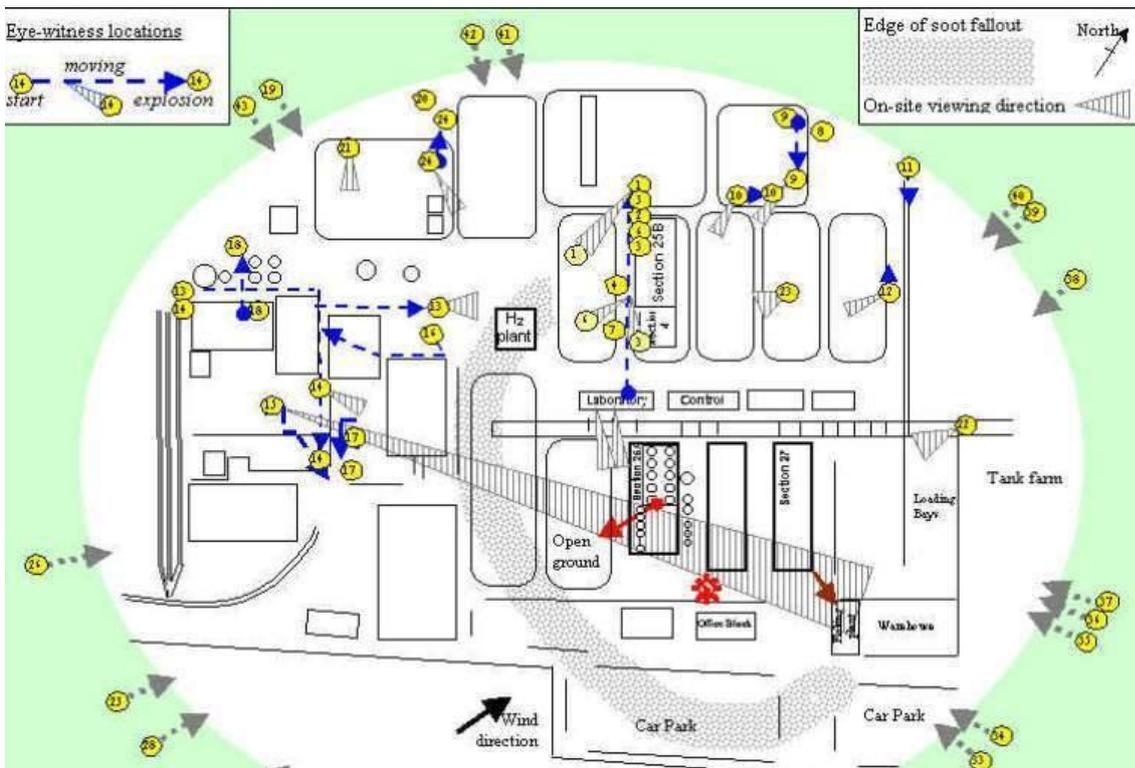
Figure 3: Graphic showing edge of soot fallout – which marks the edge of the rich part of the cloud

There was noticeable fall out of soot from the explosion – even close to the upwind edge - which suggests much the cloud was quite rich. It seems likely that the average cloud depth over much of its plan area was around 3-4 m (9.8 – 13.1 ft). The depth close to the source would have been much greater i.e. >15m (>49 ft).

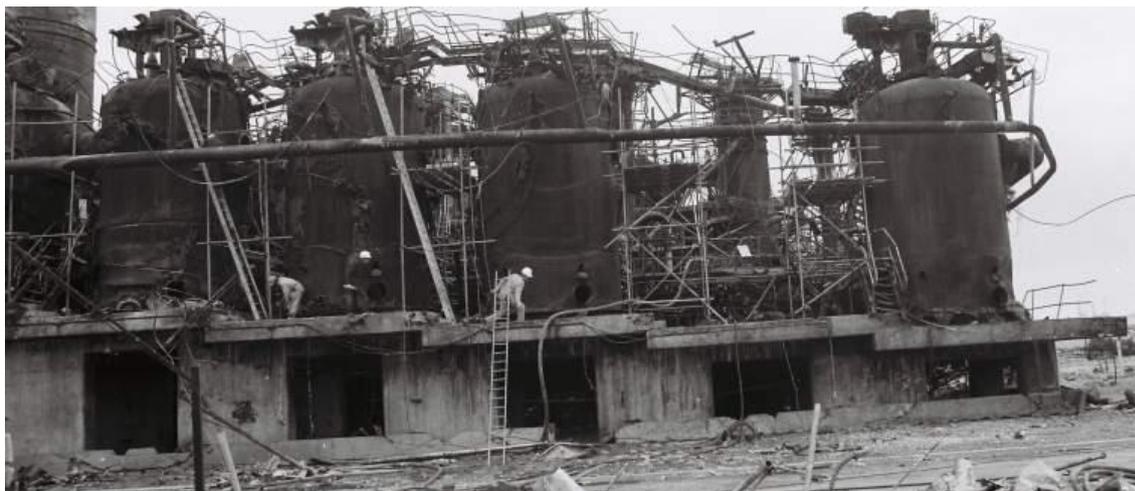
Figure 8: Photograph of part of the reactor train after the incident the dog leg bypass was lost completely. Scaffolding has been erected after the incident.

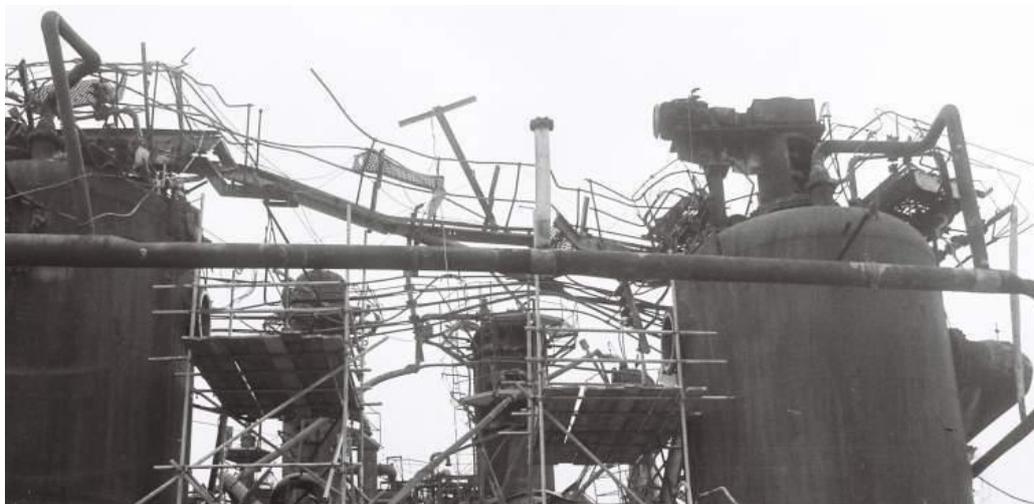
Figure 9 shows a close-up of the 28” flanges left after the failure of the 20” by-pass. It can be appreciated that the source term would have been complex with expanding, two-phase jets issuing from both holes in opposite directions. These off-set jets would have collided, forming an angled fan of vapour and fine droplets. Later in the release the combination of tanks 1-4 would have depressurised less quickly than Tank 6: the release would have increasingly resembled a jet directed towards the car parking areas.

Figure 9: Openings left after loss of bypass pipe.

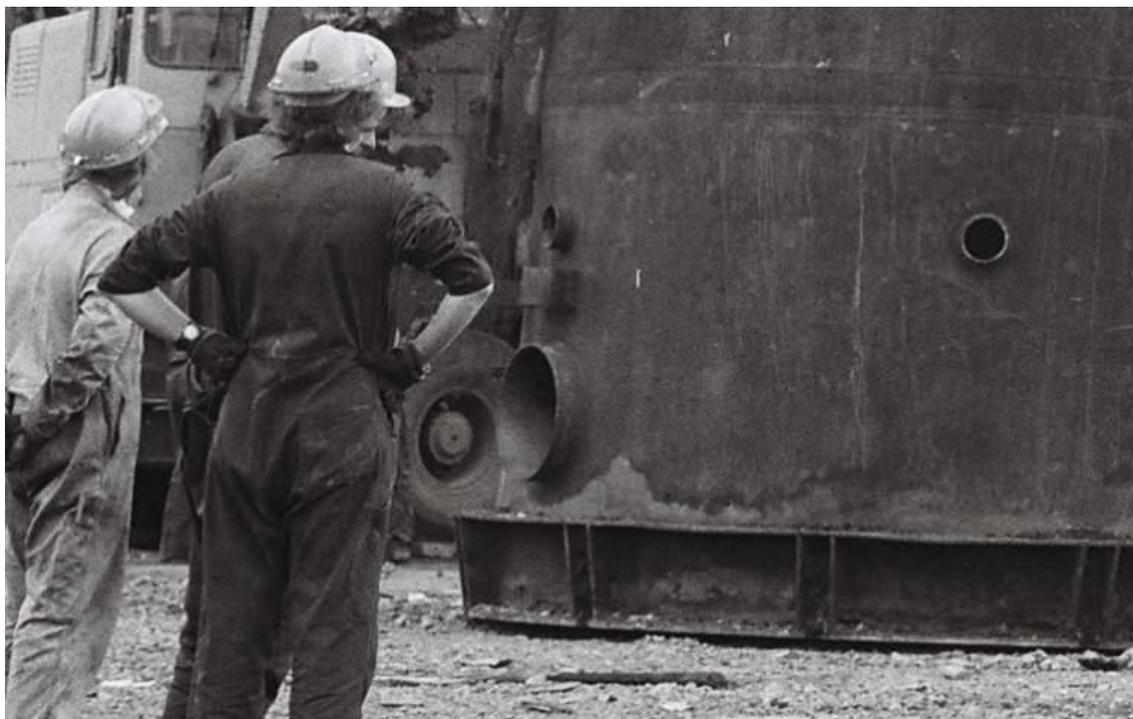
The level of damage clearly increase as the reactors step down in elevation and (presumably) further away from the ignition point in the sequence 2,3, and 6. The damage to the vessel in an **open area** (Reactor 5) is noticeably more severe than those on the plant. This side of the reactor was facing the plant so if the cloud engulfing Reactor 5 detonated, then the reflected pressure on the upstream face would be around 35-40 bar (507 – 580 psi) – compared with the side-on overpressure in a detonation of around 15-18 bar (217 – 261 psi).

Figure 10- Reactor 2: Limited pressure damage to reactor skirt

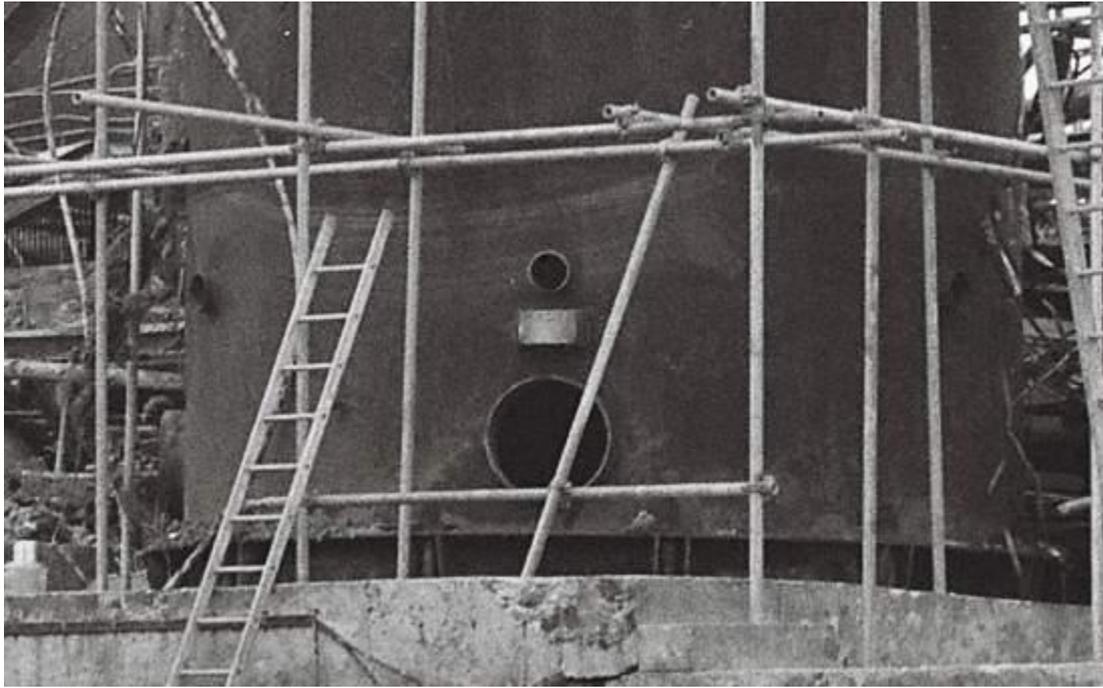
Figure 11- Reactor 3: Limited pressure damage to reactor skirt

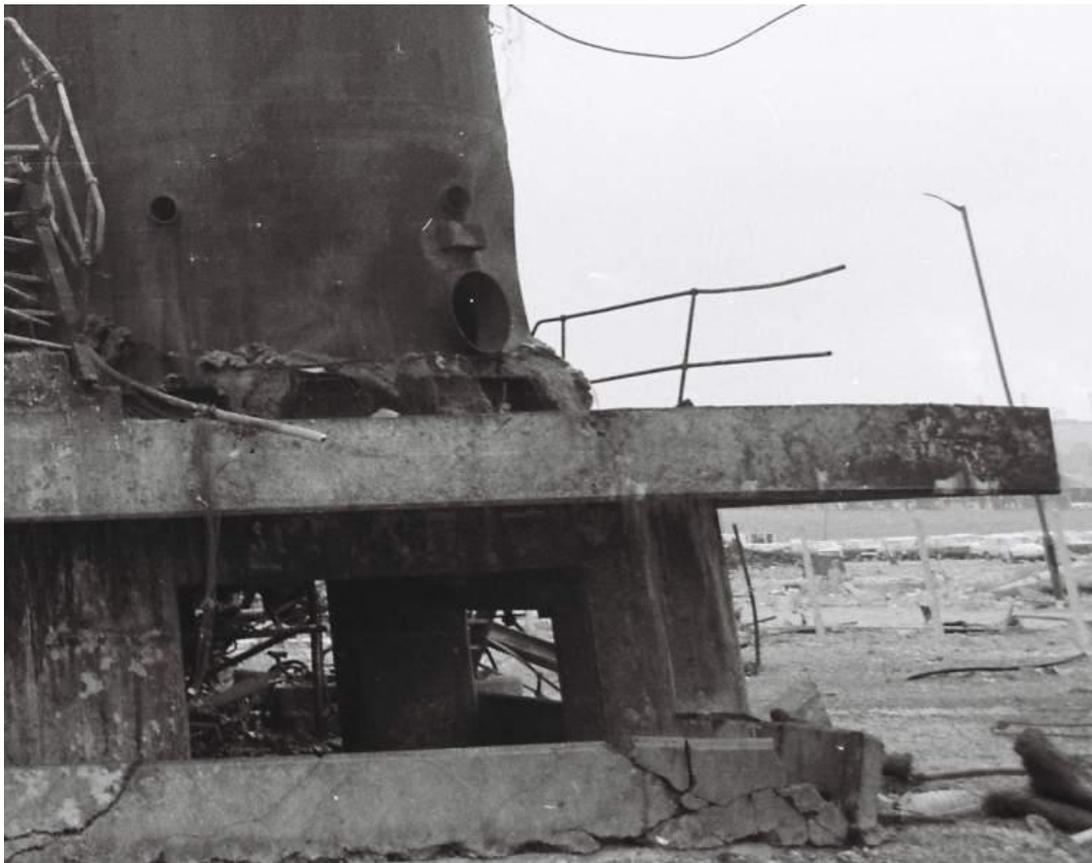
Figure 12: Reactor 6 (Number 5 missing). Significant pressure damage to the skirt

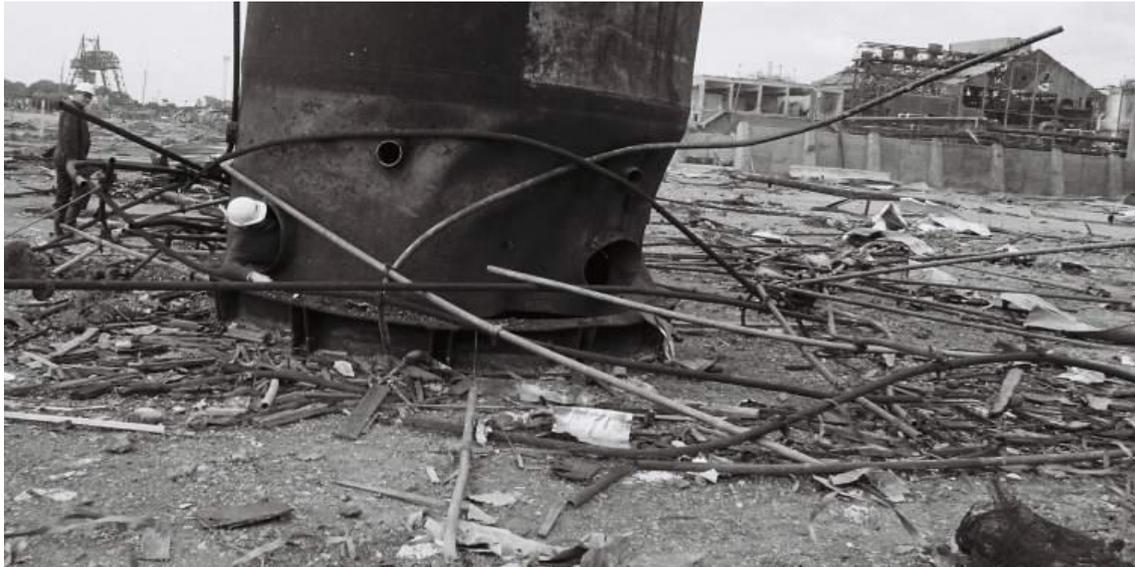
Figure 13: Reactor 5 - Located in open ground approximately 40 m (131 ft) from the leak. Substantial damage to the reactor skirt on the side facing the plant

The curved scaffold tubes in the wreckage surrounding Reactor 5 are also significant (Figure 13 and Figure 14). Numerous pieces of scaffold boarding are visible in their midst and it is clear that there was no sustained fire around the vessel. It follows that the curvature of the tubes was caused by the explosion not by any subsequent fire.

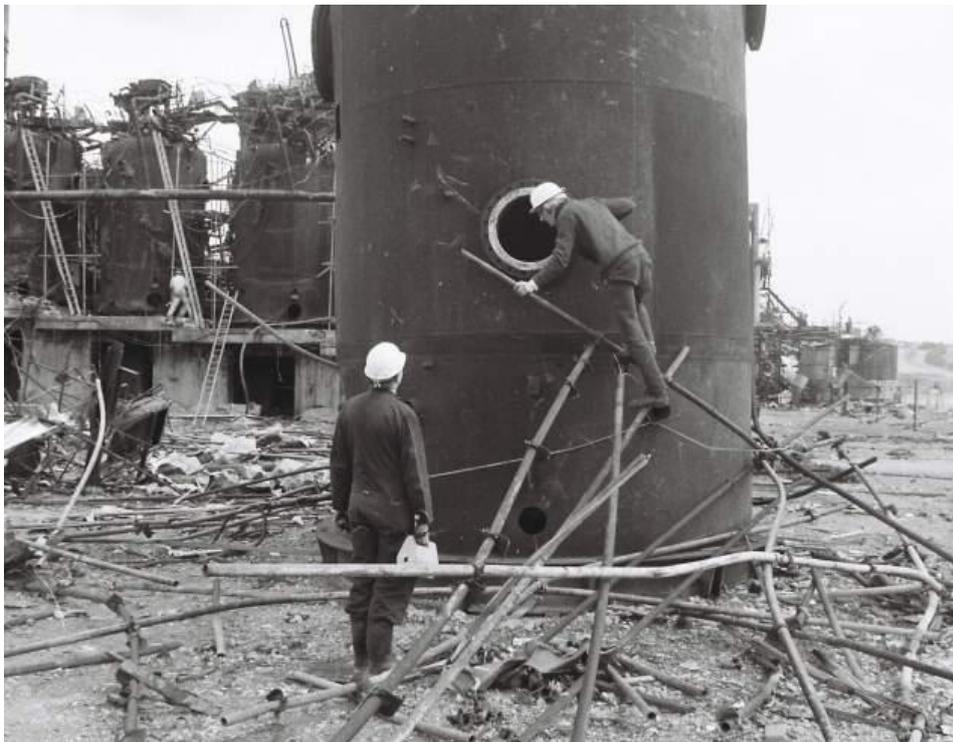
Figure 14 shows the back face of Reactor 5. Comparison with Figure 13 confirms that there is the clear asymmetry in damage level to be expected for an impinging detonation.

Figure 14: Reverse face of Reactor 5 showing asymmetry in damage.

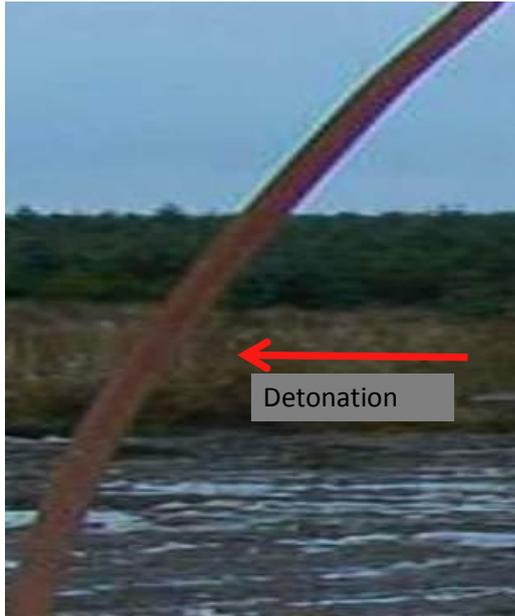
The weight, second moment of area and degree of end constraint of these tubes is comparable with the angle iron used to fabricate the tents in Buncefield JIP detonation tests (SCI 2014). The general character of the deformation and extent of deformation are also comparable (Figure 15).

Figure 15: Angle iron deformed by a detonation (cloud depth 3m)

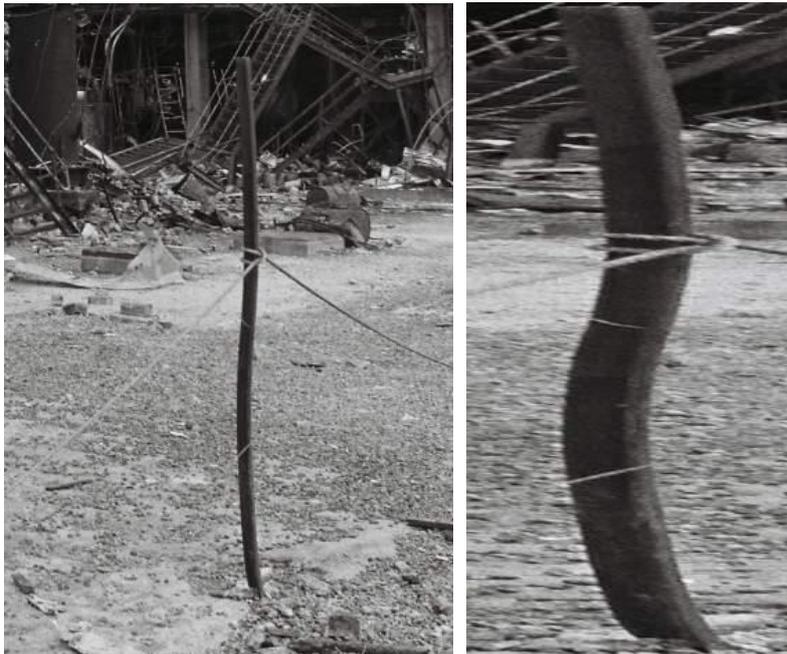
Similar examples of continuous curvature are seen in fence posts and barriers to the south of the cyclohexane oxidation plant (Figure 16, Figure 17 and Figure 18).

Figure 16: Curved fence posts in open areas to the south of the cyclohexane oxidation plant.

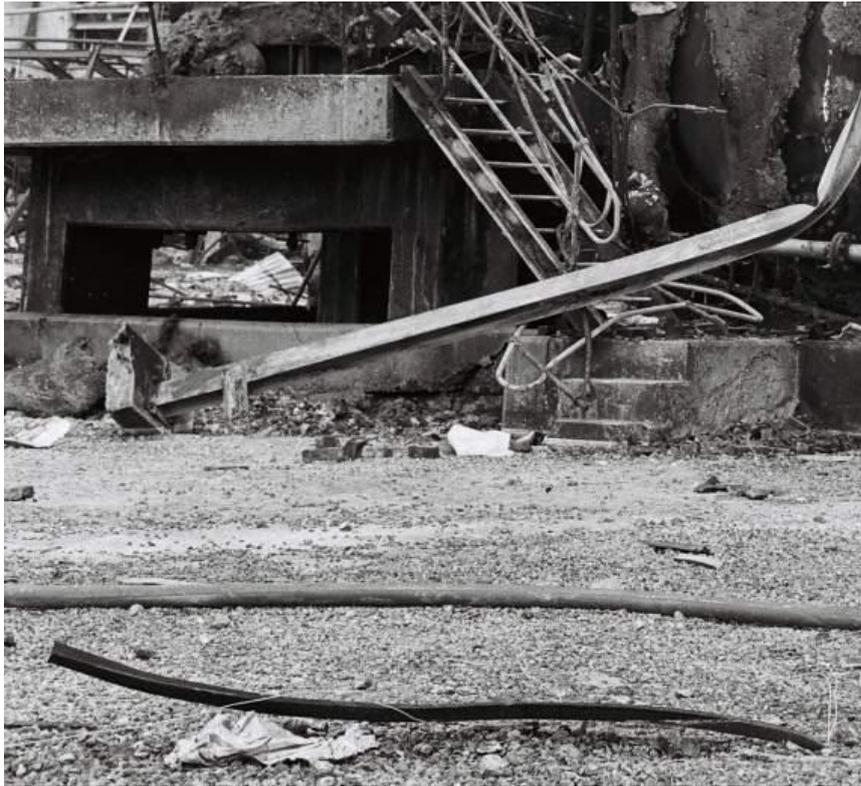
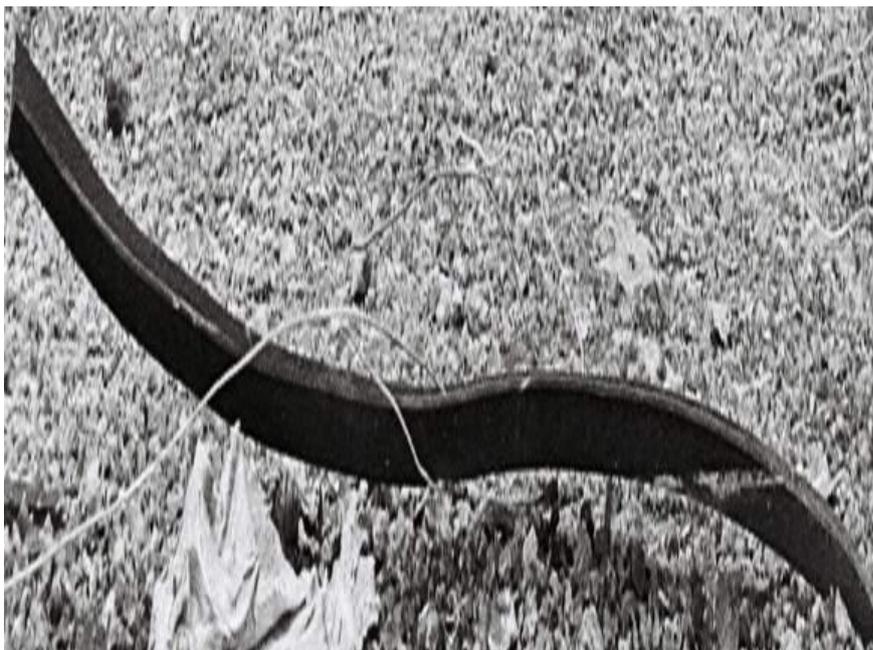
Figure 17: Curved fence posts in open areas to the south of the cyclohexane oxidation plant.

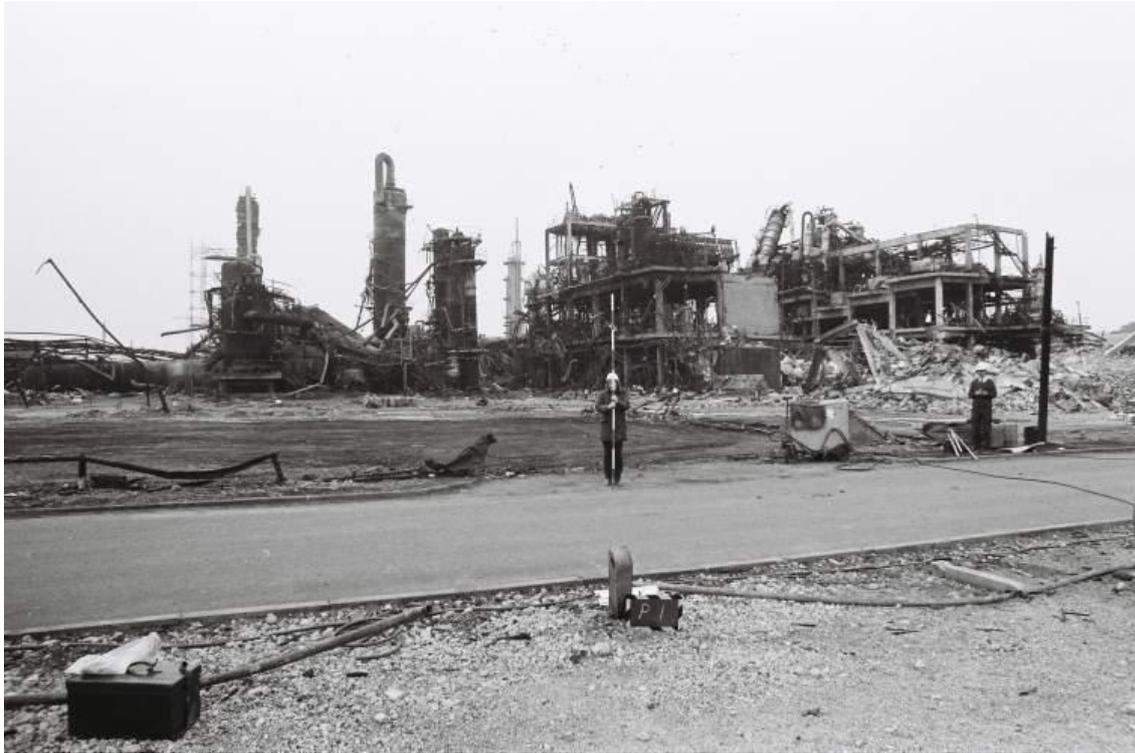
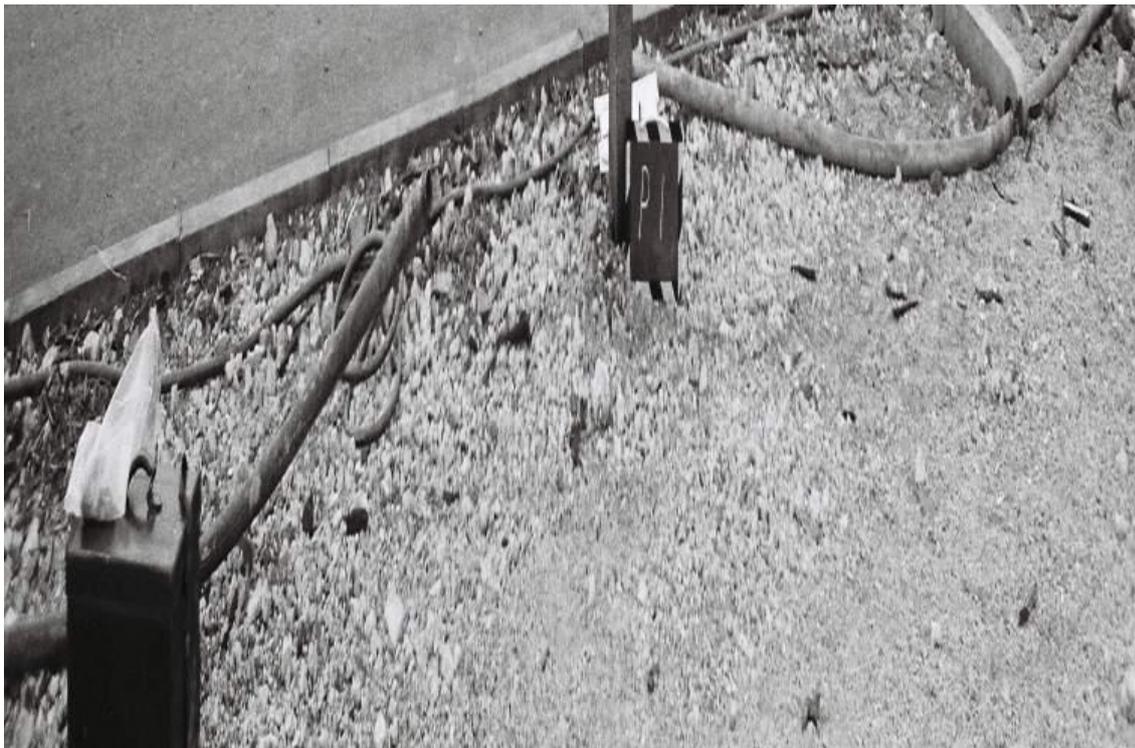
Figure 18: Curved barriers

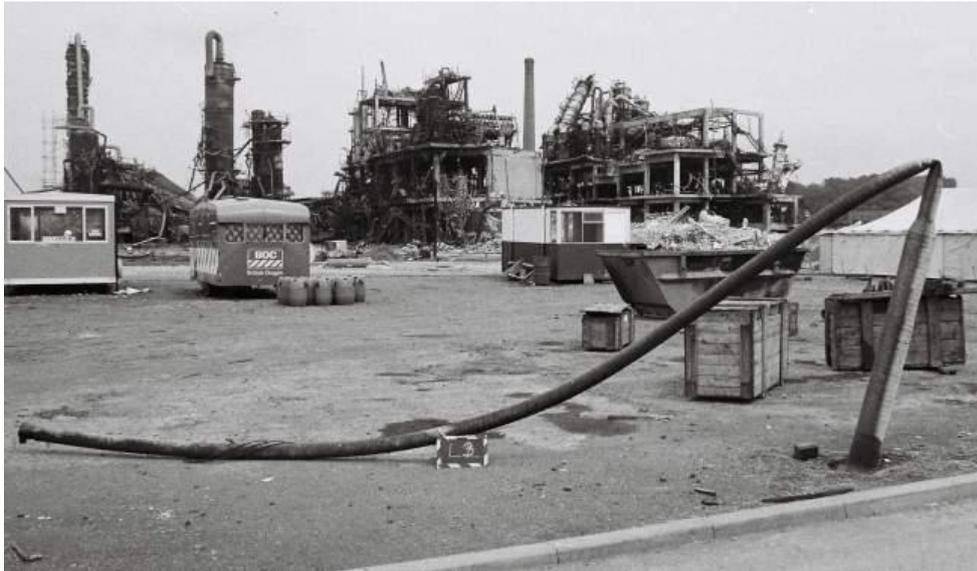
Continuous curvature was also observed in lamp posts within the cloud (Figure 19 and Figure 20). The most pronounced curvature along the length of the posts was observed around the fringes of the cloud where the mixture would have been detonable through the whole depth.

Figure 19: Lamp post within the cloud – approx. 130 m (426 ft) south of vapour source.

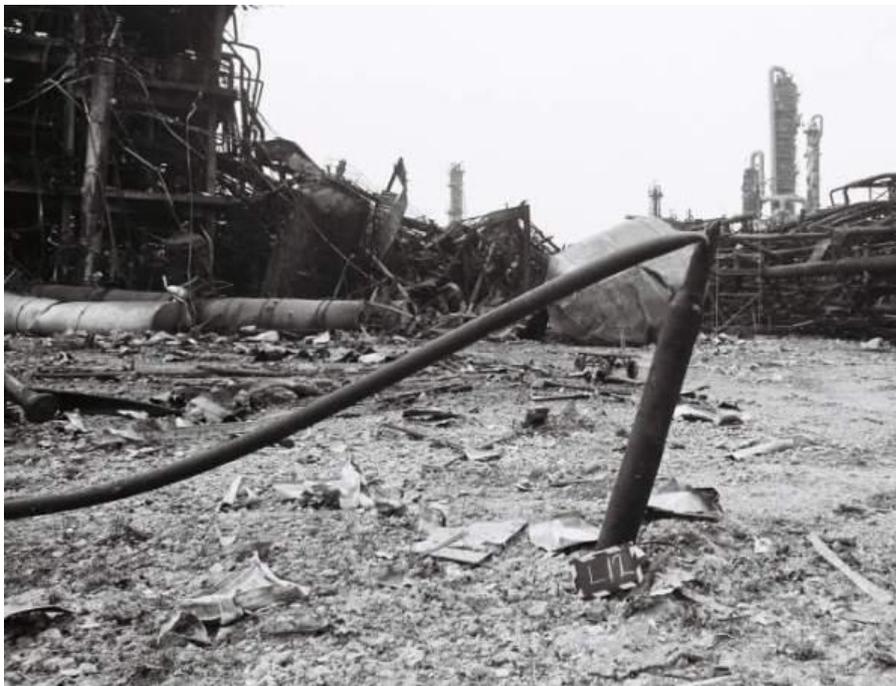
Figure 20: Lamp post within the cloud – approx. 180 m (590 ft) NE of vapour source

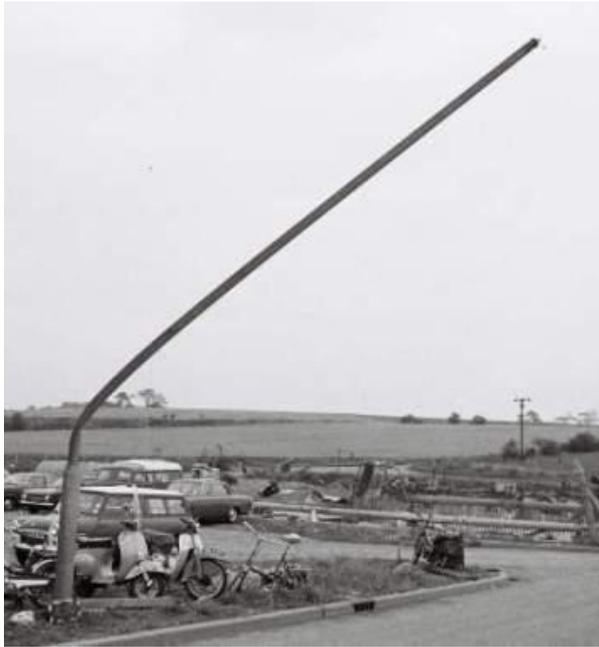
Outside the cloud the posts did not exhibit plastic deformation along the whole length (Figure 21 and Figure 22). Plastic deformation was concentrated near the base of the main stem – where the moment of blast forces would have been greatest.

Figure 21: Lamp post outside the cloud to the East

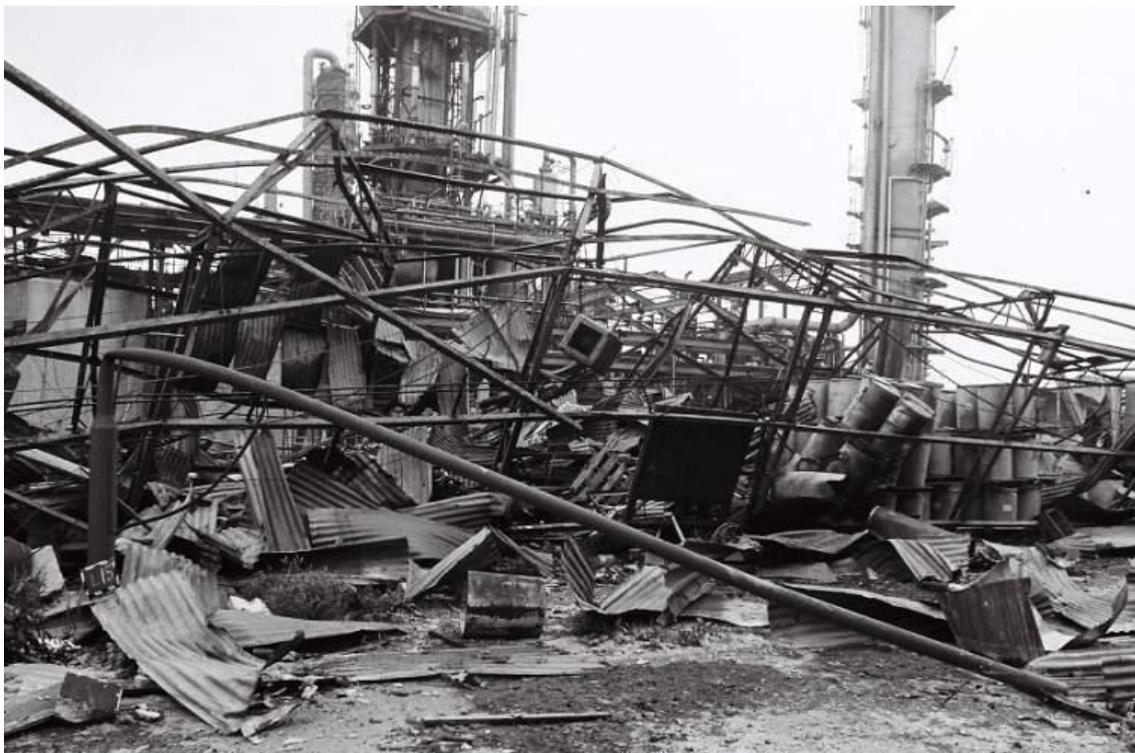
Figure 22: Lamp post outside the cloud to the North

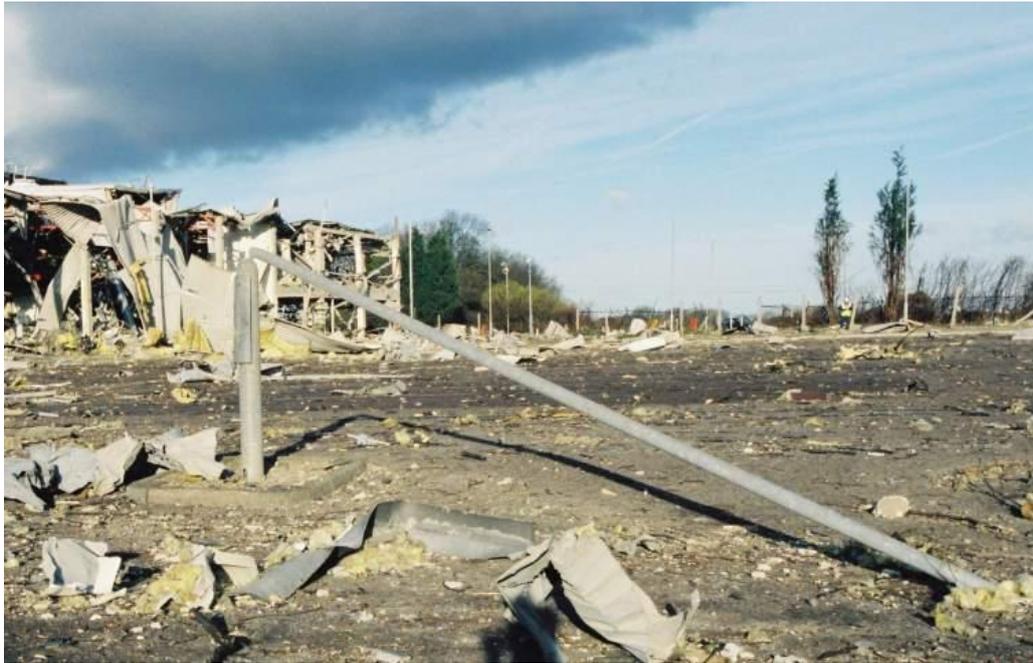
Figure 24: Typical deformation of a lamp post at Buncefield

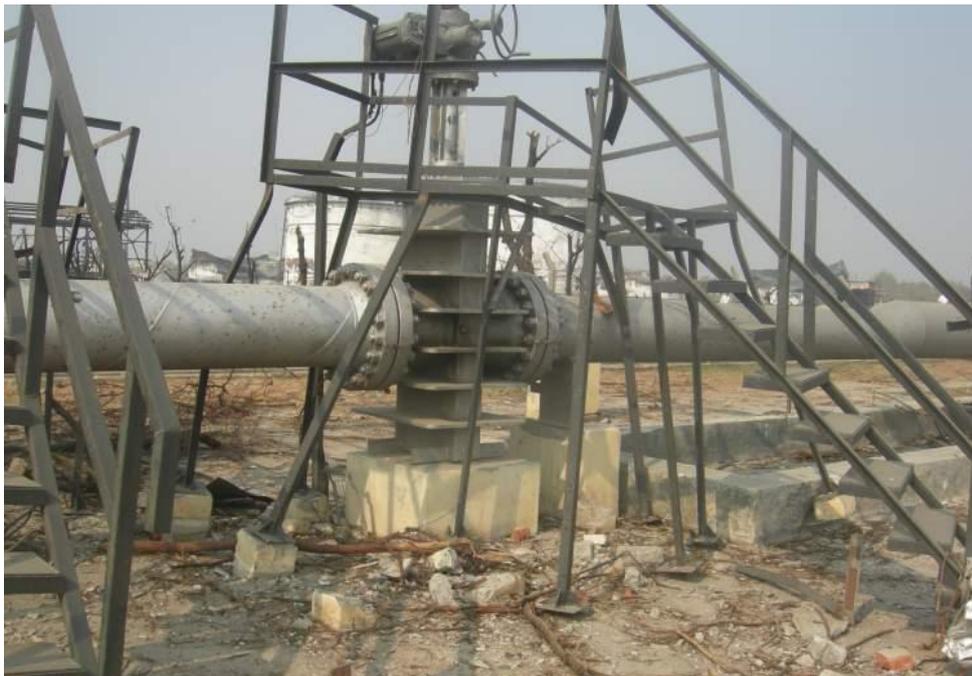
Figure 25: Lightweight open steel structures in the centre of the Jaipur explosion

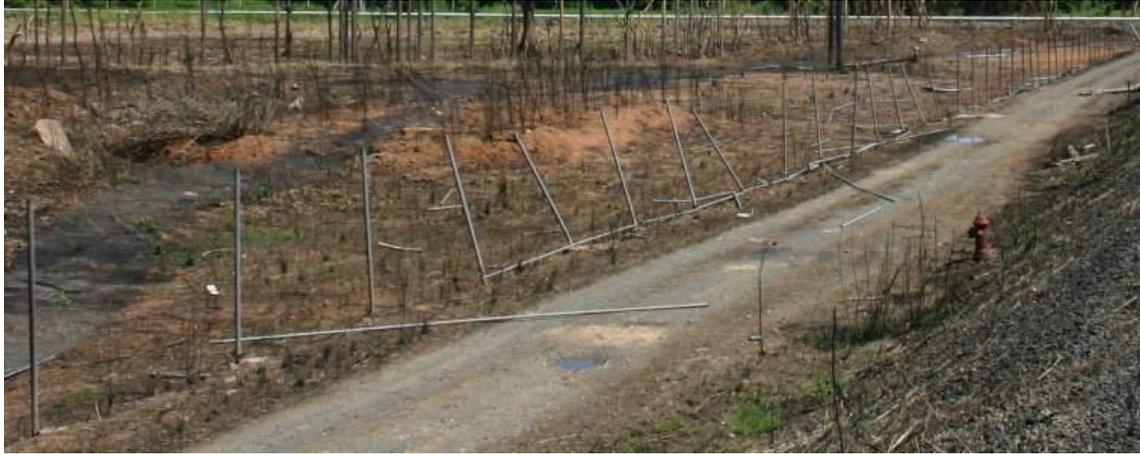
Figure 26: Section of boundary fence in the San Juan incident (CSB, 2015)

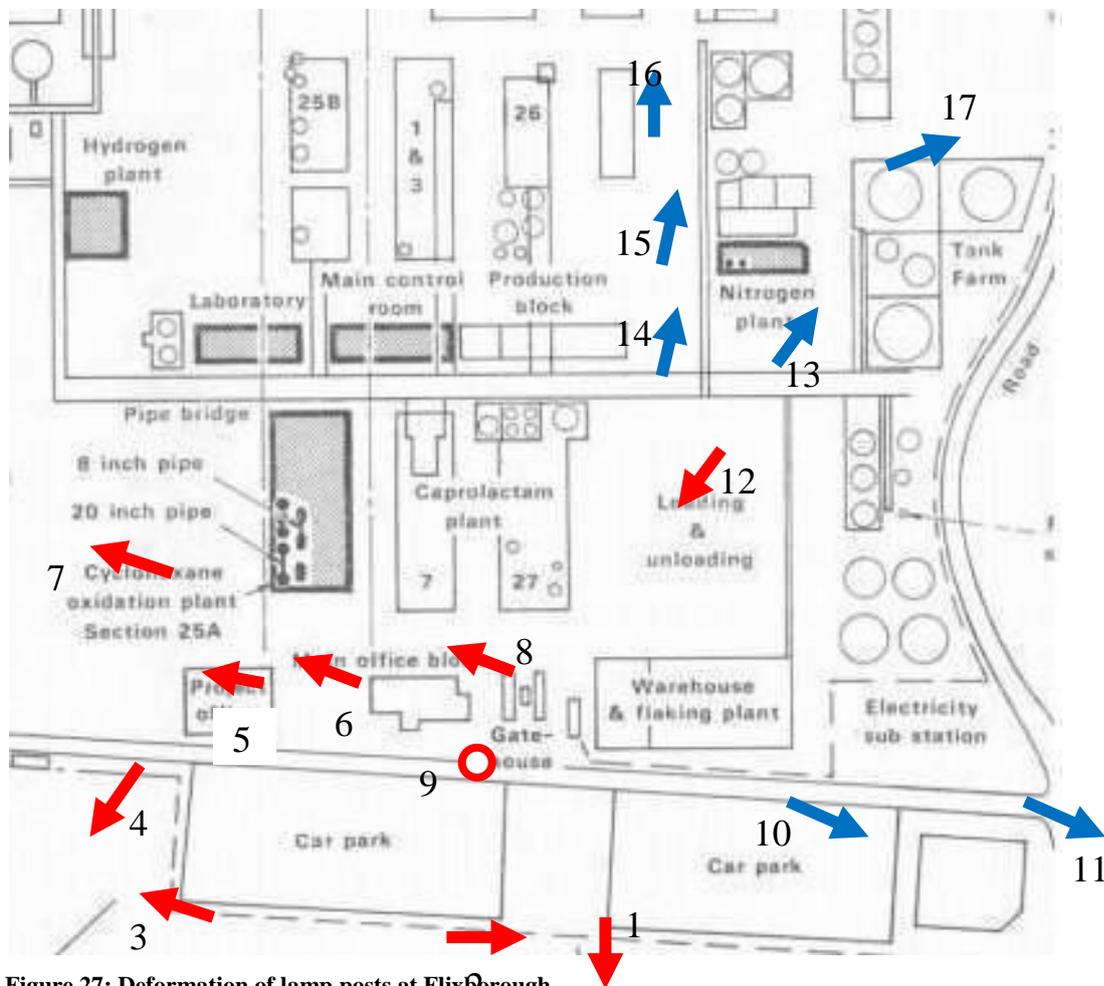
Red arrows indicate continuous curvature of the main lamp post stems or mid-span hinging and probably indicate direct exposure to detonation of the surrounding cloud. The direction of arrows indicates the final direction of the stem in the photographs. Numbers correspond to the ID numbers chalked on boards and included in the original photographs.

Blue arrows correspond to lamp posts where plastic deformation was confined to an area near the base of the main stem.

Figure 27: Deformation of lamp posts at Flixborough

It appears that detonation affected a high proportion of the cloud away from the main plant areas. However no clear pattern emerges from the direction of the red arrows that might allow the tracking of detonation's progress.
