Learning from Incidents: How a Serious Fire in a High Pressure Polyethylene Plant Led to Improvements in Process Safety

Peter Shields, MSc, FSaRS, Safety Health and Environment Director, Innospec Inc, Innospec Manufacturing Park, Oil Sites Road, Cheshire, CH65 4EY

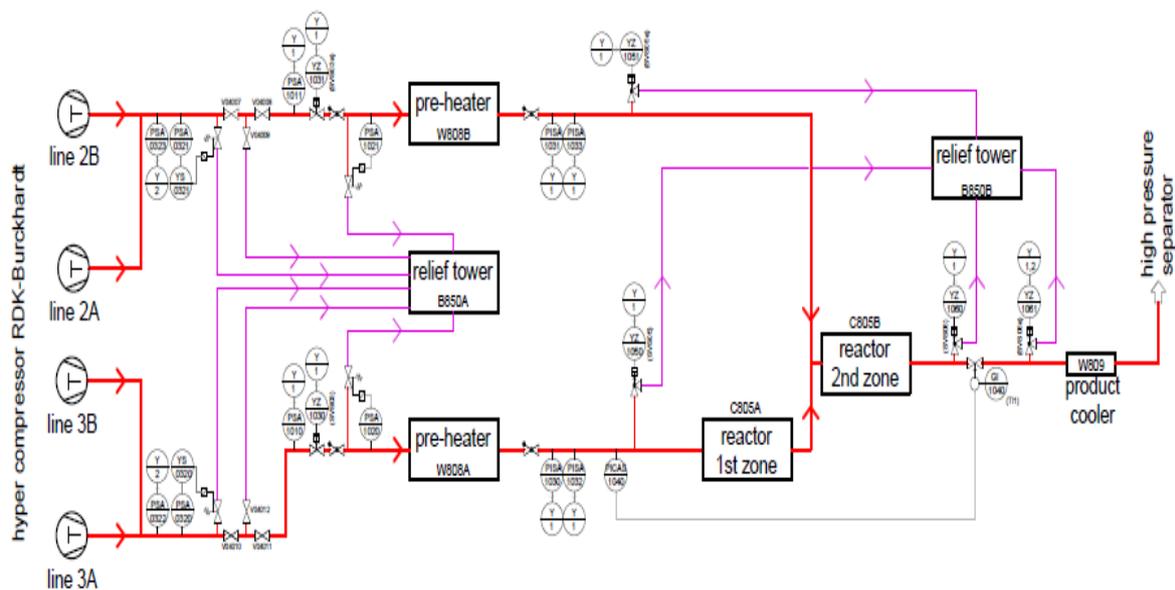
Figure 1 Outline Process Flow Diagram

As the polymerisation reaction can undergo an uncontrollable decomposition reaction, the plant is continuously monitored by an array of temperature and pressure sensors. Any deviation outside the safe operational envelope triggers an emergency venting and shutdown operation. Production is controlled by a DCS system however the plants emergency venting system is a hardwired operation. The system is equipped with 4 large hydraulically operated relief valves, each one capable of venting down the process safely which protects the plant from any decomposition over pressurisation. These vent to the relief tower B850B shown on the right hand side of figure 1.

The plant also has several smaller pressure relief valves to protect the plant from pressure generated by any material trapped between closed valves when sections of the plant are isolated. These smaller relief valves have a dual operating mode with an electro-magnetic actuator and a spring mechanism. The electro-magnetic actuator would be activated (2,450 bar) by pressure monitoring system, if this failed and the pressure continued to rise the spring mechanism would be forced open (2,500bar). These smaller relief valves vent to atmosphere to the relief tower B850A shown in the centre of figure 1.

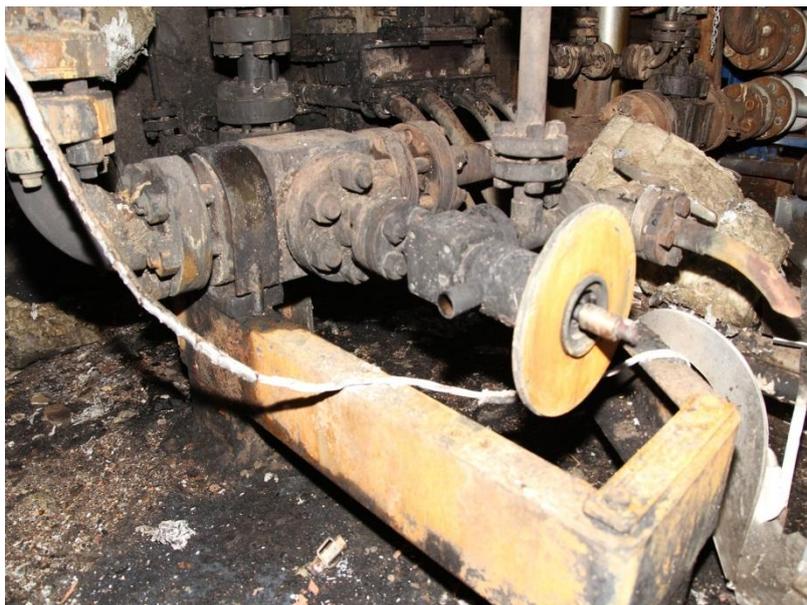
The plant management found that the flame had emanated from a tell-tale vent on one of the thermal expansion valves located on the ground floor of the reactor area. In addition the electro-magnetic actuator of this valve had been displaced and the electrical connections broken. The flame damage indicated that some structural steelwork had been exposed to a high temperature typical of a jet flame. Electrical equipment on peripheral equipment had been damaged to a height of 3 floors above the ground floor.

Picture 1: Relief valve missing the actuator and showing the short stub of the tell-tale vent point

The valve was reassembled and under test was found to pass at 25bar as opposed to its 2,500bar setting. In addition the vent line to the roof was blocked with polymeric material.

- a) The connecting drive shaft from the actuator to the valve was found to be bent.
- b) Several albeit minor alterations to the valve internals were found
- c) Damaged bolting elements had been reused following a recent refurbishment
- d) Equipment with evidence of corrosion had been reused following a recent refurbishment.

The spindle driving the valve seat became bent either before or as a result of the action at the time which prevented it from resealing. These valves are of a special design suitable for very high pressure duty. As such their maintenance and testing is beyond the capabilities of the in-house team. A maintenance contractor with experience of high pressure systems was employed to provide this service. The investigation revealed that other than a general request for the testing and refurbishment there was very little provided to or asked for by, the contractor on the specification of the tasks required. While it cannot be categorically stated that the poor standard of refurbishment was the direct cause there is no doubt that there was sufficient play on the spindle to allow it to leave its normal central position thus allowing the potential for deformation during operation.

A re-evaluation of the need for the expansion relief valves was carried out with the assistance of an external specialist. It was concluded that the plant could be modified so that the prospect of locking in material between valves was no longer possible. After conducting a HAZOP all the isolating valves in the process stream were removed thus allowing the removal of the expansion relief systems, see figure 2.

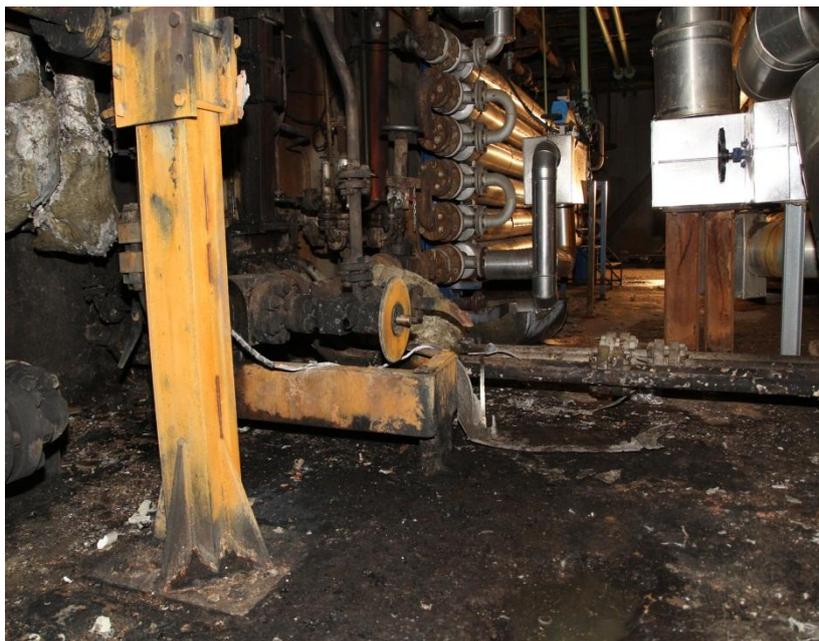
Picture 2: Structural steel work showing effects of extreme heat after exposure to the jet flame
