Investigation of an acetylene cylinder explosion incident

Phil Hooker¹, John Hodges¹, Bill Geary¹, Shane Wakefield²

¹ Health and Safety Executive, Harpur Hill, Buxton SK17 9JN.

This paper describes the investigation into an incident in which a dissolved acetylene [DA] cylinder exploded during the filling operation at a facility in GB. The investigation was carried out by the Health and Safety Executive (HSE). At the end of the investigation HSE had produced an understanding of the failure mechanism. Acetylene is an unstable explosive gas that is stabilised in the cylinder by dissolving it in acetone within a porous mass. The direct cause of the incident was a combination of an initiation event and the failure of the charcoal porous mass / acetone system to suppress that initiation. Major learnings from the investigation covering the valve design, the potential for human error on safety critical tasks, the management of ageing mobile equipment, and the role of the acetone / porous mass stabilisation system are presented.

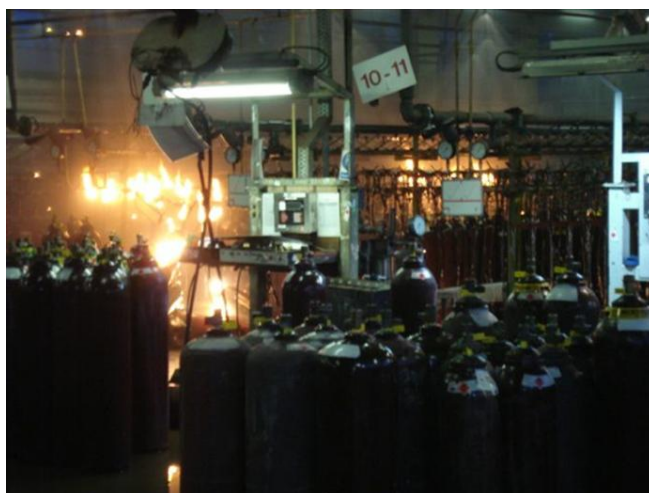
The fire service had placed video cameras within the filling plant following failure of the cylinder and these showed the flames that were established within the plant (Figure 1). The total acetylene release rate was calculated from the observed flame lengths. This, together with an estimate of the building ventilation rate, allowed a decision to be made to safely extinguish the flames and allow the acetylene to vent to atmosphere. Each cylinder valve was eventually turned off to isolate the acetylene supply and prevent further venting to atmosphere.

Figure 1. Fires of leaking acetylene following the initial cylinder explosion

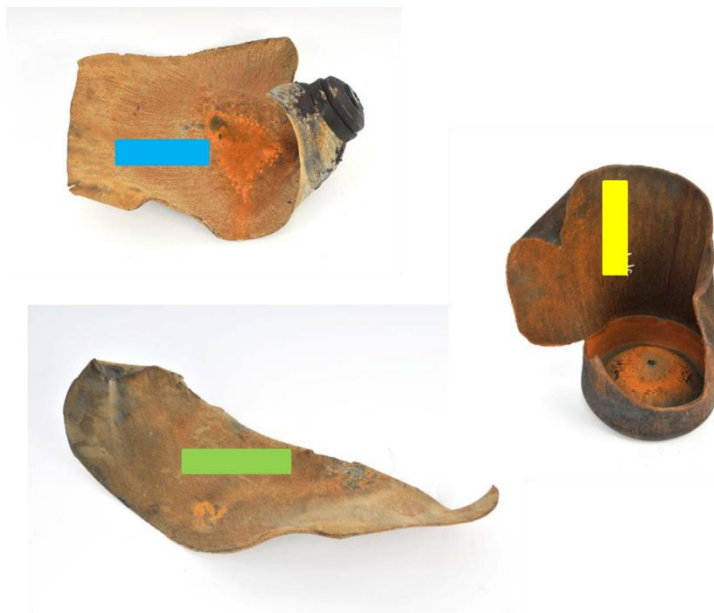
The incident cylinder had fractured into three pieces which were projected in different directions (Figures 2 and 3). The largest section included part of the top of the cylinder. As the cylinder burst, this part was projected eight metres along the gangway between the filling racks. The valve stem was retained in the cylinder top and had fractured level with the cylinder top. The middle part of the cylinder was projected towards the adjacent filling rack, hitting and damaging three cylinders before finally coming to a rest two metres from its original position. The bottom part of the cylinder was projected over the filling rack, impacting cylinders in the adjacent rack, coming to rest approximately six metres from its original position.

Figure 2. The three fragments of the incident cylinder - colours relate to flight paths shown in Figure 3

The cylinder had fractured into three parts accompanied by significant, large scale, plastic deformation. Measurements showed that the cylinder had a minimum thickness of 4.1 mm, somewhat lower than the specified minimum of 4.76 mm. At an operating pressure of 17 bar, this would have resulted in a hoop stress of 42 MPa. Based on tensile properties, a pressure of 260 bar would have been required to cause cylinder failure. Such pressures are conceivable from a decomposition of acetylene in the cylinder.

Macroscopically, the fracture surfaces exhibited areas of both single sided and double shear. Scanning electron microscopy (SEM) showed that failure had occurred by microvoid coalescence; both observations were consistent with a ductile overload failure mechanism. There was no evidence of progressive modes of failure, such as fatigue or stress corrosion cracking that could have contributed to failure.

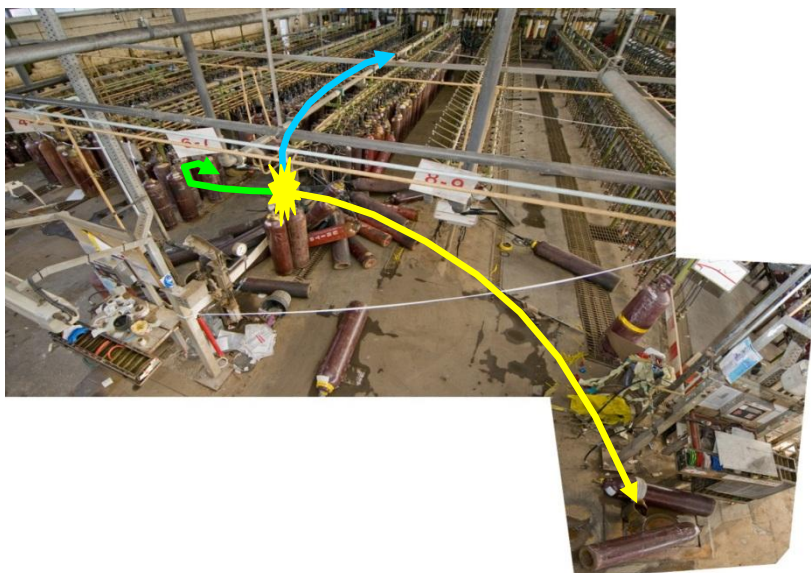
Figure 3. Indicative flight paths of the three parts of the incident cylinder. Blue arrow – cylinder top, Green arrow – cylinder middle, Yellow arrow – cylinder bottom

When the incident cylinder burst, it is believed that the bottom part of it came into violent contact with the adjacent cylinder, forcing this cylinder to the side and upward. The impacted cylinder, attached to the filling hose, swung into

a near horizontal position until the tensile force on the hose caused it to rupture. The impacted cylinder was then projected through the air, hitting several other cylinders, before striking a wall 19 metres away.

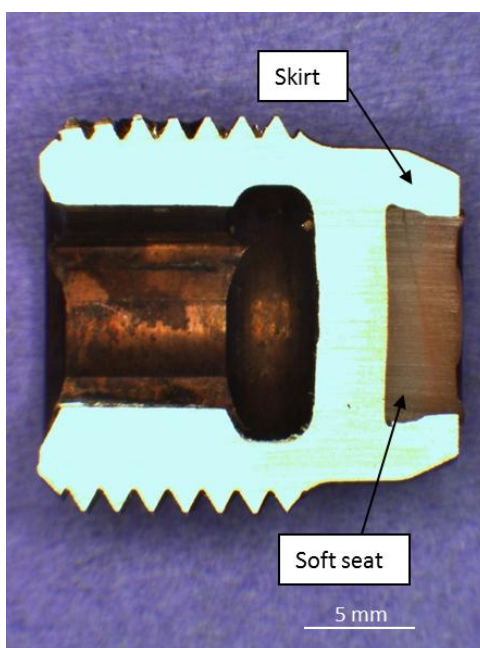
The inner spindle was activated by a screw thread and formed a seal against the valve orifice via a cylindrical soft seat component, shown in Figure 4. The soft seat had been manufactured from nylon 6, 6 and retained in position in a recess by the inner spindle skirt. The nylon soft seat component had a diameter of 8.7 mm and a thickness of 3.1 mm.

Figure 4. Section through intact inner spindle

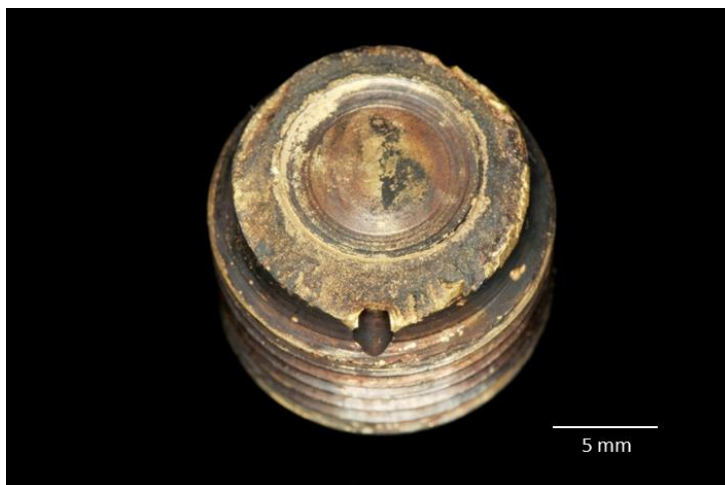
The valve was radiographed on receipt; this indicated features consistent with fracture of the inner spindle skirt. The valve was subsequently disassembled and this showed that the inner spindle had fractured around the base of the skirt at a point where the service stresses would have been highest (Figure 5). Fracture had also occurred longitudinally through the skirt, resulting in six individual fragments.

Figure 5. Inner spindle of incident valve

Failure of the inner spindle had originated at the change in section in the soft seat recess. Significant tensile stresses are likely to have been generated in this area, resulting from compression of the soft seat during and following valve closure, or as a result of swelling of the soft seat material due to water absorption. It is probable that the stress concentration factor associated with the change in section was sufficient to exceed the threshold for SCC.

The investigation highlighted the need for suitable design review processes in equipment for high hazard plant. Following the investigation, a number of changes to valve design have been implemented, including changes to: a) the position of the valve port; b) the geometry of the soft seat recess to reduce the stress concentration factor at the base of the skirt, and c) changes to the material specification to reduce the potential for the development of copper acetylide.

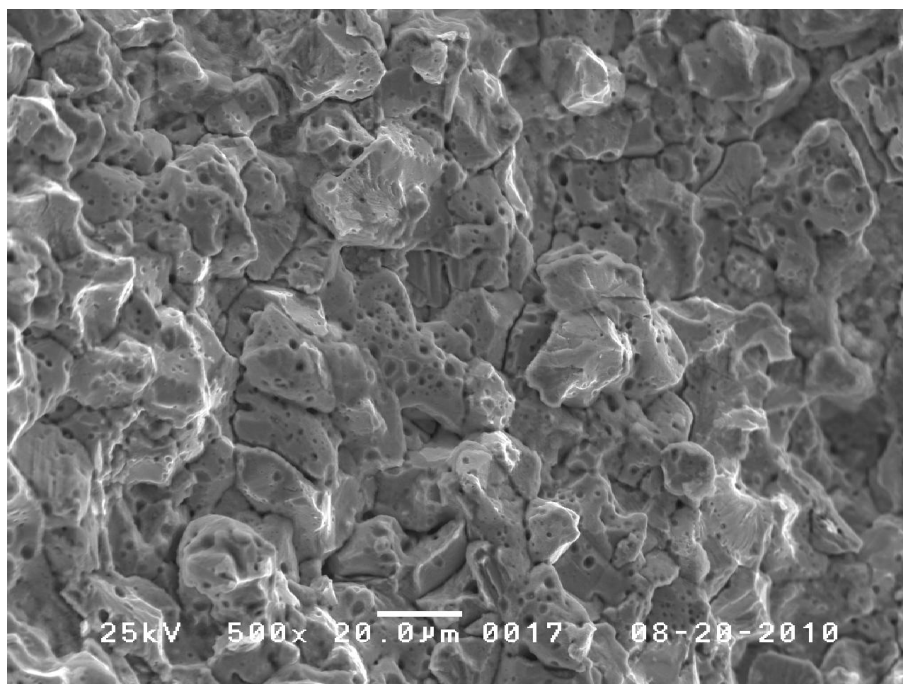
Examination of the fractured inner spindle and the skirt fragments in an SEM showed that many areas of the fracture surfaces were intergranular (Figure 6). The presence of intergranular facets was consistent with an environmentally assisted mode of failure such as stress corrosion cracking (SCC). A detailed survey of each of the fragments showed that there was no evidence of other progressive modes of failure, for example, by fatigue.

Figure 6. Intergranular surface of inner spindle

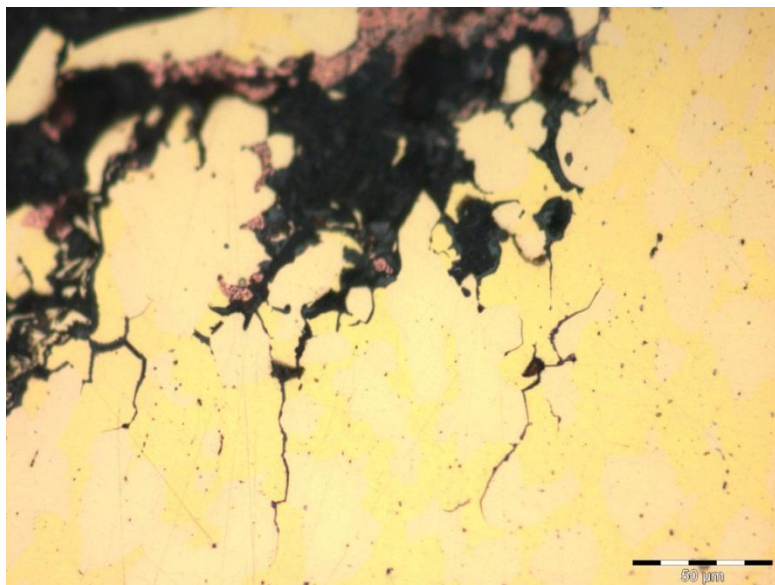
A longitudinal section through the inner spindle was mounted and polished to a 1 μm finish and examined optically. This showed that the fracture path was intergranular; secondary intergranular cracking was also apparent close to the fracture surface (Figure 7).

Figure 7. Detail of intergranular cracking and dezincification

In summary, failure of the inner spindle was associated with an intergranular crack growth mechanism, consistent with environmentally assisted or stress corrosion cracking (SCC). In addition, areas of metal loss by a corrosion or dealloying (dezincification) process were also observed, in some cases in association with intergranular cracking and in others, remote from it.

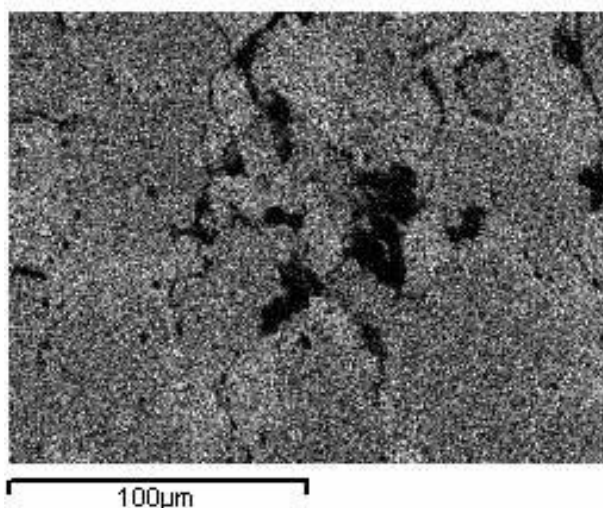
Examination of the as-polished and etched surfaces in the SEM confirmed the intergranular nature of the cracking. X-ray mapping, using an energy dispersive spectroscopy technique, of the fracture surface and the areas of secondary cracking exhibiting pink deposits, showed that these were associated with a significant reduction in the presence of zinc (Figure 8).

Figure 8. Zinc X-ray map of area of secondary cracking

It is clear that, in the case of the incident valve, dezincification occurred within the soft seat recess of the inner spindle. Furthermore, it is highly likely that both dezincification and SCC occurred as a result of attack by the same active agent, ammonia being the most likely candidate. It is worth noting that acetylene made via the calcium carbide process, as was the case in the incident, is likely to contain some residual ammonia depending upon the effectiveness of the scrubbing system [Miller 1965]. It is also apparent that for attack to occur under the soft seat, the material in this area must have been accessible to the active agent. Capillary action at the interface between the soft seat and the inner spindle skirt by an aqueous environment is most likely.

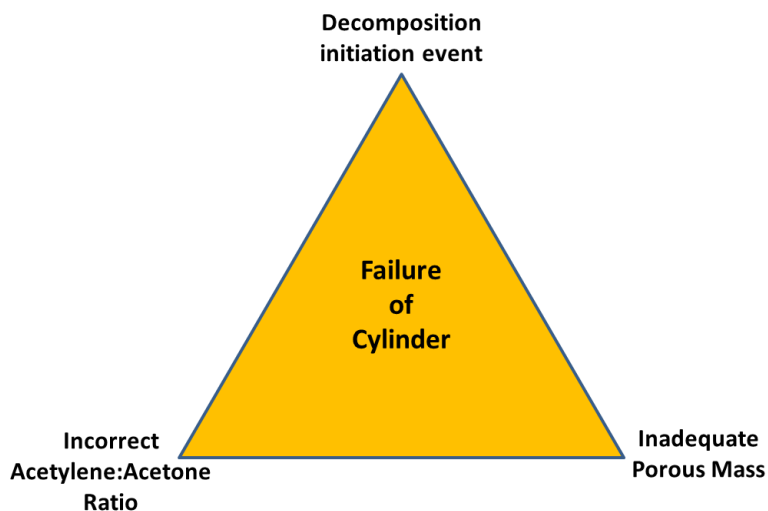
Figure 9. Conditions required for failure of a mechanically sound DA cylinder due to acetylene decomposition

If the stabilisation system comprising the acetone and porous mass system had been effective, an initiation event at the cylinder valve would not have resulted in bursting of the cylinder, providing that the cylinder was mechanically sound. The effectiveness of this system in stabilising the DA depends upon achieving the correct ratio of acetylene and acetone and maintaining an undamaged porous mass (Figure 9).

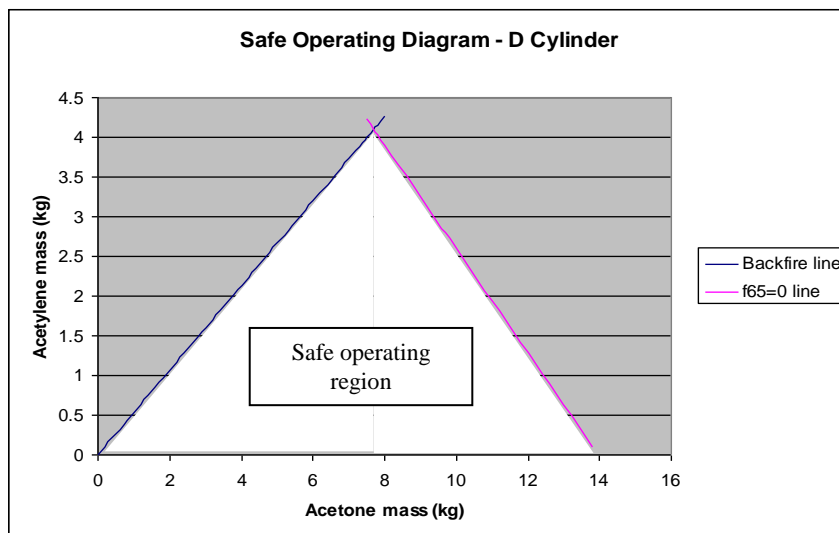
The safe operating region for a D size cylinder is shown in Figure 10. It can be seen that increasing the acetylene to acetone mass ratio would eventually result in exceeding the boundary for failure during a backfire test. It can also be seen that increasing either the acetone mass or acetylene mass above the nominal amounts would eventually result in exceeding the boundary for failure of the elevated temperature test.

Figure 10. Safe operating area determined for a D size cylinder using the methods given by AGA

The above factors may have introduced a significant error in the acetylene to acetone ratio such that it was no longer within the safe operating region where a decomposition would have been contained in the event of an initiation, even if the porous mass was in good condition.
