Investigation of an acetylene cylinder explosion incident

Phil Hooker¹, John Hodges¹, Bill Geary¹, Shane Wakefield²

¹ Health and Safety Executive, Harpur Hill, Buxton SK17 9JN.

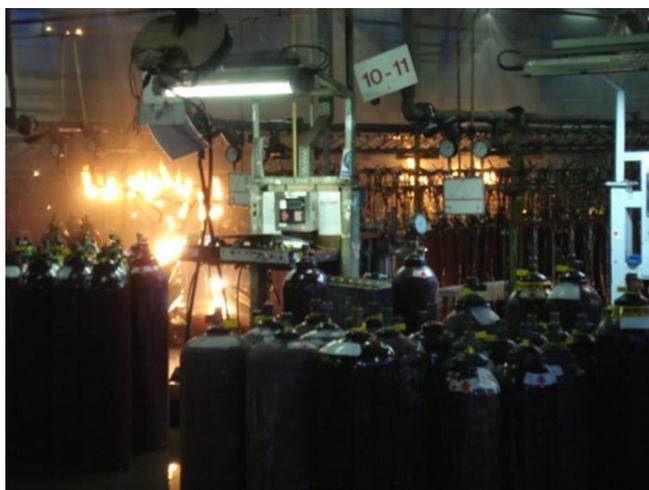
The fire service had placed video cameras within the filling plant following failure of the cylinder and these showed the flames that were established within the plant (Figure 1). The total acetylene release rate was calculated from the observed flame lengths. This, together with an estimate of the building ventilation rate, allowed a decision to be made to safely extinguish the flames and allow the acetylene to vent to atmosphere. Each cylinder valve was eventually turned off to isolate the acetylene supply and prevent further venting to atmosphere.

Figure 1. Fires of leaking acetylene following the initial cylinder explosion

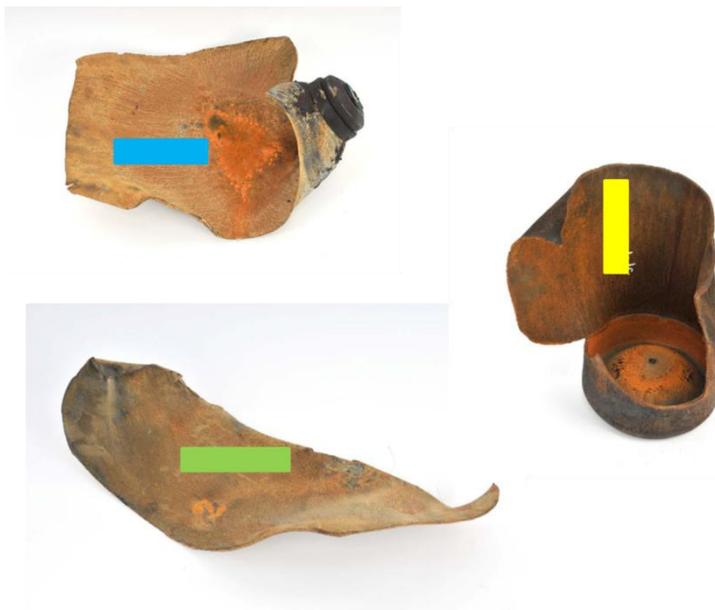
The incident cylinder had fractured into three pieces which were projected in different directions (Figures 2 and 3). The largest section included part of the top of the cylinder. As the cylinder burst, this part was projected eight metres along the gangway between the filling racks. The valve stem was retained in the cylinder top and had fractured level with the cylinder top. The middle part of the cylinder was projected towards the adjacent filling rack, hitting and damaging three cylinders before finally coming to a rest two metres from its original position. The bottom part of the cylinder was projected over the filling rack, impacting cylinders in the adjacent rack, coming to rest approximately six metres from its original position.

Figure 2. The three fragments of the incident cylinder - colours relate to flight paths shown in Figure 3

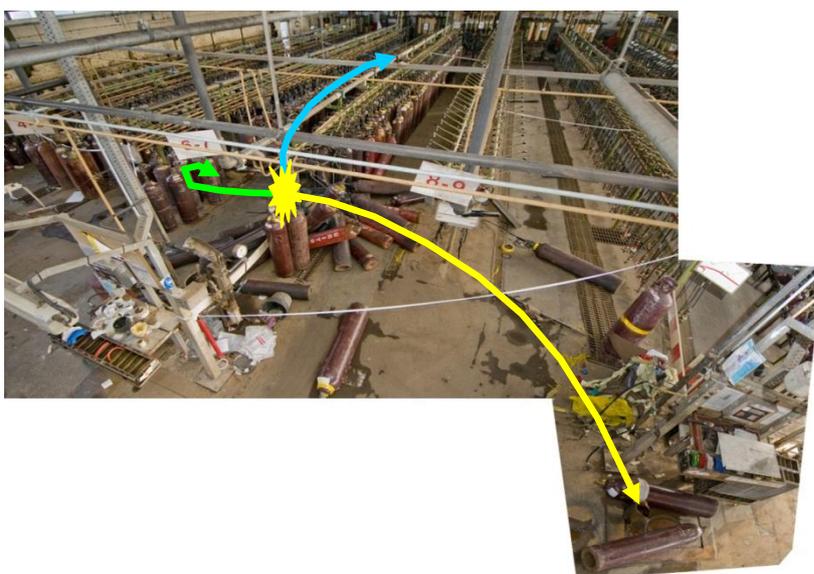
Figure 3. Indicative flight paths of the three parts of the incident cylinder. Blue arrow – cylinder top, Green arrow – cylinder middle, Yellow arrow – cylinder bottom

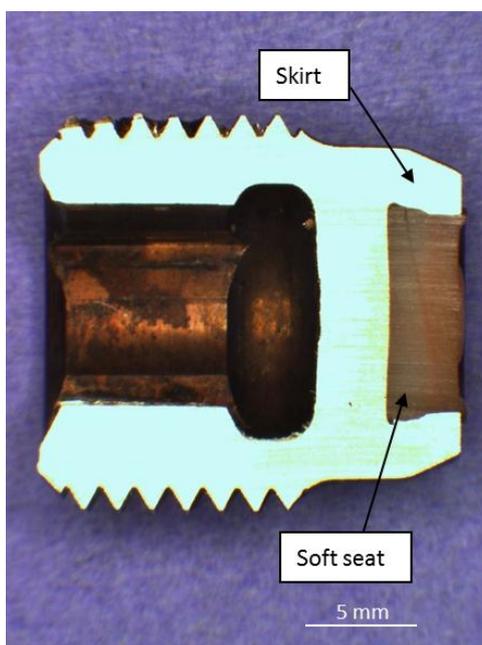
The inner spindle was activated by a screw thread and formed a seal against the valve orifice via a cylindrical soft seat component, shown in Figure 4. The soft seat had been manufactured from nylon 6, 6 and retained in position in a recess by the inner spindle skirt. The nylon soft seat component had a diameter of 8.7 mm and a thickness of 3.1 mm.

Figure 4. Section through intact inner spindle

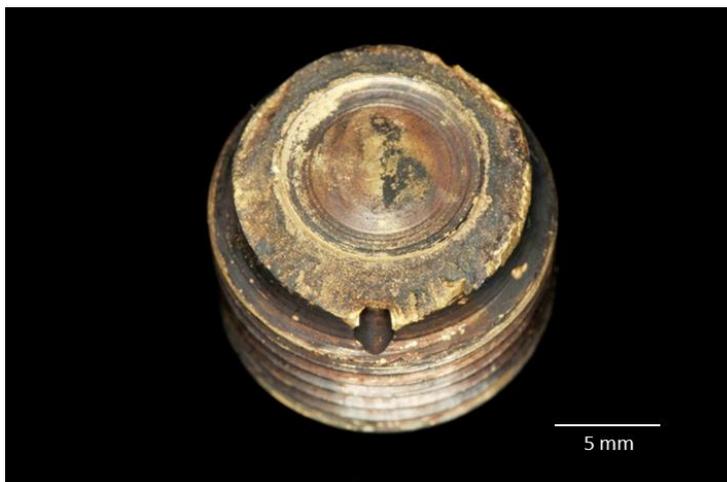
The valve was radiographed on receipt; this indicated features consistent with fracture of the inner spindle skirt. The valve was subsequently disassembled and this showed that the inner spindle had fractured around the base of the skirt at a point where the service stresses would have been highest (Figure 5). Fracture had also occurred longitudinally through the skirt, resulting in six individual fragments.

Figure 5. Inner spindle of incident valve

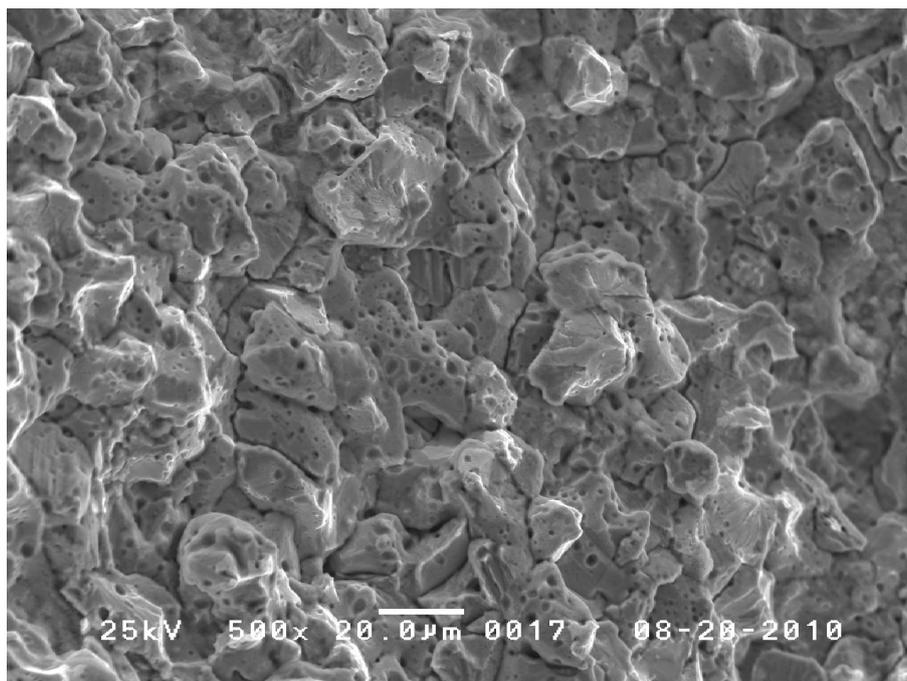
Examination of the fractured inner spindle and the skirt fragments in an SEM showed that many areas of the fracture surfaces were intergranular (Figure 6). The presence of intergranular facets was consistent with an environmentally assisted mode of failure such as stress corrosion cracking (SCC). A detailed survey of each of the fragments showed that there was no evidence of other progressive modes of failure, for example, by fatigue.

Figure 6. Intergranular surface of inner spindle

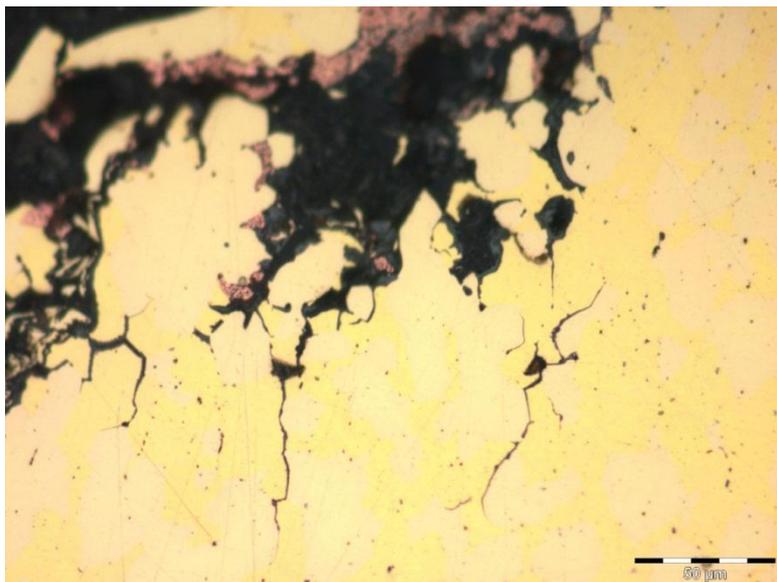
A longitudinal section through the inner spindle was mounted and polished to a 1 µm finish and examined optically. This showed that the fracture path was intergranular; secondary intergranular cracking was also apparent close to the fracture surface (Figure 7).

Figure 7. Detail of intergranular cracking and dezincification

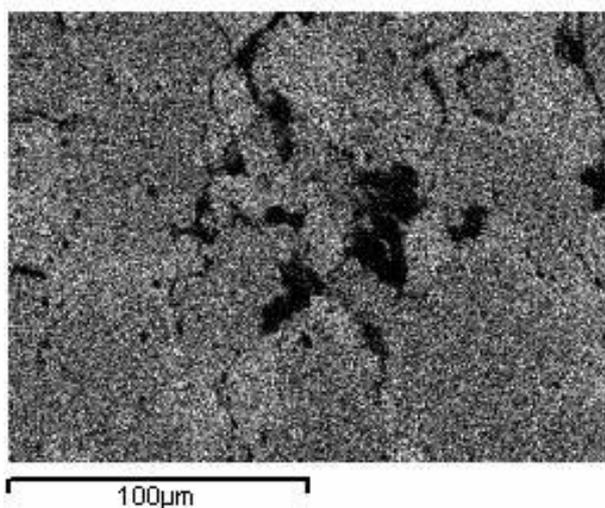
Examination of the as-polished and etched surfaces in the SEM confirmed the intergranular nature of the cracking. X-ray mapping, using an energy dispersive spectroscopy technique, of the fracture surface and the areas of secondary cracking exhibiting pink deposits, showed that these were associated with a significant reduction in the presence of zinc (Figure 8).

Figure 8. Zinc X-ray map of area of secondary cracking

In summary, failure of the inner spindle was associated with an intergranular crack growth mechanism, consistent with environmentally assisted or stress corrosion cracking (SCC). In addition, areas of metal loss by a corrosion or dealloying (dezincification) process were also observed, in some cases in association with intergranular cracking and in others, remote from it.

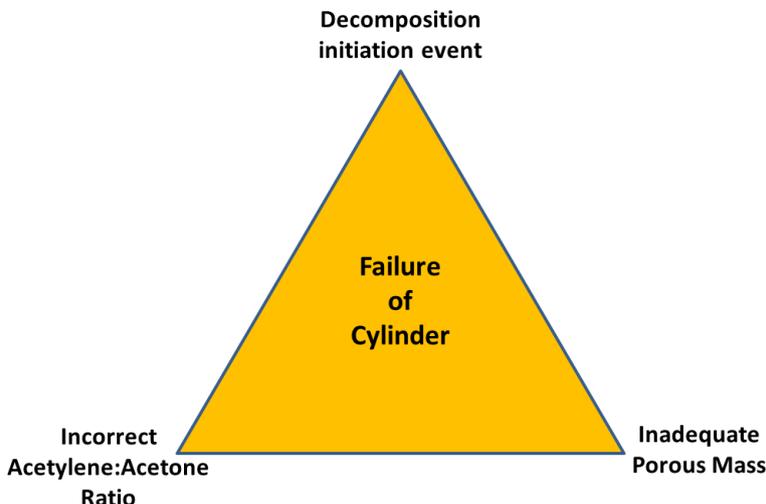
Figure 9. Conditions required for failure of a mechanically sound DA cylinder due to acetylene decomposition

If the stabilisation system comprising the acetone and porous mass system had been effective, an initiation event at the cylinder valve would not have resulted in bursting of the cylinder, providing that the cylinder was mechanically sound. The effectiveness of this system in stabilising the DA depends upon achieving the correct ratio of acetylene and acetone and maintaining an undamaged porous mass (Figure 9).

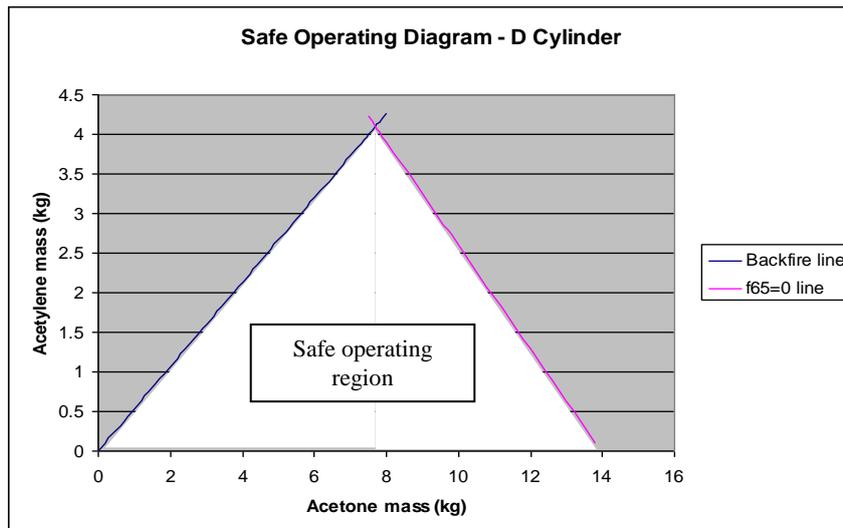
The safe operating region for a D size cylinder is shown in Figure 10. It can be seen that increasing the acetylene to acetone mass ratio would eventually result in exceeding the boundary for failure during a backfire test. It can also be seen that increasing either the acetone mass or acetylene mass above the nominal amounts would eventually result in exceeding the boundary for failure of the elevated temperature test.

Figure 10. Safe operating area determined for a D size cylinder using the methods given by AGA
