Incident

Piper Alpha – What have we learned?

Fiona Macleod and Stephen Richardson

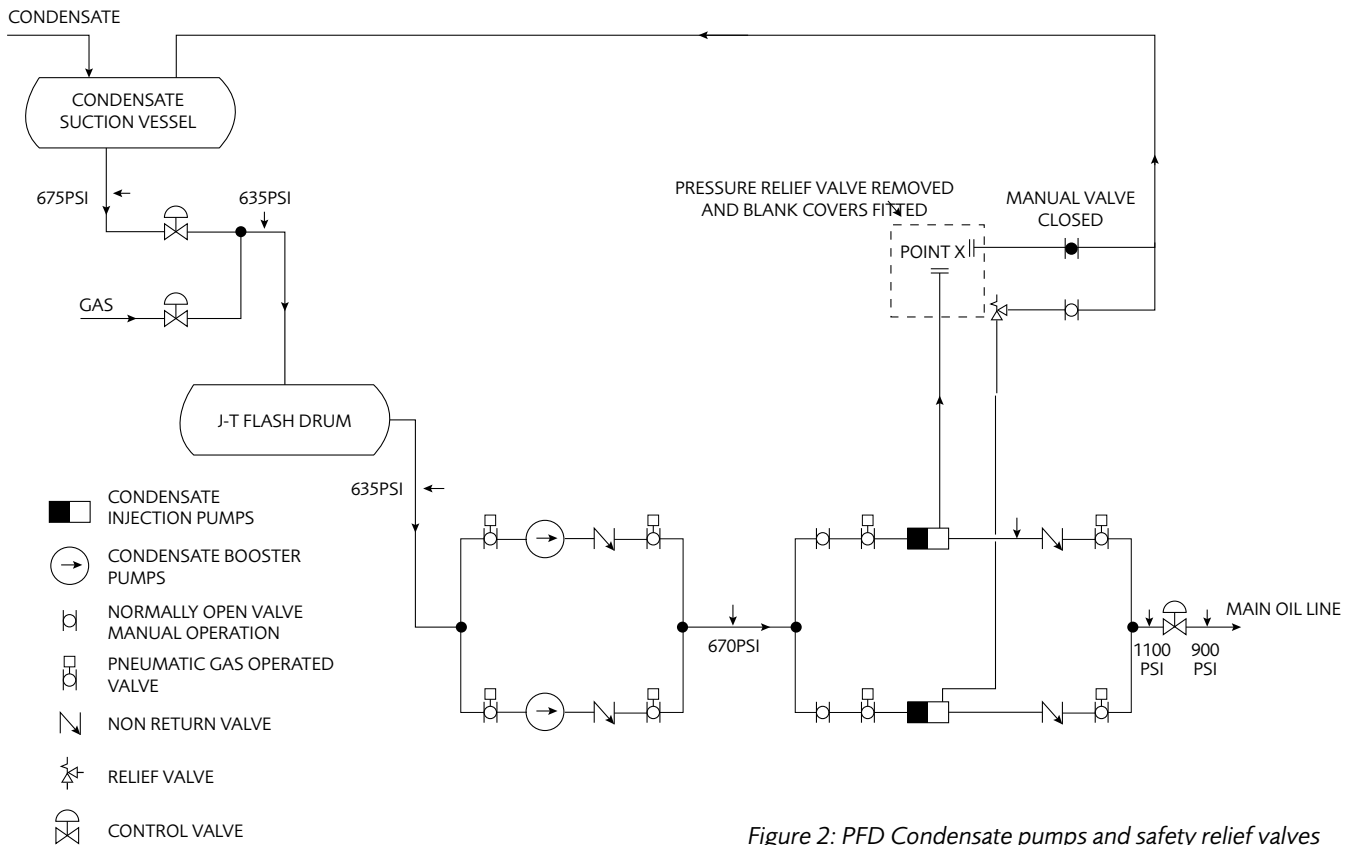
Figure 2: PFD Condensate pumps and safety relief valves

On the evening of 06 July 1988, condensate pump A was isolated for maintenance on its motor drive coupling. Pump A pressure relief valve had also been removed for maintenance under a separate permit and a blind flange almost certainly fitted in its place. The flange was not, however, leak-tested or pressure-tested. When pump B tripped at about 21.45, the operators tried unsuccessfully to restart it.

It is believed that the operators took steps to reinstate pump A and condensate leaked from the blind flange which had been installed in place of the pressure relief valve, but not fully tightened up.

The pressure relief valves for the condensate injection pumps were located one floor above the pumps. Although it is almost always best practice for a pressure relief valve to be sited as close as possible to the unit that it is protecting, condensate on the downstream side had to be able to drain to an appropriate vessel, so the valve was placed about 8 metres above (and 15 metres away from) the pump.

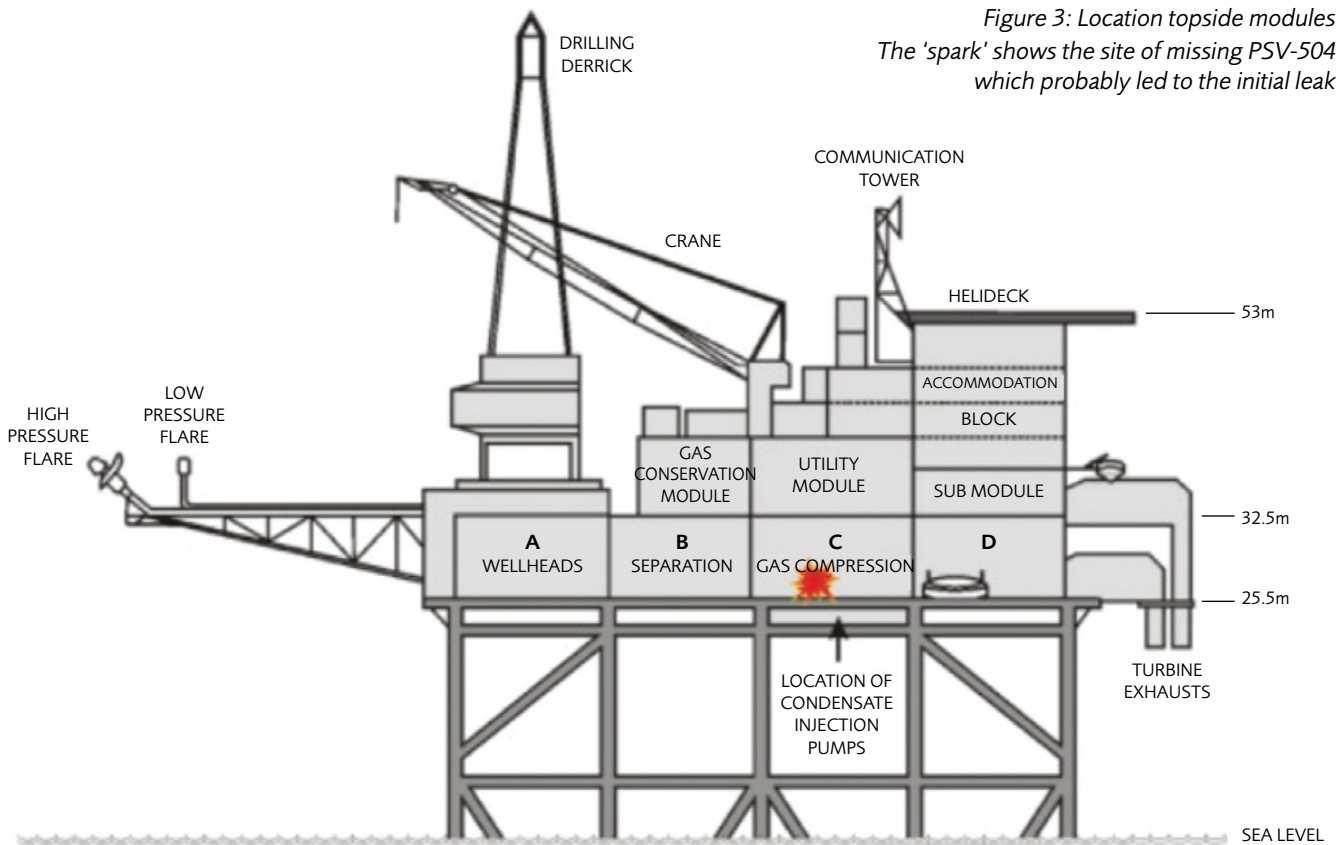
The inquiry concluded that the most likely cause of the first explosion was the release of as little as 30 kg of condensate (mainly propane) over thirty seconds through an unsecured blind flange in Module C where a pressure safety relief valve had been removed as part of maintenance on the standby condensate pump.

Figure 3: Location topside modules
The 'spark' shows the site of missing PSV-504 which probably led to the initial leak

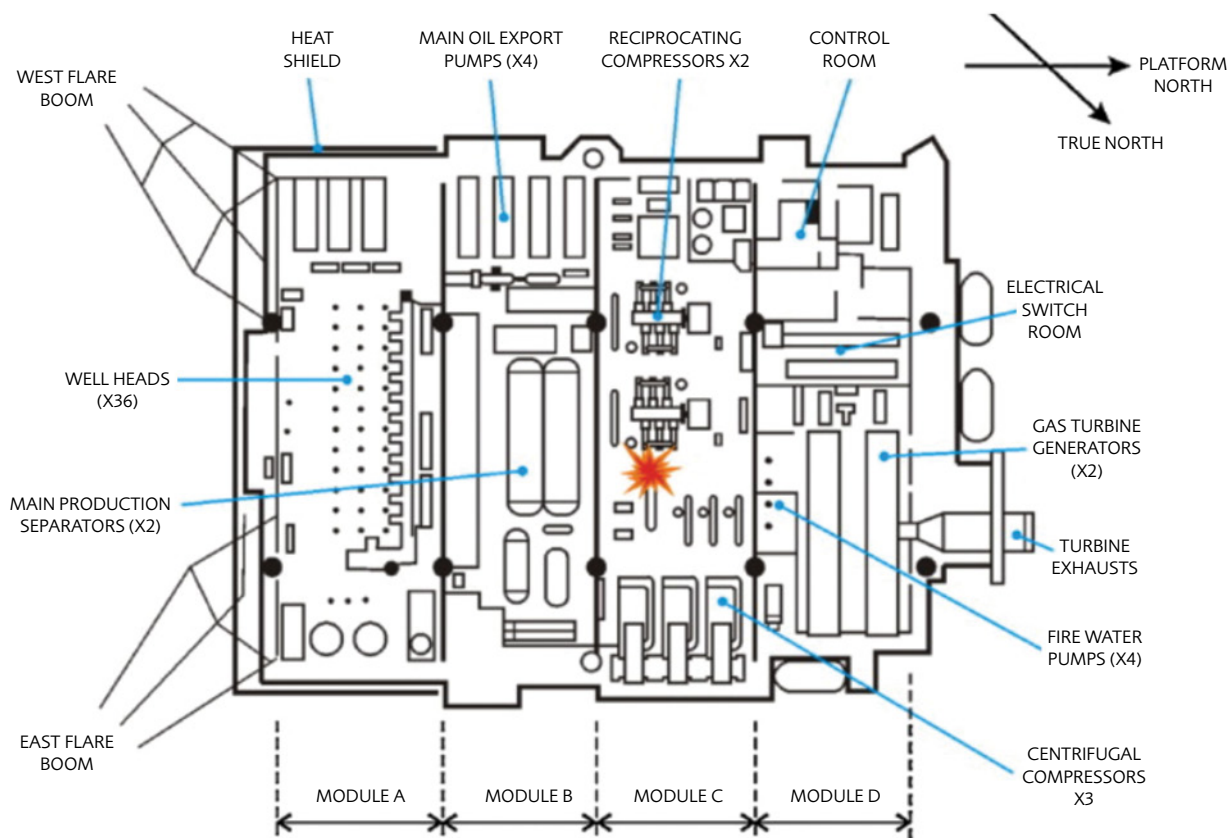
The new facilities were located beside the control room, under the electrical power, radio room and accommodation modules, so that when disaster struck, it did so with disastrous effect on the rest of Piper Alpha.

The control room was badly damaged in the first explosions (the control room operator survived and gave valuable evidence to the Public Inquiry on the sequence of alarms preceding those first explosions). The radio room was rendered useless; communications were lost almost at once.

Figure 4: Horizontal diagram with control room, radio room and gas compression module
