# Bhopal gas tragedy – the scar of process safety

Tze Lin Kok, Yeuan Jer Choong, Chee Kean Looi and Jing Han Siow,  
Universiti Teknologi Petronas, Malaysia

## Summary

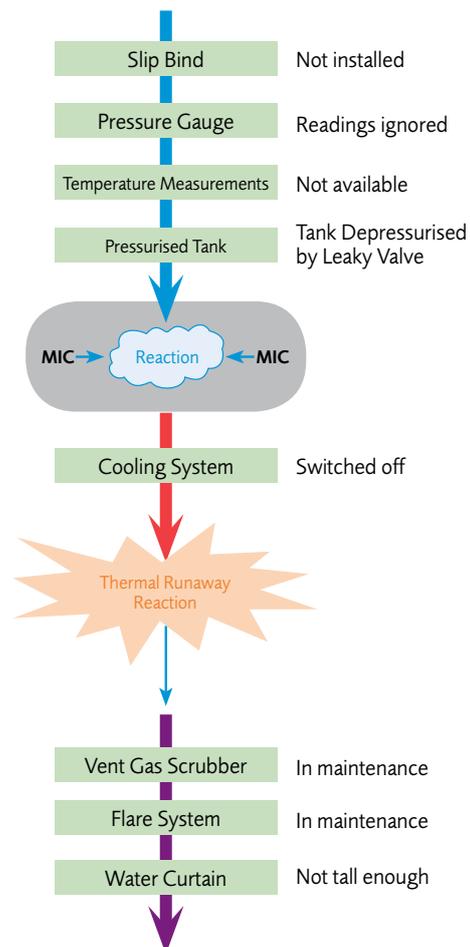
Figure 1—Series of failures leading to the Bhopal gas tragedy

The sequence of events leading to the occurrence of the disaster are illustrated in Figure 1. It should be noted that if any of the safety measures (in green boxes) had been functioning properly, the incident could have been prevented.
