Incident

Buncefield: Lessons learned on emergency preparedness

Graham Atkinson, Health and Safety Executive, UK

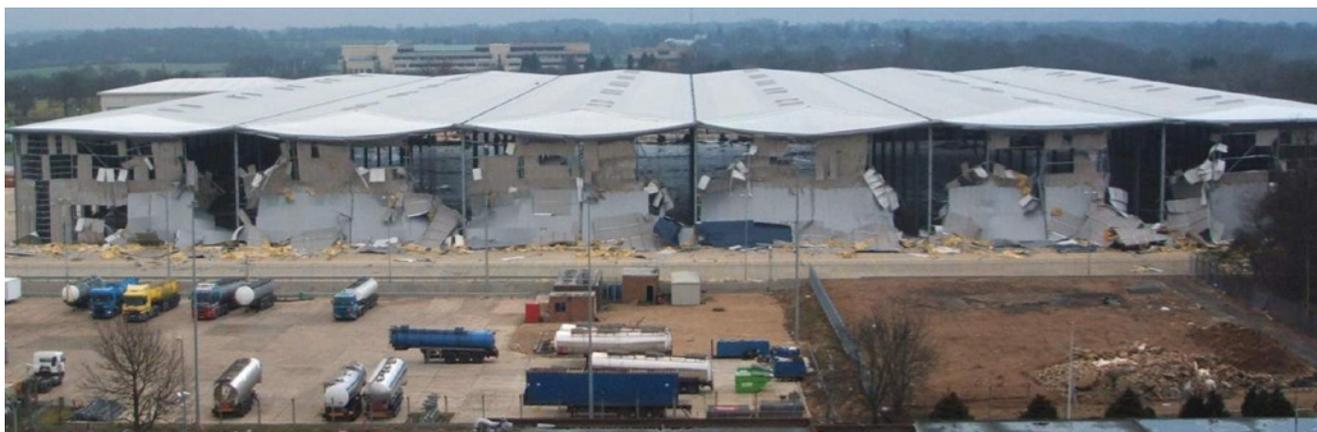
The blast effects caused catastrophic damage to all of the areas, both on and off-site, that were covered by the cloud: all of the buildings, tanks and plant in this area had to be completely cleared. Commercial and residential premises within about 100m of the edge of the cloud also suffered serious structural damage and several had to be demolished. Lower levels of blast damage affected many commercial buildings within about a kilometer from the site: damage was typically to the cladding and weather-sealing of these large buildings (Figure 1). Although the damaged cladding could be replaced, the scale of this work meant that many businesses were forced to relocate for months or even years causing serious commercial losses.

Figure 1 – Damage to a warehouse 400m from the overfilled tank (Copyright: HSE)

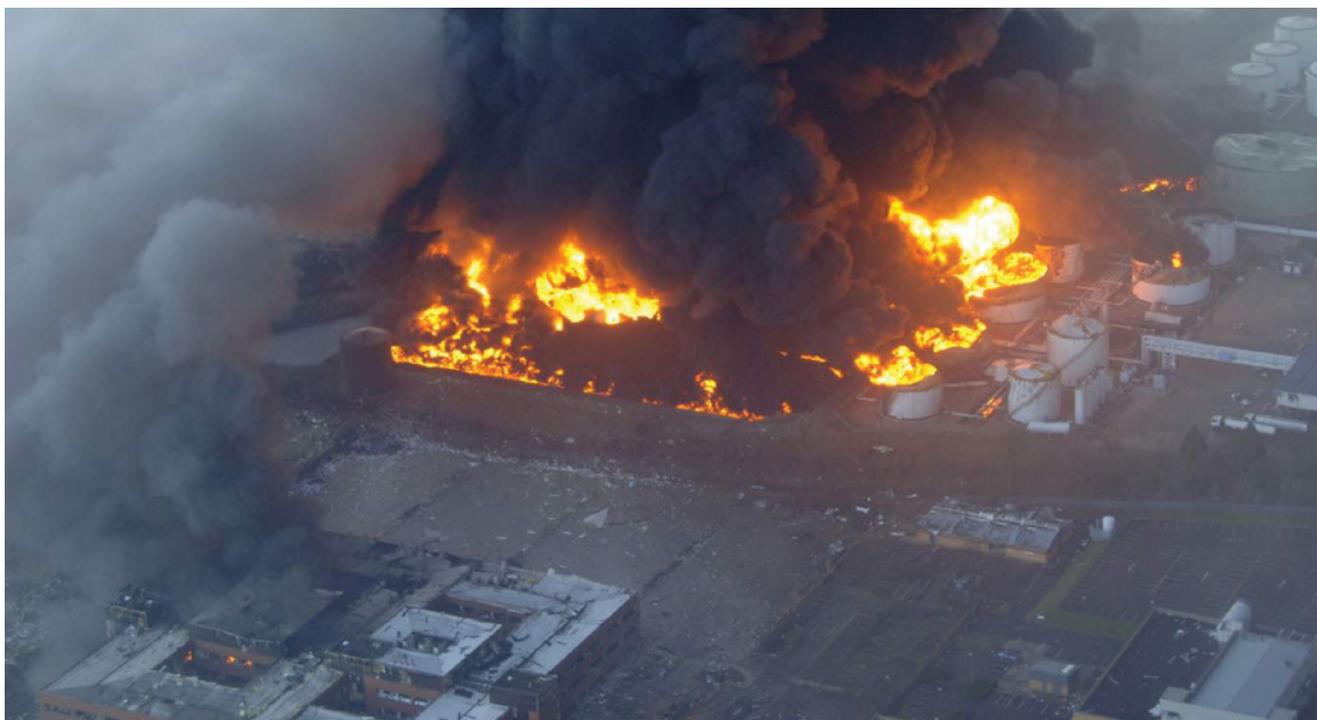
The FRS dealt with smaller fires in office buildings around the site, but until midday on 11/12/2005 the tactical mode of on-site operations remained defensive (Figure 2). Some hoses for cooling jets were laid around the site perimeter and foam calculations were carried out for attack on the main fire. Local stocks of foam were nowhere near sufficient to allow an attack on the main tank/bund fires. Within an hour of the explosion the FRS had contacted the main UK supplier of fire-fighting foam to discuss mustering national stocks of foam concentrate.

Figure 2 – Photograph taken at 10:40am 11/12/2005 (4.6 hours after the explosion) (Copyright Chiltern Air Support). The photograph shows the main bund fire. The explosion has also caused a fire in the office building in the bottom left corner

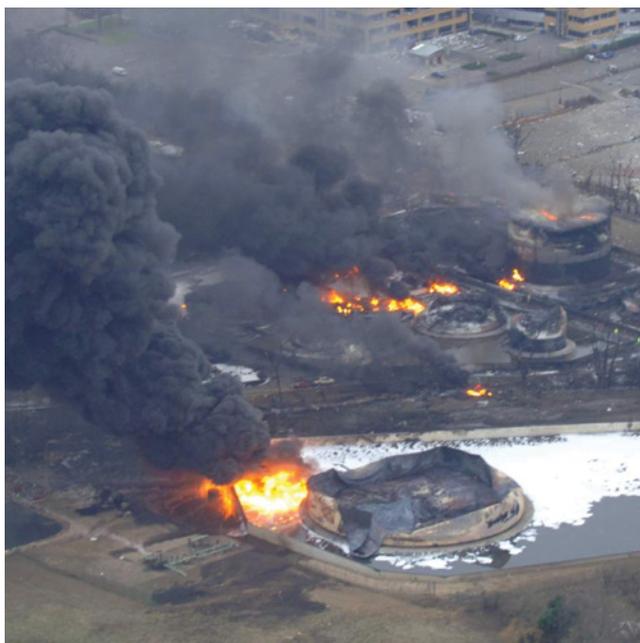
Figure 3 – Photograph taken at 15:47pm 13/12/2005 (57 hours after the explosion) (Copyright Chiltern Air Support). The photograph shows residual tank fires: Tank 912 (top right) still has a substantial inventory.

4. High ground level smoke concentrations as the heat release was reduced;
5. Flange fires that could not be isolated at the foot of tanks with high initial inventories (Figure 3).

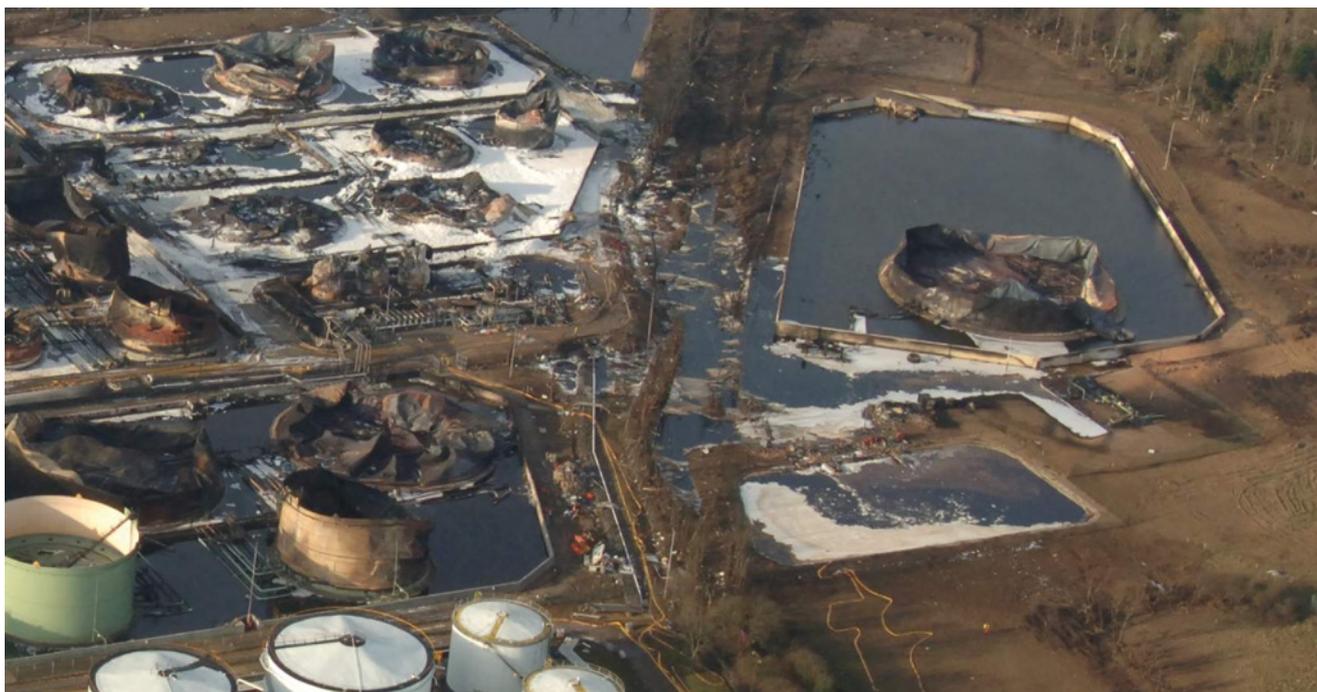
The fire was declared to be "ALL OUT" at 12:30 on 15/12/2005 (+102 hours Figure 4). Many nationally mobilised resources were released in the evening of 16/12/2005. Foam application (to maintain blanketing) was halted at 10:40 on 17/12/2005 but there was a re-ignition soon afterwards. A permanent FRS presence on the site was required until 5/1/2006. Freezing temperatures caused hose bursts and affected some appliances.

Only 2.5 million litres of firewater retention capacity could be made available by emptying the site waste water reservoir; which corresponded to <5% of the total tertiary containment capacity required. Water was regularly redistributed around various bunds that were available, but many were compromised. Effluent was pumped into bunds on an adjacent fuel depot site but then had to be pumped back when advice on bund integrity changed. A local electrical sub-station was inundated by rising water levels and had to be isolated.

Figure 4 – Photograph taken at 12:52pm 15/12/2005 (102 hours after the explosion) (Copyright Chiltern Air Support). The photograph shows rising water levels - due to continued water use and leakage from bunds
