Loss Prevention Bulletin

Environment agency
special issue

Case studies of
environmental
incidents at major
hazard sites

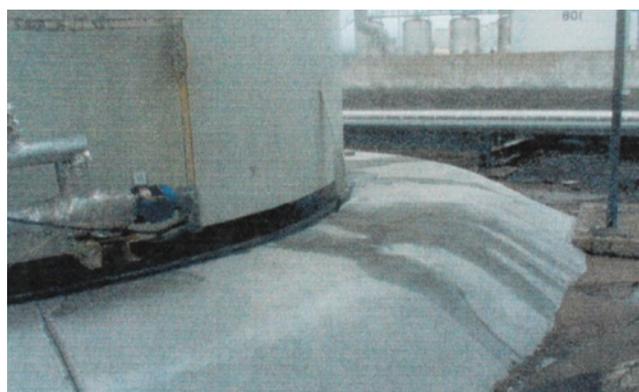
The cause of the leak was a weld slag inclusion that had been formed during the original fabrication of the tank in 1977. The tank was designed in accordance with BS2654:1973 and went into sodium cyanide service in 1991. In September 1998, following a discrepancy in a routine stock reconciliation, it was found that the tank was leaking as a result of the construction defect in the floor welds. It was concluded that the failure of the defect was caused by high pressure water jetting during routine maintenance in May 1998. The tank was repaired subsequently, inspected and found to be fit for purpose. Despite the clean bill of health, the tank leaked again in July 1999. This time the loss was detected by its strong almond odour and the visible trace of sodium cyanide on the berm.

Though the bund was sufficient in protecting people it did not prevent release to the environment. Two failure modes were highlighted:

- the base of the bund allowed some seepage into the ground; and

Tees storage leak: sodium cyanide leaking onto tank 713 berm – 21 July 1999.

- the bund drain valve was closed but not seated correctly allowing the release to enter the drainage system and hence to the discharge point to the river.

Subsequent changes include 3 pass welding techniques and improved design standards. Modern inspection equipment and techniques are now in place that reduces the risk of weld failure but additional consideration needs to be given to tanks of this age.

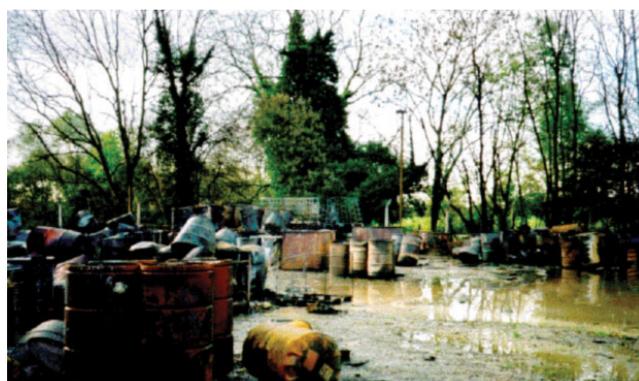
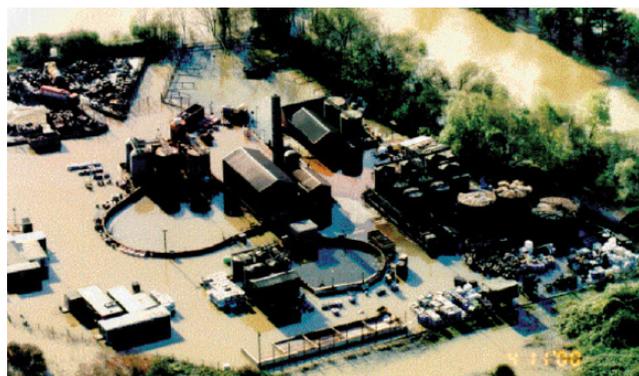
The direct cause of this incident was the ignition of flammable materials in an area of the site that was storing intermediate bulk containers (IBCs) containing IPA, in addition to large numbers of one litre containers of acetone and lab "smalls" (primarily flammable solvents). The ignition source has never been identified, though a number of possibilities have been proposed, including:

(Top to bottom): CSG Sandhurst: seat of fire and flooding

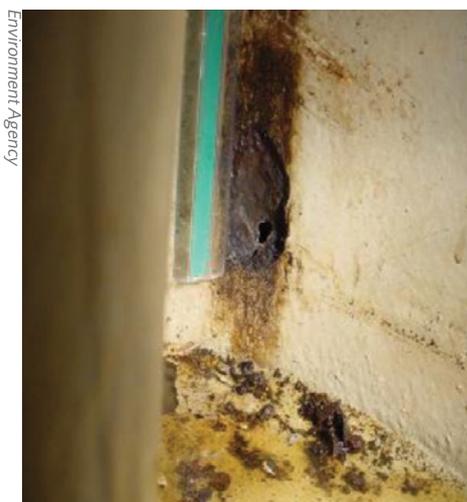
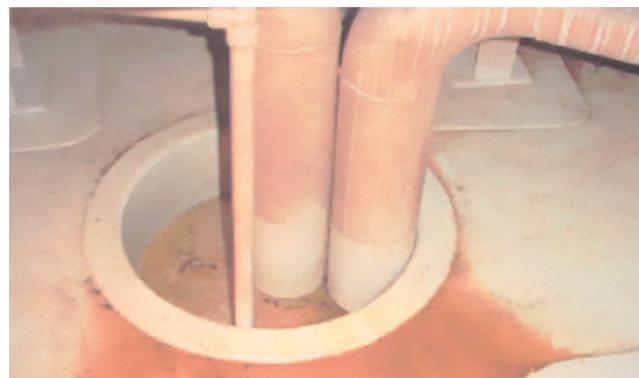
The cause of this incident was corrosion in the sump of tank T115, leading to the release of kerosene from the tank base. Although the tank was internally lined in 2001, it is believed the presence of the corrosion was due to either erosion of the lining (from movement of one of the pipes in the sump) or more likely there was no lining there as there was no access for painting with the pipes in situ. The corrosion was greatly accelerated by further erosion of the corrosion, each time the pipe was used. The pipe was not securely fastened and could move up and down against the wall of the sump. This is important as it would not be expected that corrosion alone would have penetrated an 8mm thick sump in such a short period.

Tank 115 base internal sump and pipes (below) with erosion and corrosion causing hole in the sump wall (left)

Moreover, a modification was made that allowed a third pipe to be put into the sump, which forced the try line against the sump wall. The standards do not deal with multiple pipes into a single sump. It should also be noted that the pipe support system across the tank floor did not prevent vertical movement of the pipes and this was a direct cause of the incident.

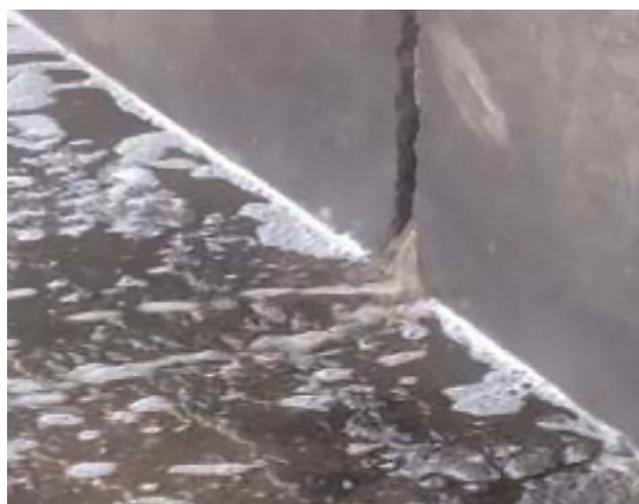
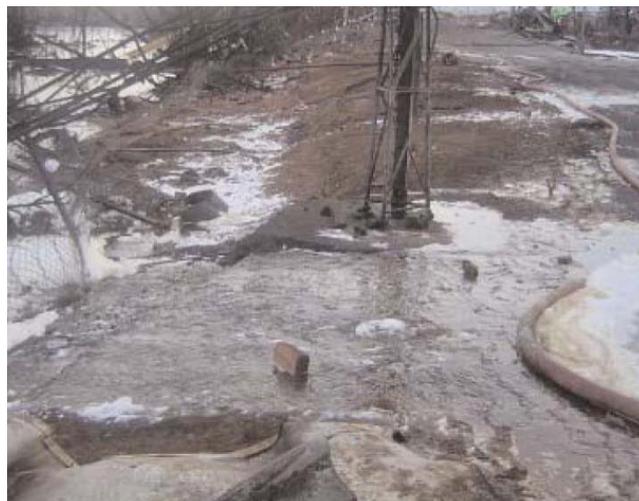
Buncefield: leaking bund wall (top), firewater runoff (bottom)

Multiple design, modification, inspection and maintenance issues with the bunds meant that these vital secondary containment measures failed during the fire. The major cause of bund failure on both HOSL and BPA sites was the failure of flexible sealant joints between concrete sections. The sealant was incapable of withstanding the temperatures generated in the fire, leaving gaps in the bunds through which liquids could escape. This was exacerbated by the presence of holes in some of the bund walls through which pipes had been routed and in some cases pipe movement caused the HOSL bund walls to catastrophically fail.

Tertiary containment on the site (at HOSL and BPA site boundaries and the common effluent plant) also failed to prevent the flow of firewater, fuel and foam offsite. This was because tertiary containment walls either did not exist or were limited to low kerbs, and because previously unidentified pathways, on and off-site existed. Runoff was able to directly pass into the underlying aquifer.

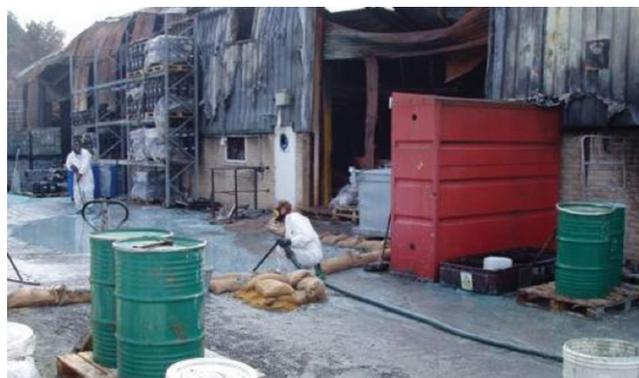
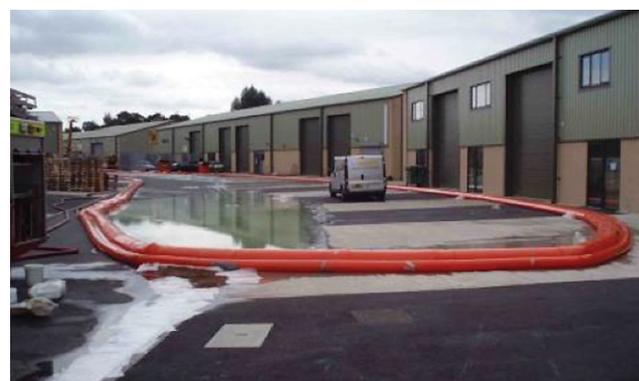
The most likely direct cause of the fire was mechanical overheating in the polypropylene tube of the conveyor carrying sodium dichloroisocyanurate dihydrate. It would appear that the mechanical heating caused the chemical to reach its thermal decomposition temperature, followed by self-heating decomposition and the subsequent fire.

(Top to bottom) Biolab fire: damage and emergency containment

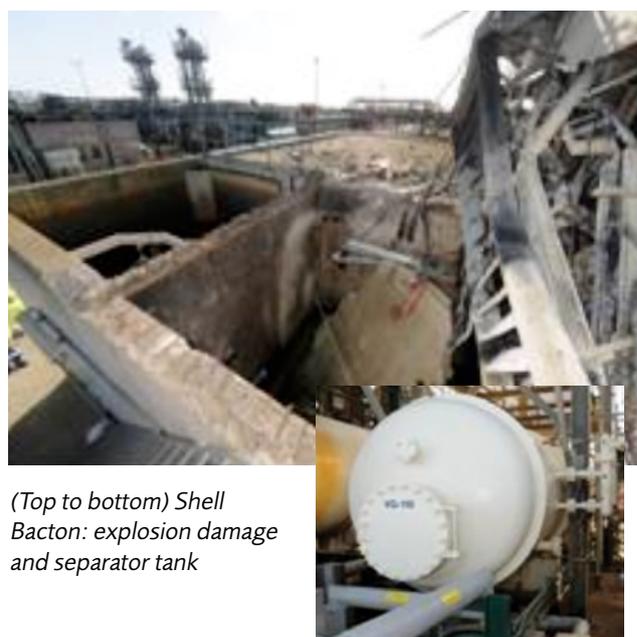
The immediate cause of the explosion was the highly flammable condensate vapour entering the wastewater treatment buffer tank and coming into contact with the

(Top to bottom) Shell Bacton: explosion damage and separator tank

heated elements in the vessel. There should not have been flammable hydrocarbon vapours in the wastewater buffer tank as this was designated a no-hydrocarbon zone. The presence of hydrocarbon condensate was due the malfunctioning of a separator vessel upstream of the wastewater plant, VG110.
