## Process safety essentials: Preparation for maintenance

# Explosion at the Phillips' Houston chemical complex, Pasadena, 23 October 1989

Published in LPB097, February 1991

An abstract of the Report to the President by the US Department of Labour, Occupational Safety and Health Administration, April 1990

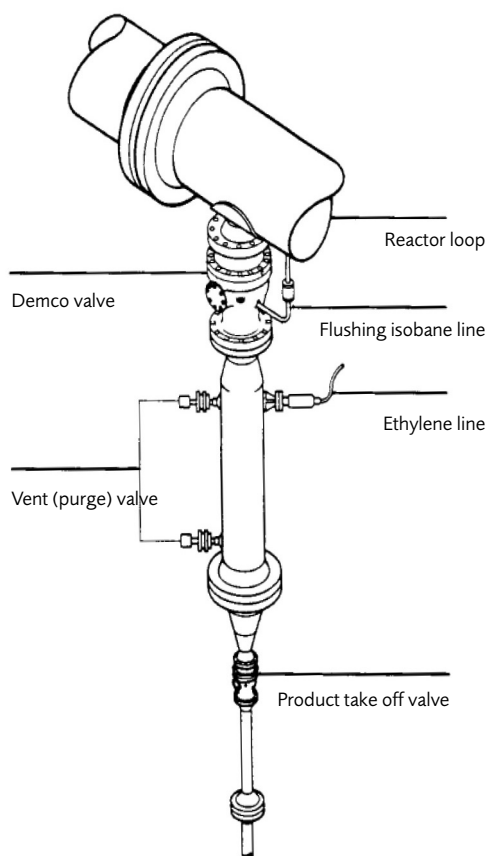
Figure 1: Typical piping settling leg arrangement

At the top of each leg is a ball valve (Demco brand) where it joins the reactor pipe loop. This ball valve is kept open

during normal operation. Clogging of the settling legs occurs periodically and on these occasions the top Demco ball valve is closed and the leg removed to clear the blockage. The reaction is continued during this operation as the product is able to settle out in adjacent settling legs.

The investigation was carried out by OSHA and established that the Demco valve was open at the time of the release. The air hoses which supplied air pressure to actuate the ball valve were found to be connected in a reverse manner such that the air pressure would open the valve even though the actuator switch called for the valve to be closed. The established procedure for carrying out maintenance work did not call for a backup isolation system.
