The explosion at HS041175  
Appleby-Frodingham steelworks  
Scunthorpe, 4 November 1975

A report by HM Factory Inspectorate

# The explosion at the Appleby-Frodingham steelworks, Scunthorpe 4 November 1975

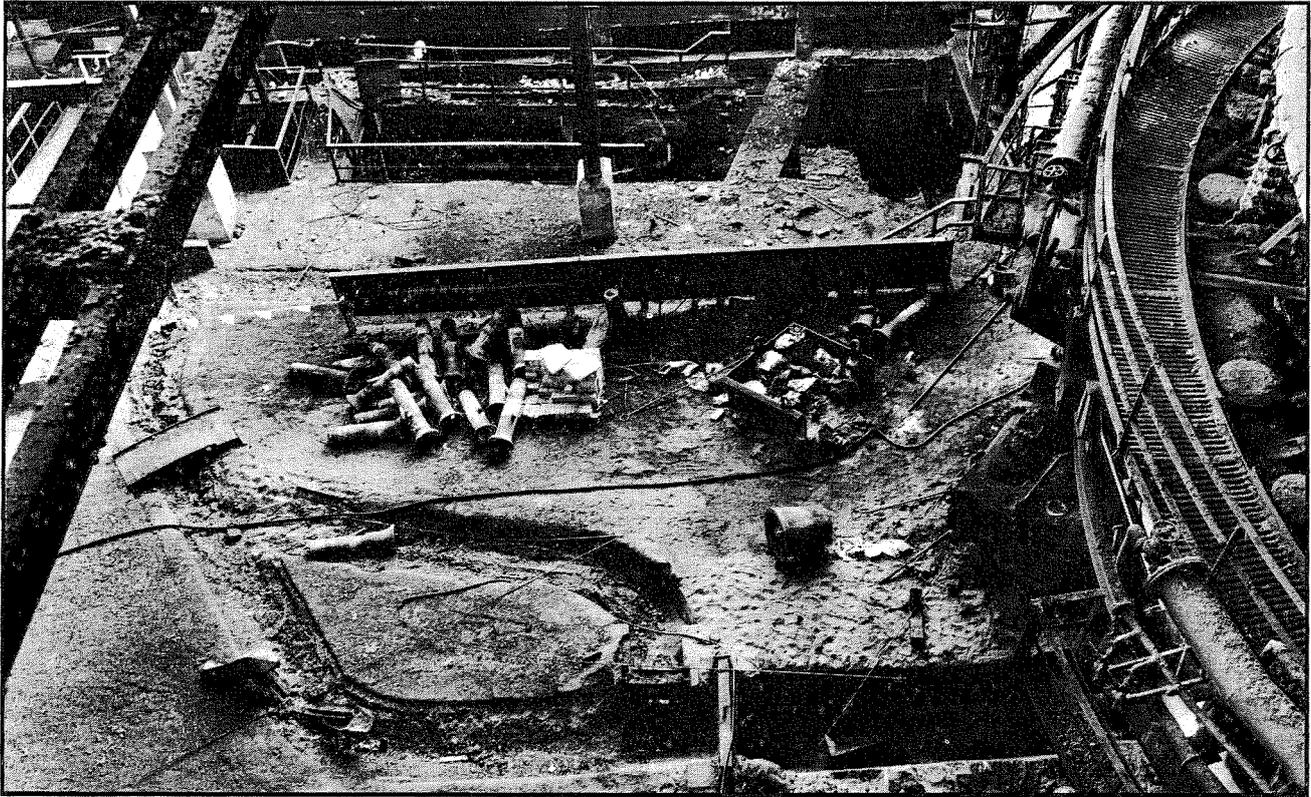
**Fig 4** View of cast house floor some sixty hours after the explosion

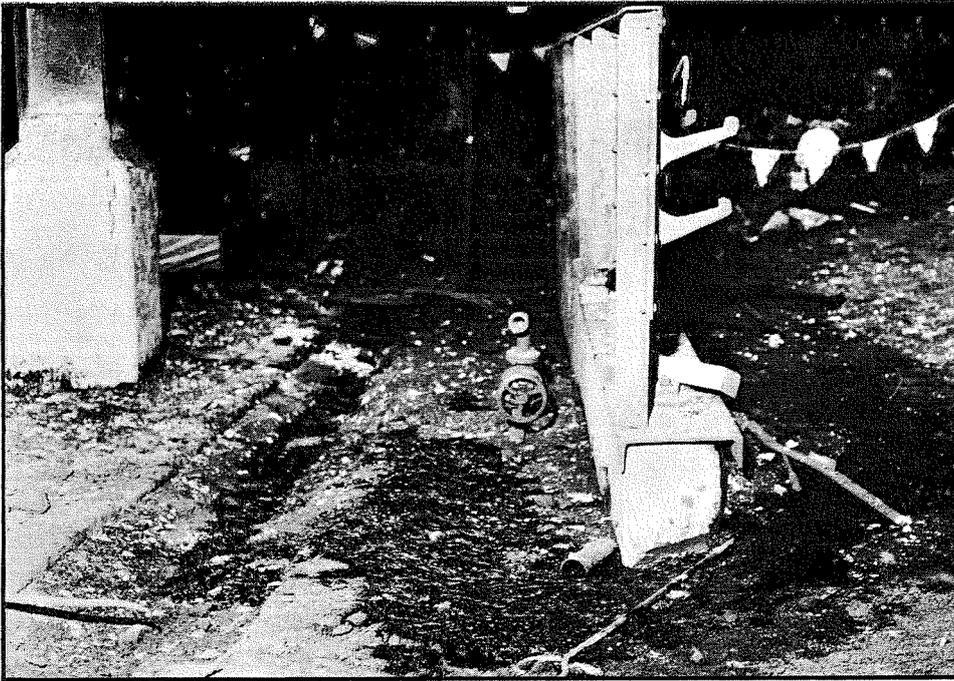
**Fig 7** Part of the path taken by the water flowing down the cast house floor to the junction with the iron runner

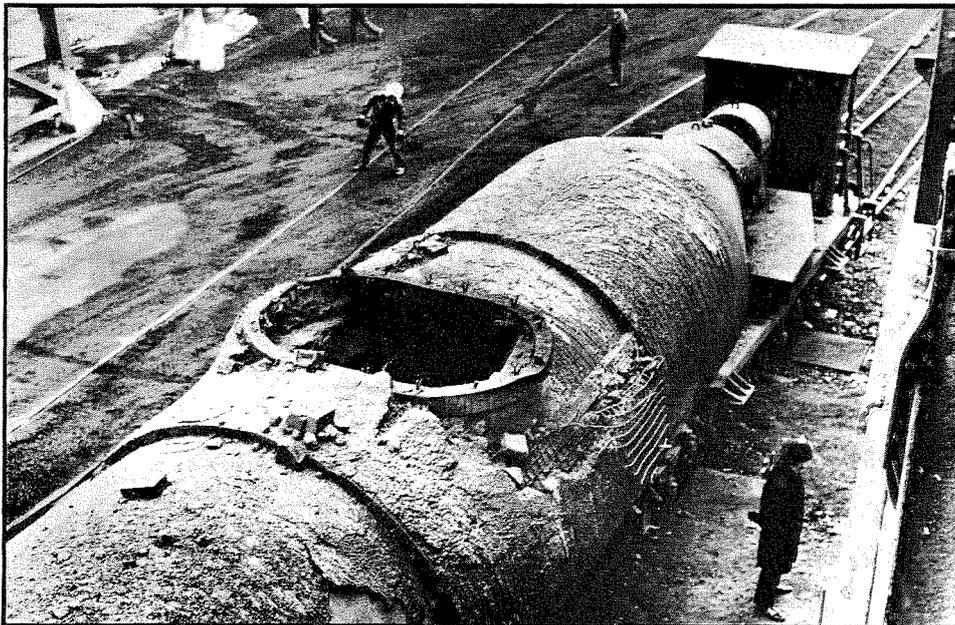
**Fig 9** The torpedo concerned photographed shortly after the incident. Metal/slag residues can be seen, and damage to the refractory lining in the throat area

50 Damage to plant, equipment and buildings were extensive in the immediate area of the explosion. All evidence pointed to the torpedo as being the seat of the explosion. Some 90 tonnes of metal ejected from the torpedo carried away the refractory brickwork from the torpedo throat, the local exhaust ventilation hood, the metal spout of the iron runner and substantial parts of the adjacent building structure. The iron runner spout weighing some  $1\frac{1}{4}$  tonnes was later found in the roof of the cast house on the opposite side of the building. Molten metal and red-hot brickwork from the ladle were sprayed over a wide area. All electrical services to the Queen Victoria and Queen Anne furnaces were disrupted. The local exhaust ventilation hood was blown vertically upwards through the roof of the cast house. The possible mechanism that would have caused the ejection of the molten metal is discussed in para 90 and Appendix 1.

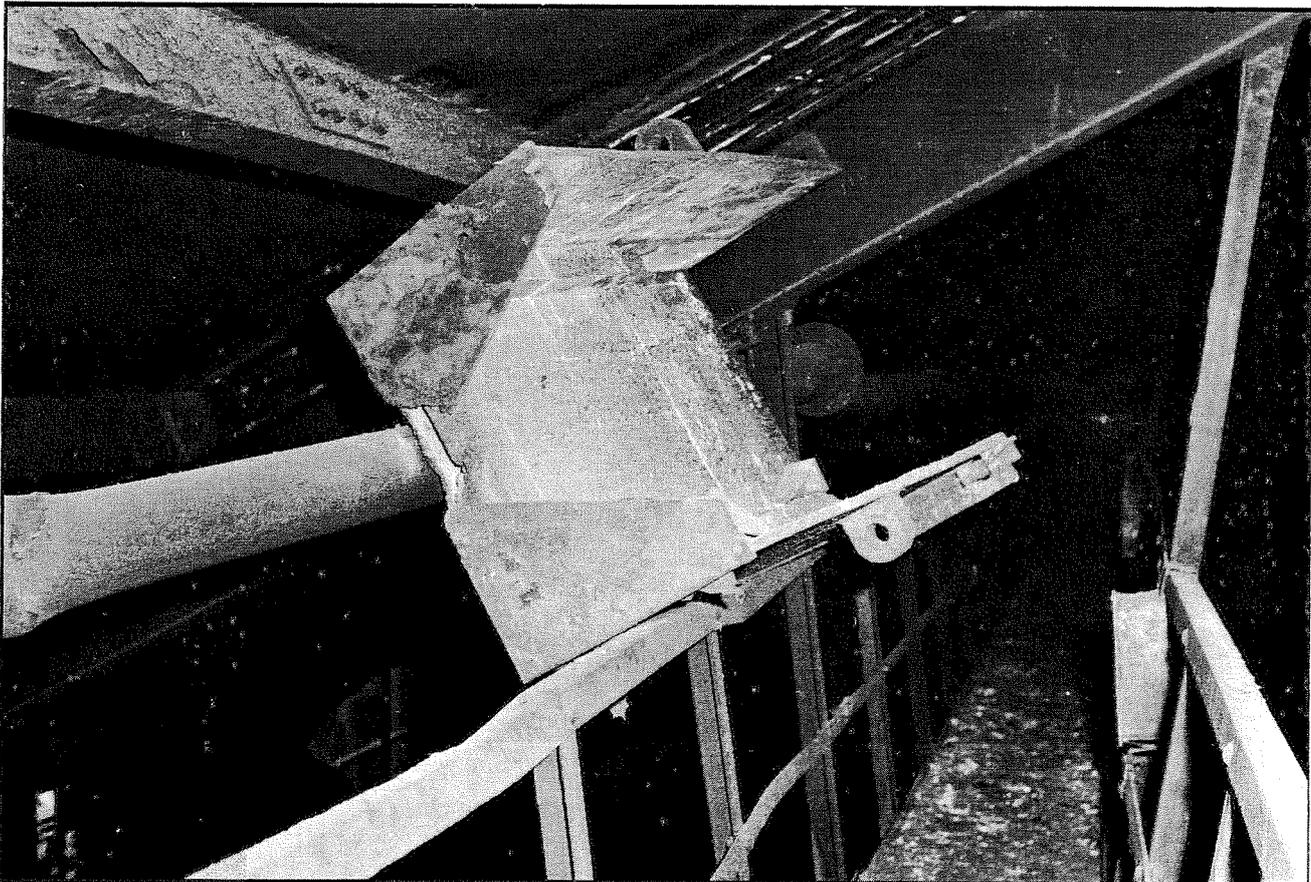
Fig 12 The  $1\frac{1}{4}$  tonne iron runner spout wedged in the roof of the cast house

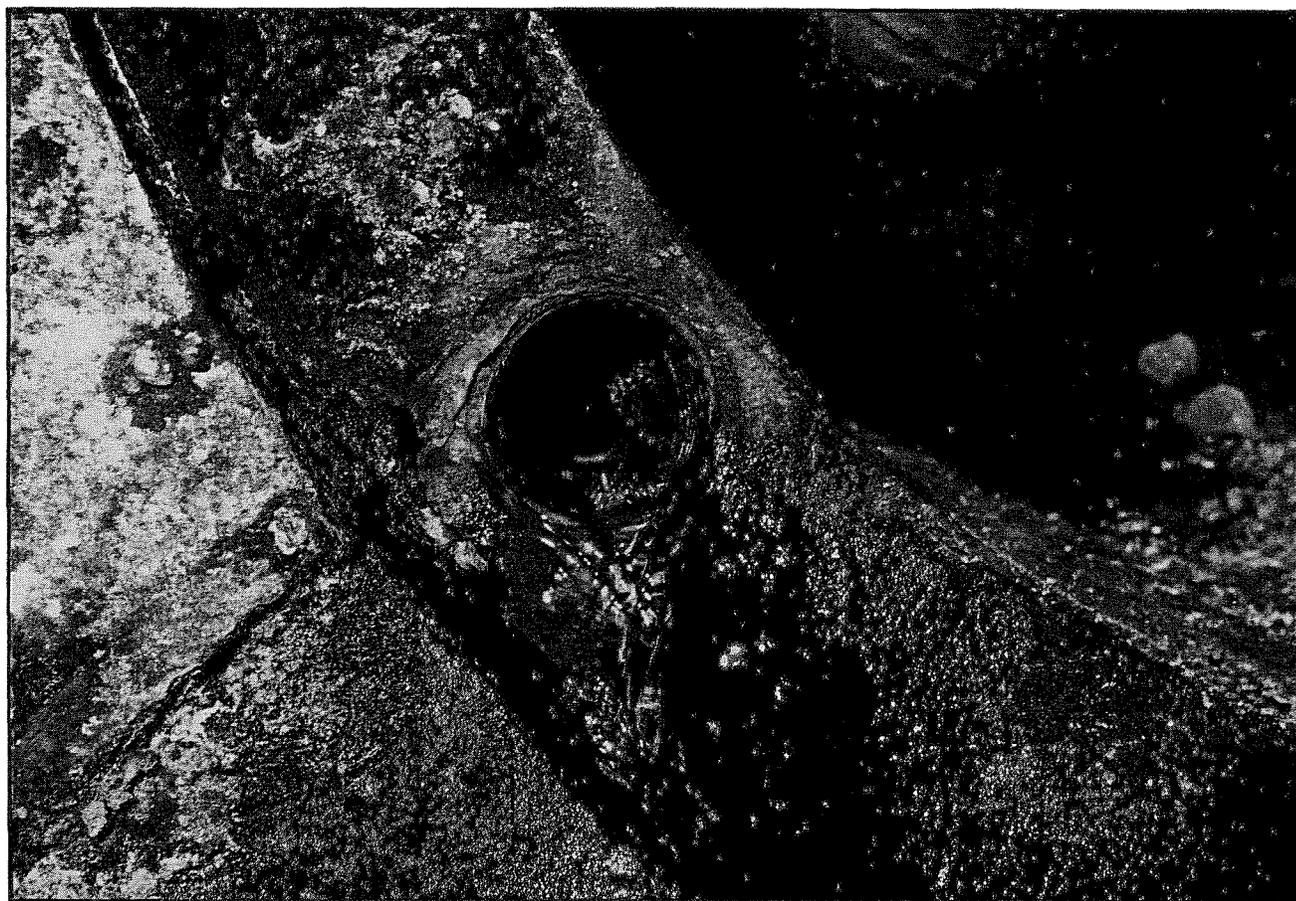
**Fig 13** Section of the No.2 hearth tuyere cooler showing the socket from which water escaped. In this view the water is not under pressure (a pressure condition is illustrated in fig 11). Part of the blast residues referred to in para 53 can be seen at the upper left-hand corner of the cooler

(a) "Debris found in the cooler socket indicated that a free-cutting steel plug had been used to blank the socket at some time and that the plug suffered corrosive attack."

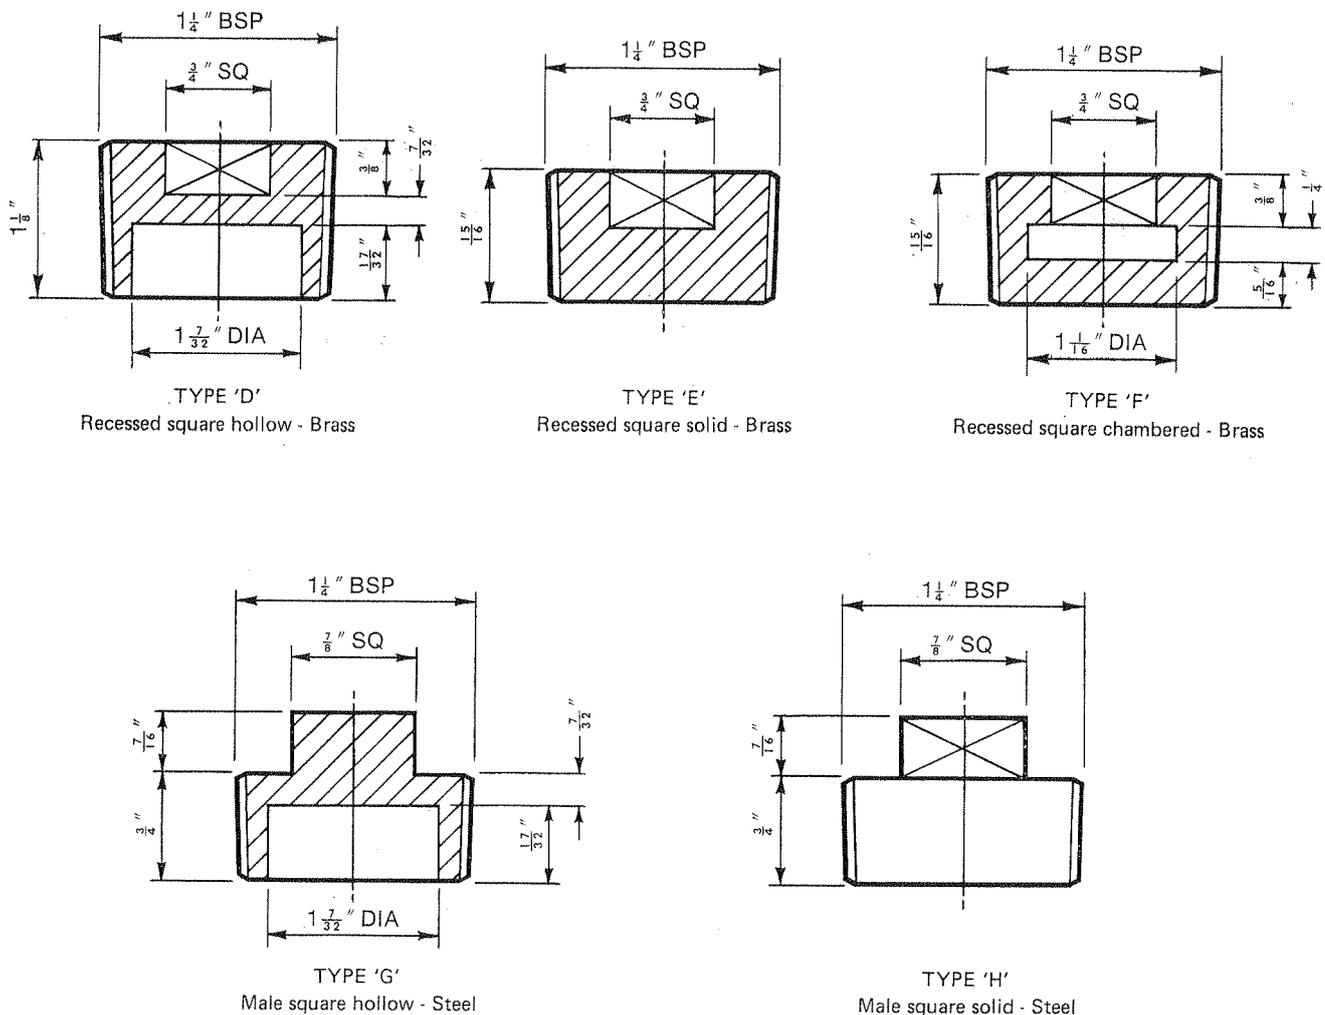
The front face of the plug (that with the square hole in it) was blackened and inside the square recess was a black, tar-like substance. The back face of the plug was lined with a grey-brown corrosion product.

Fig 2 Plugs for copper hearth tuyere coolers

Discolouration of the brass had occurred on the threaded surface. The outer four threads at either end were copper-coloured, quite distinct from the usual brass colour of the central four threads. This copper colour was also seen on the fracture surface from which the piece of thread had been broken. The appearance of a copper colouration on an otherwise typically brass-coloured component is a positive indication that the component has lost zinc, ie has been dezincified.

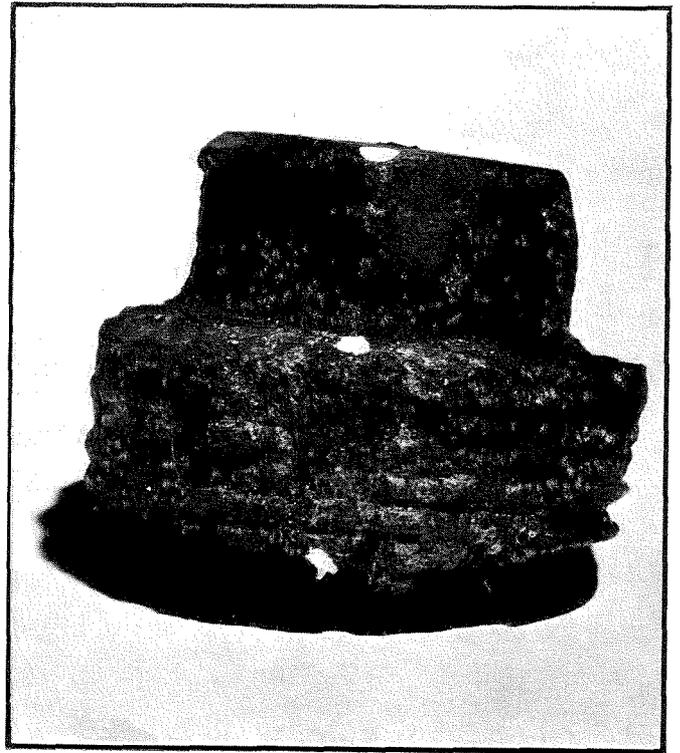
Fig 3a (top) and fig 3b  
The used ferrous plug (No. 2)

**4.2** The used, ferrous plug (No. 2) was heavily corroded, the corrosion product consisting mainly of hydrated ferric oxide and magnetite. The presence of chlorine and other elements was detected. Micro-examination of the sectioned plug showed that this corrosion had preferentially attacked the interface between the slag particles and the matrix. The orientation of the particles was such that deep penetration from the back face had

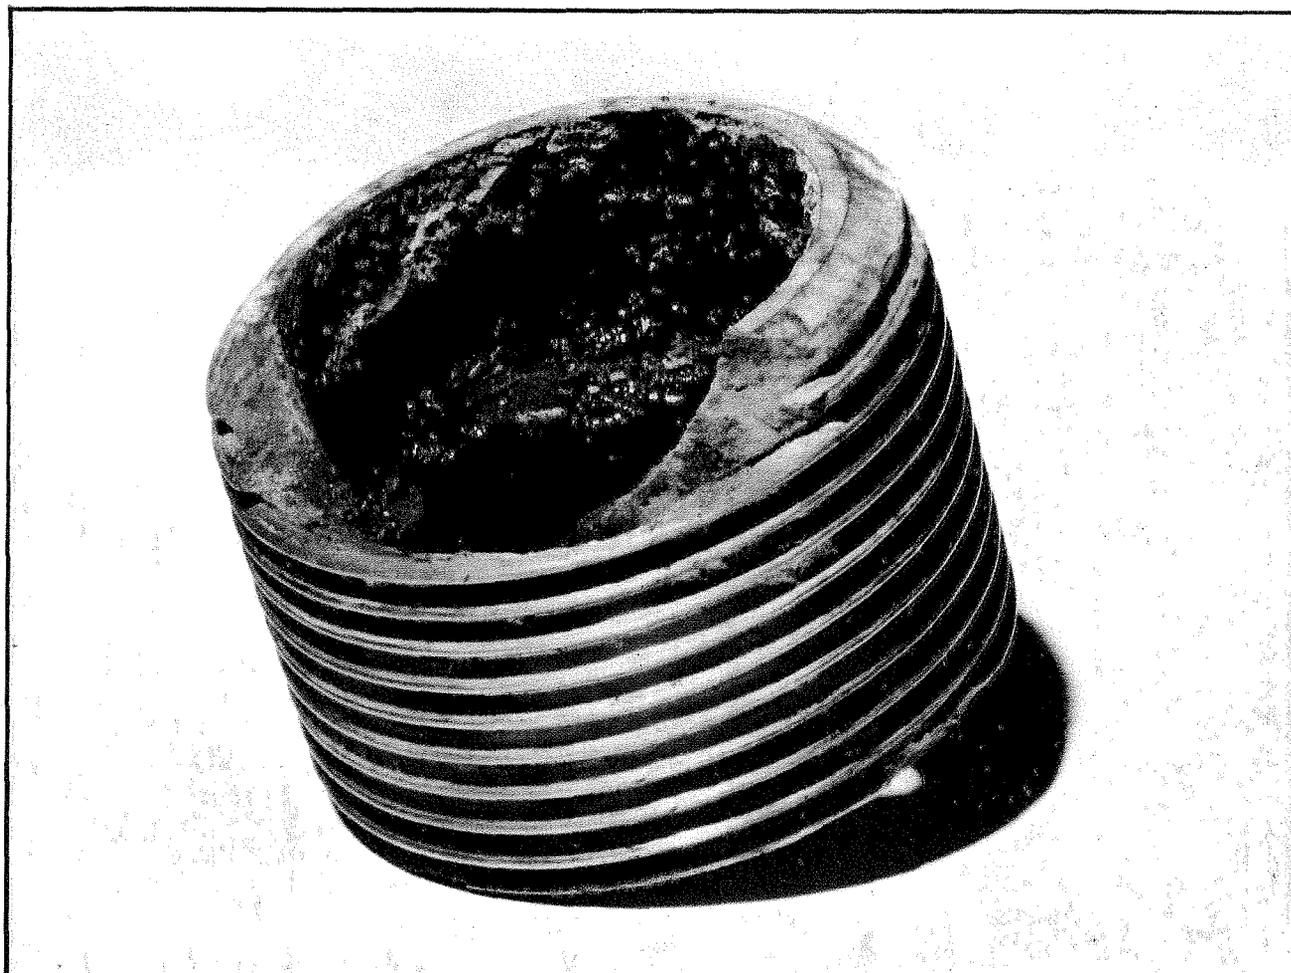
Fig 4 The used non-ferrous plug

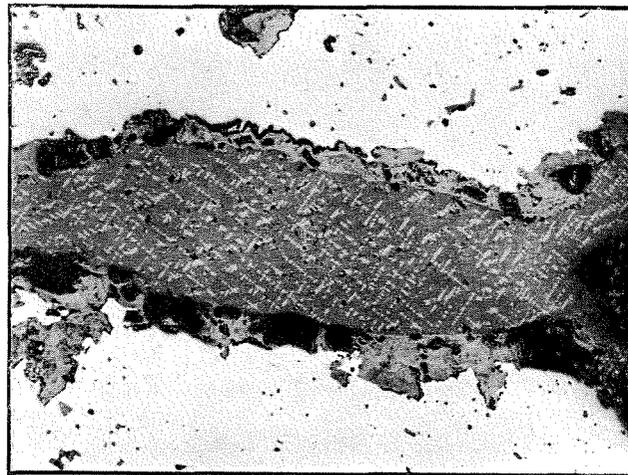
An area demonstrating corrosion penetration around a slag particle (fig 6) was selected for detailed examination under the x-ray analysis equipment on the SEM. The technique chosen was to look at the distribution of selected elements by scanning across most of the area shown in fig 6. Sulphur, aluminium, and chlorine showed no significant segregation. Silicon and phosphorus were predominantly present in the slag particle but not in the

Fig 6 Magnification 110

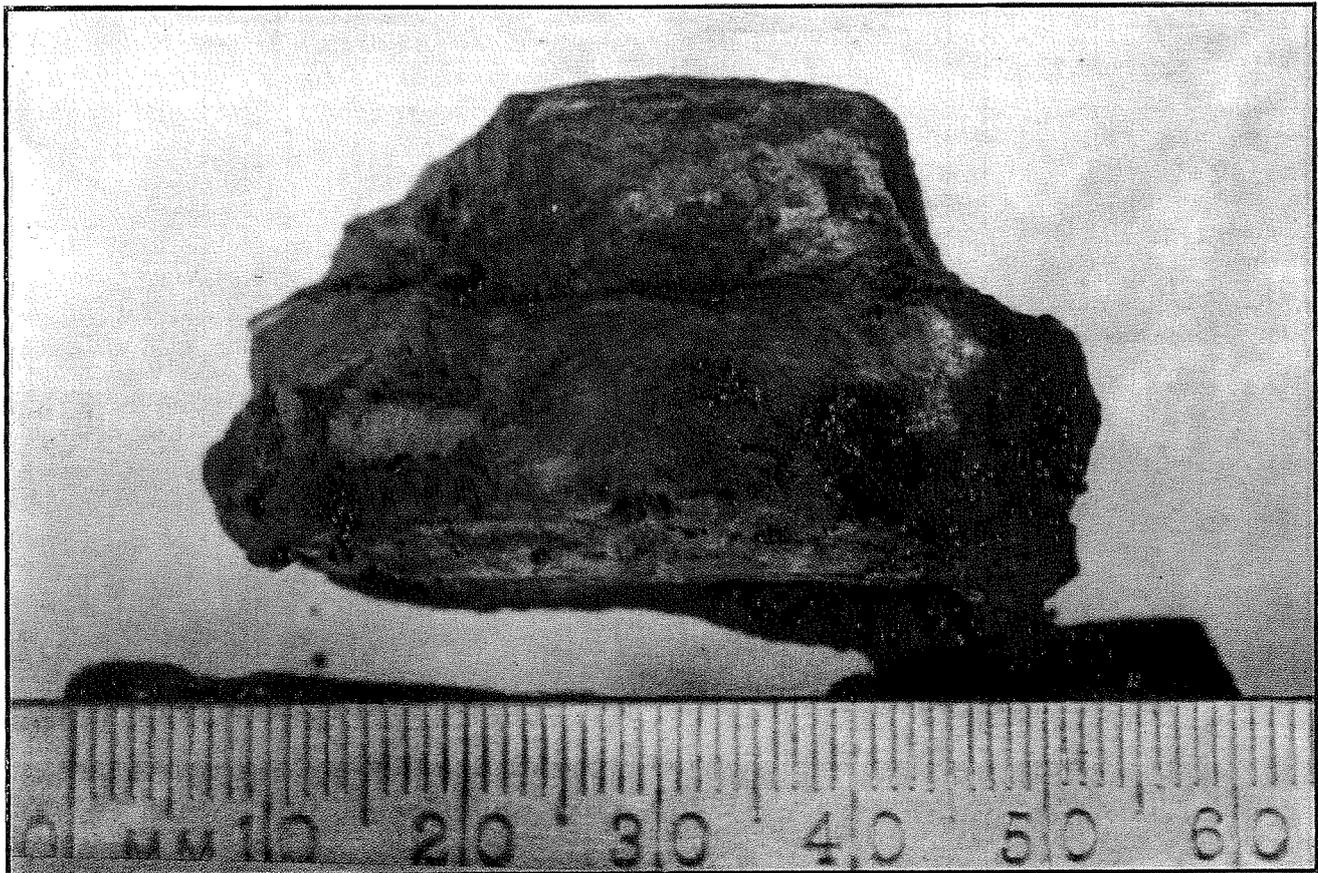
Fig 1 Corroded plug before surface non-metallic material was removed

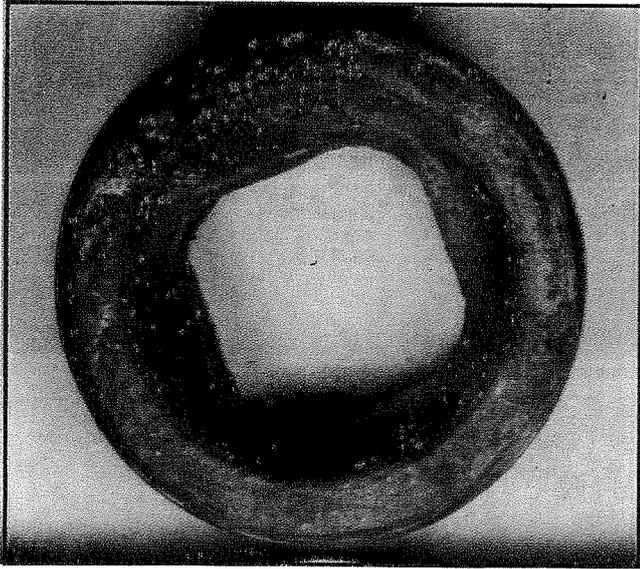
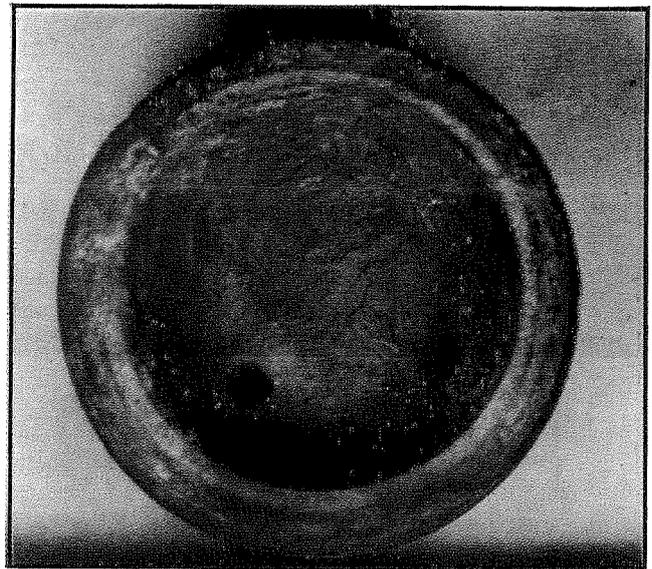
*Investigation Note:* The plugs illustrated in the figures forming part of the report of examination were of type D (Appendix 6). In certain cases difficulties that were experienced during the removal of the plugs from the coolers resulted in the centre of crown breaking away.

**Fig 1 (top) and fig 2** Brass plug taken from the No. 2 position of the No.13 cooler

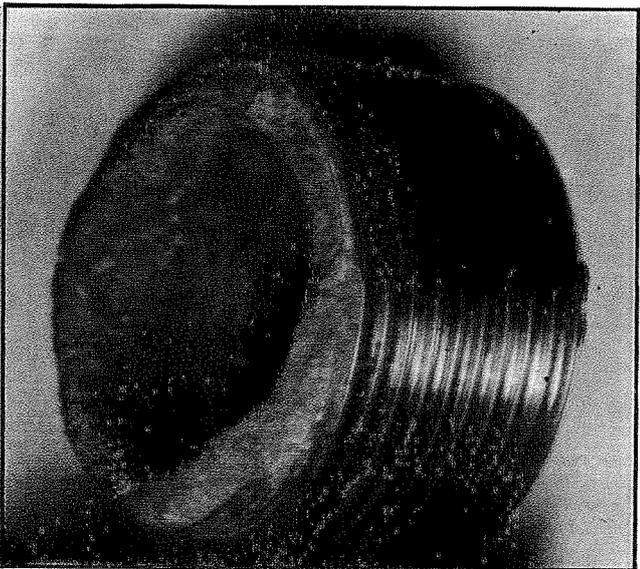
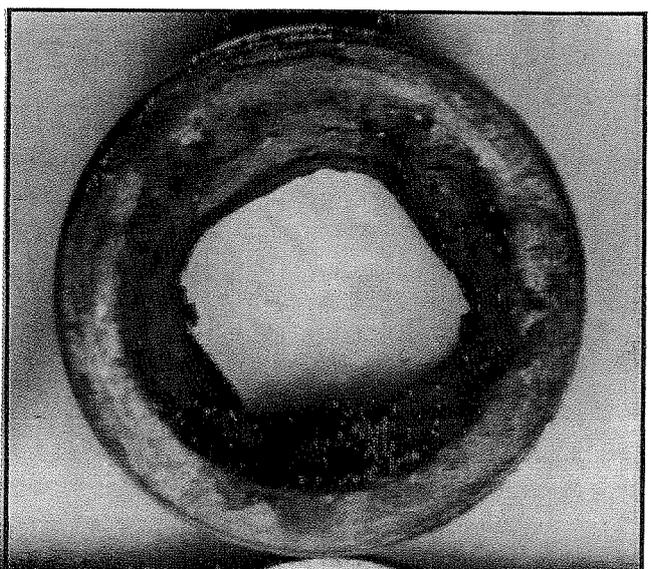
**Fig 3 (top) and fig 4** Brass plugs taken from the No.6 position of the No.13 cooler and the No.2 position of the No.15 cooler

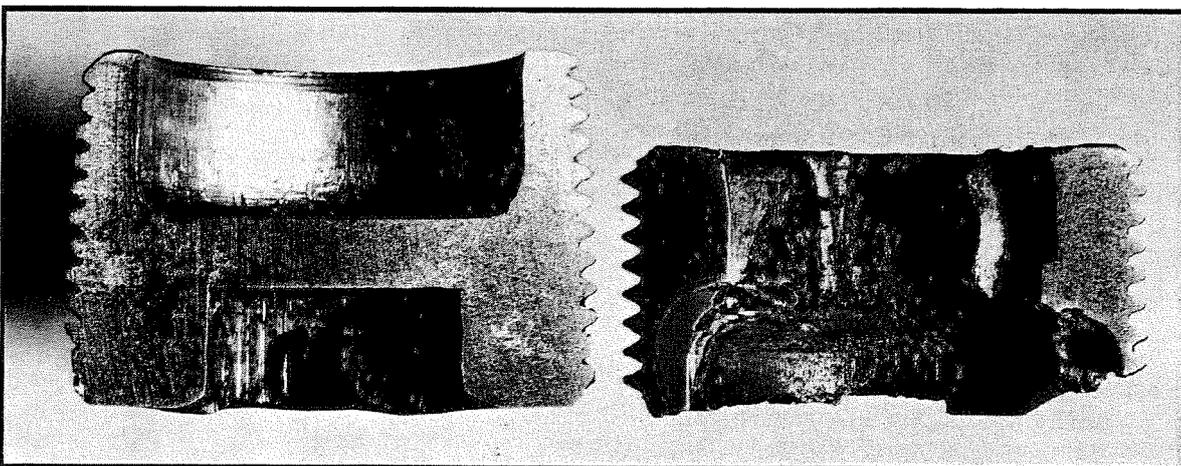
**Fig 5** Section through brass plug taken from the No.5 position of the No.20 cooler, compared with a section of a new plug

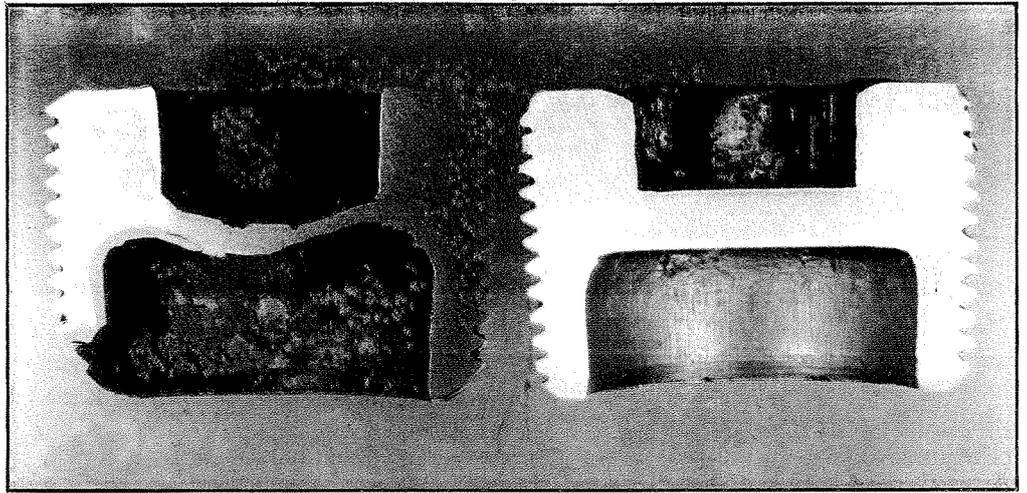
**Fig 6** Section through brass plug taken from the No.6 position of the No.13 cooler, compared with a section of a new plug

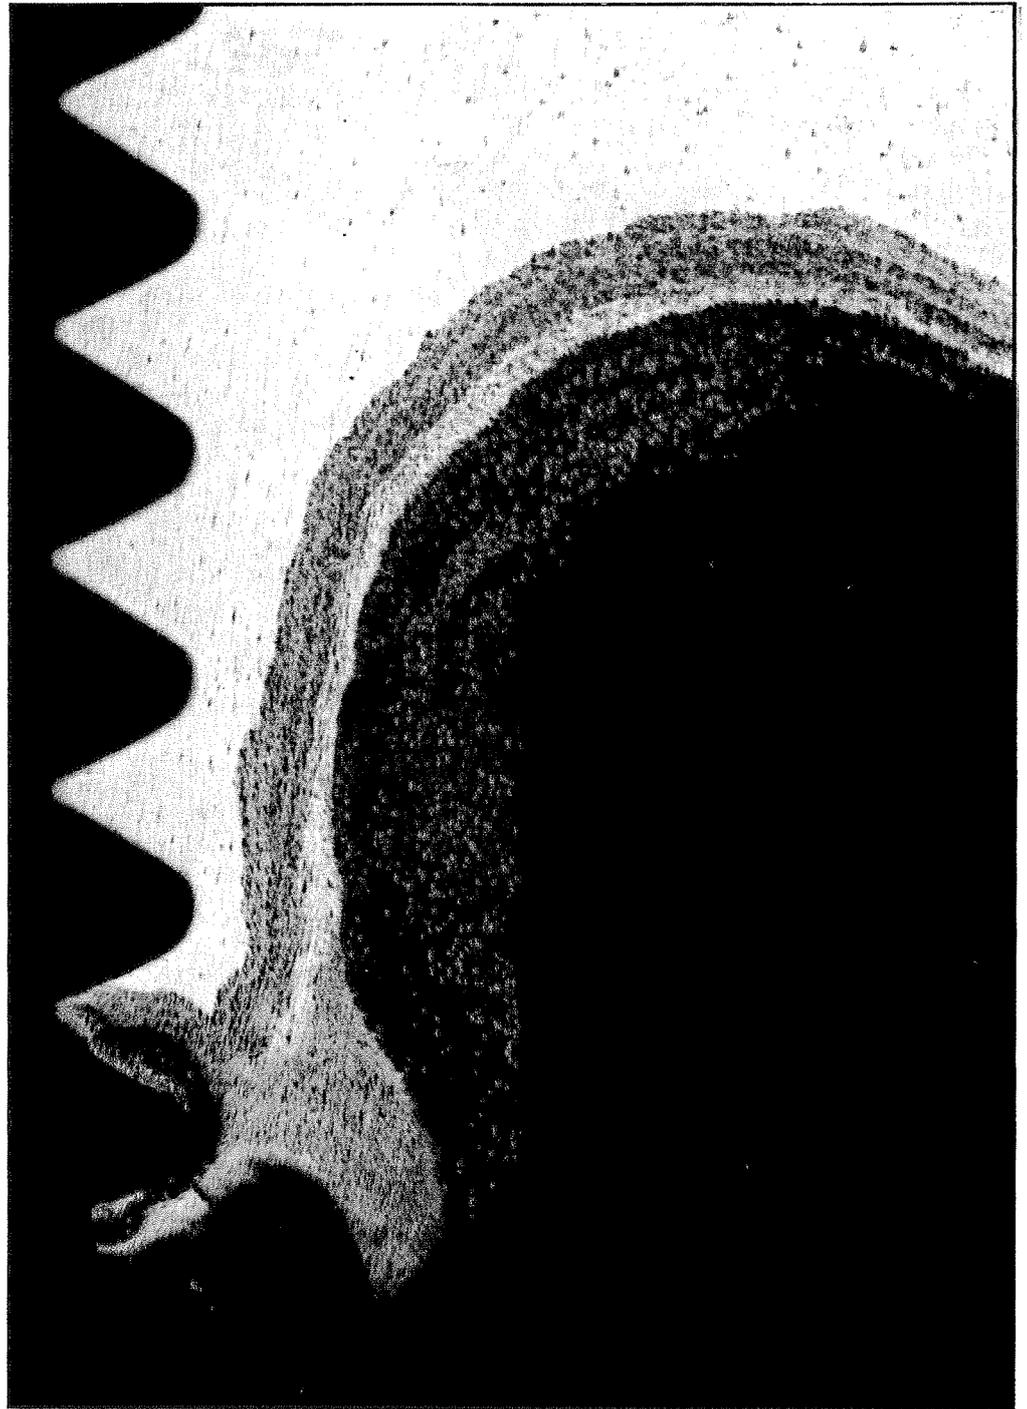
**Fig 7** Photomicrograph of lower left-hand section of plug taken from the No.6 position of the No.13 cooler
