The explosion at the Dow chemical factory, King's Lynn 27 June 1976

A report by HM Factory Inspectorate

The explosion at the
Dow chemical factory
King's Lynn
27 June 1976

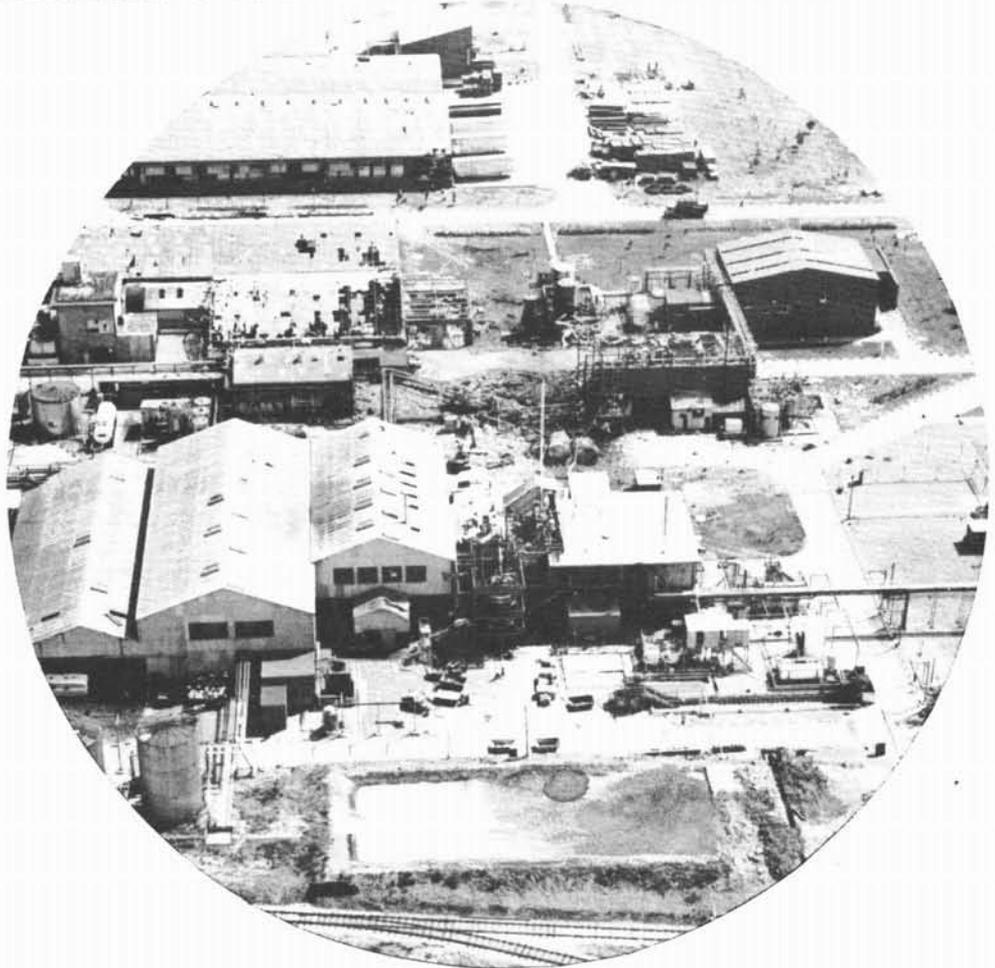
AFTER This photograph is reproduced by courtesy of the Chief Constable of the Norfolk Constabulary. It shows the Clopidol plant at the centre of the explosion (mid-foreground), and damage to the roofs of nearby warehouses. The site plan on the centre pages shows the detail of the plant and the spread of the debris flung out by the force of the explosion.

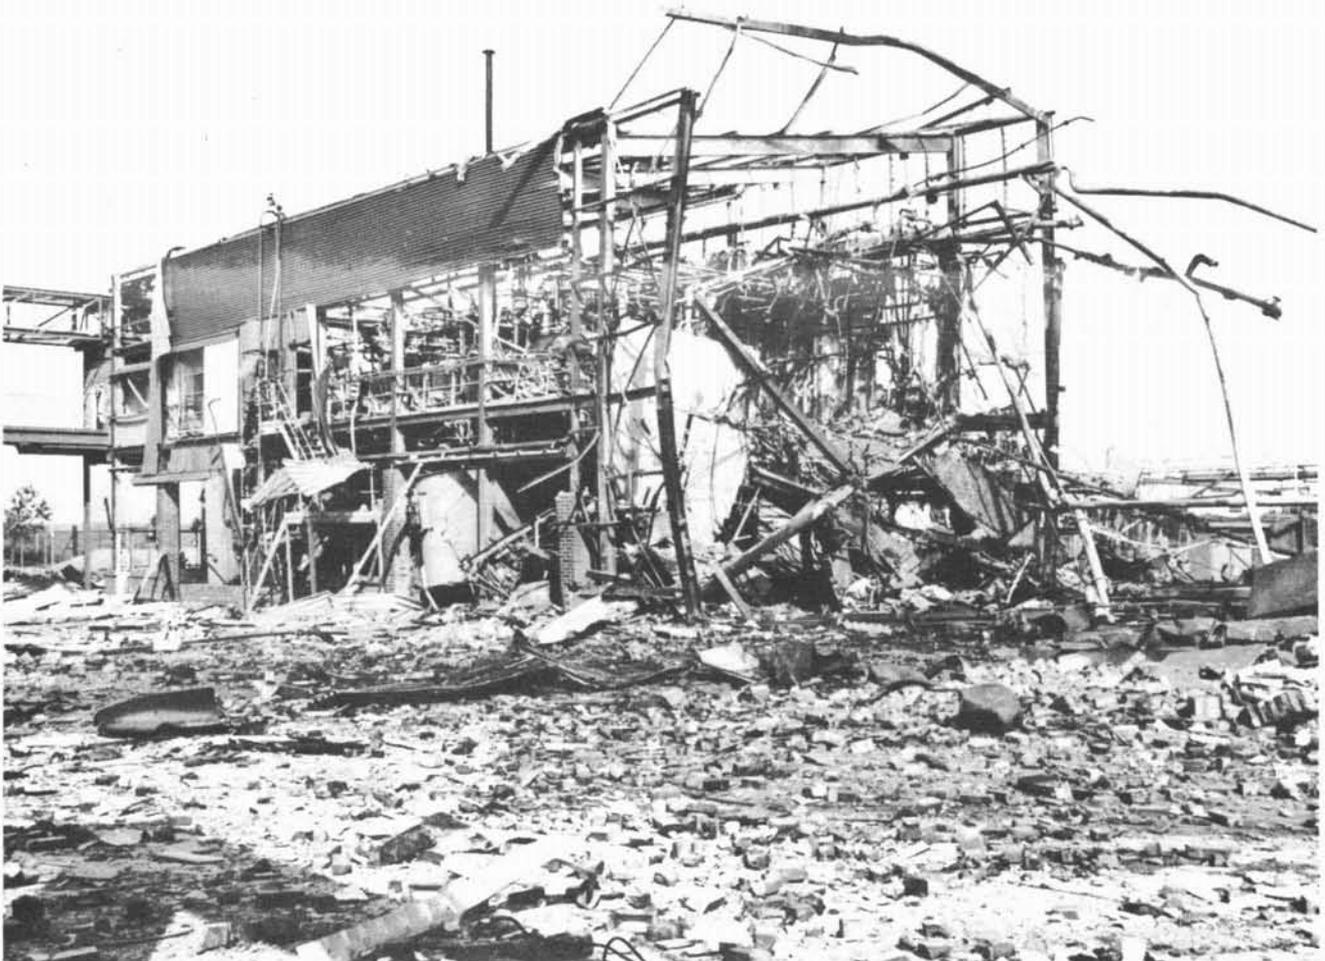
The Clopidol building after the explosion.

29 The entire eastern half of the Clopidol building was demolished, the dryer being fragmented. The conveyor and hopper were found some thirty metres to the south of their original position. Pieces of the dryer and its jacket were found a considerable distance from the site of the Clopidol building, as were pieces of the steel plate flooring and structural steelwork of the building. At least two substantial pieces of steel plate

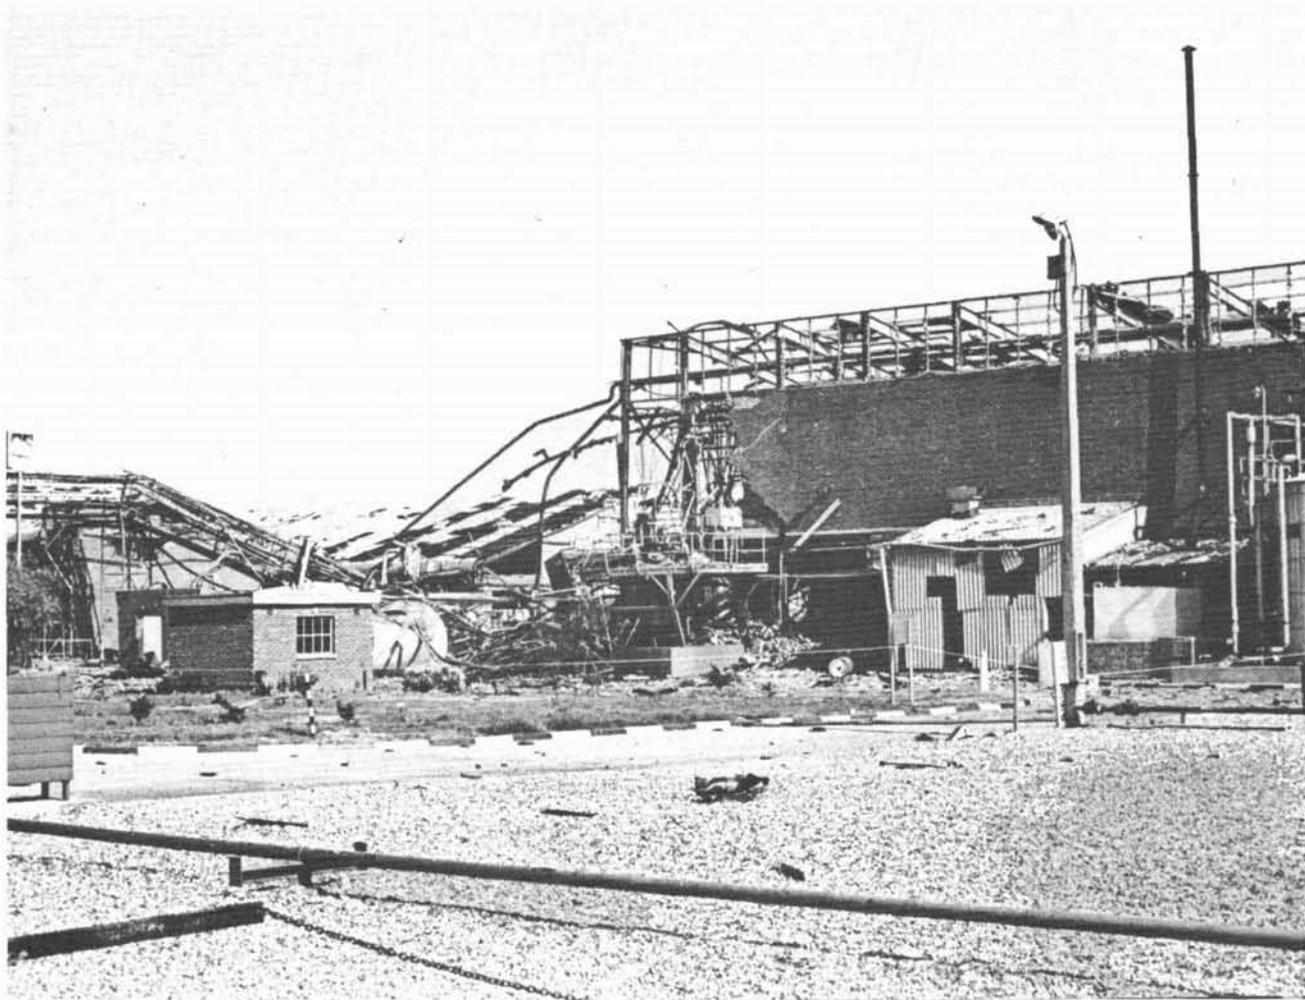
Another view of the Clopidol building showing the collapsed pipe bridge.

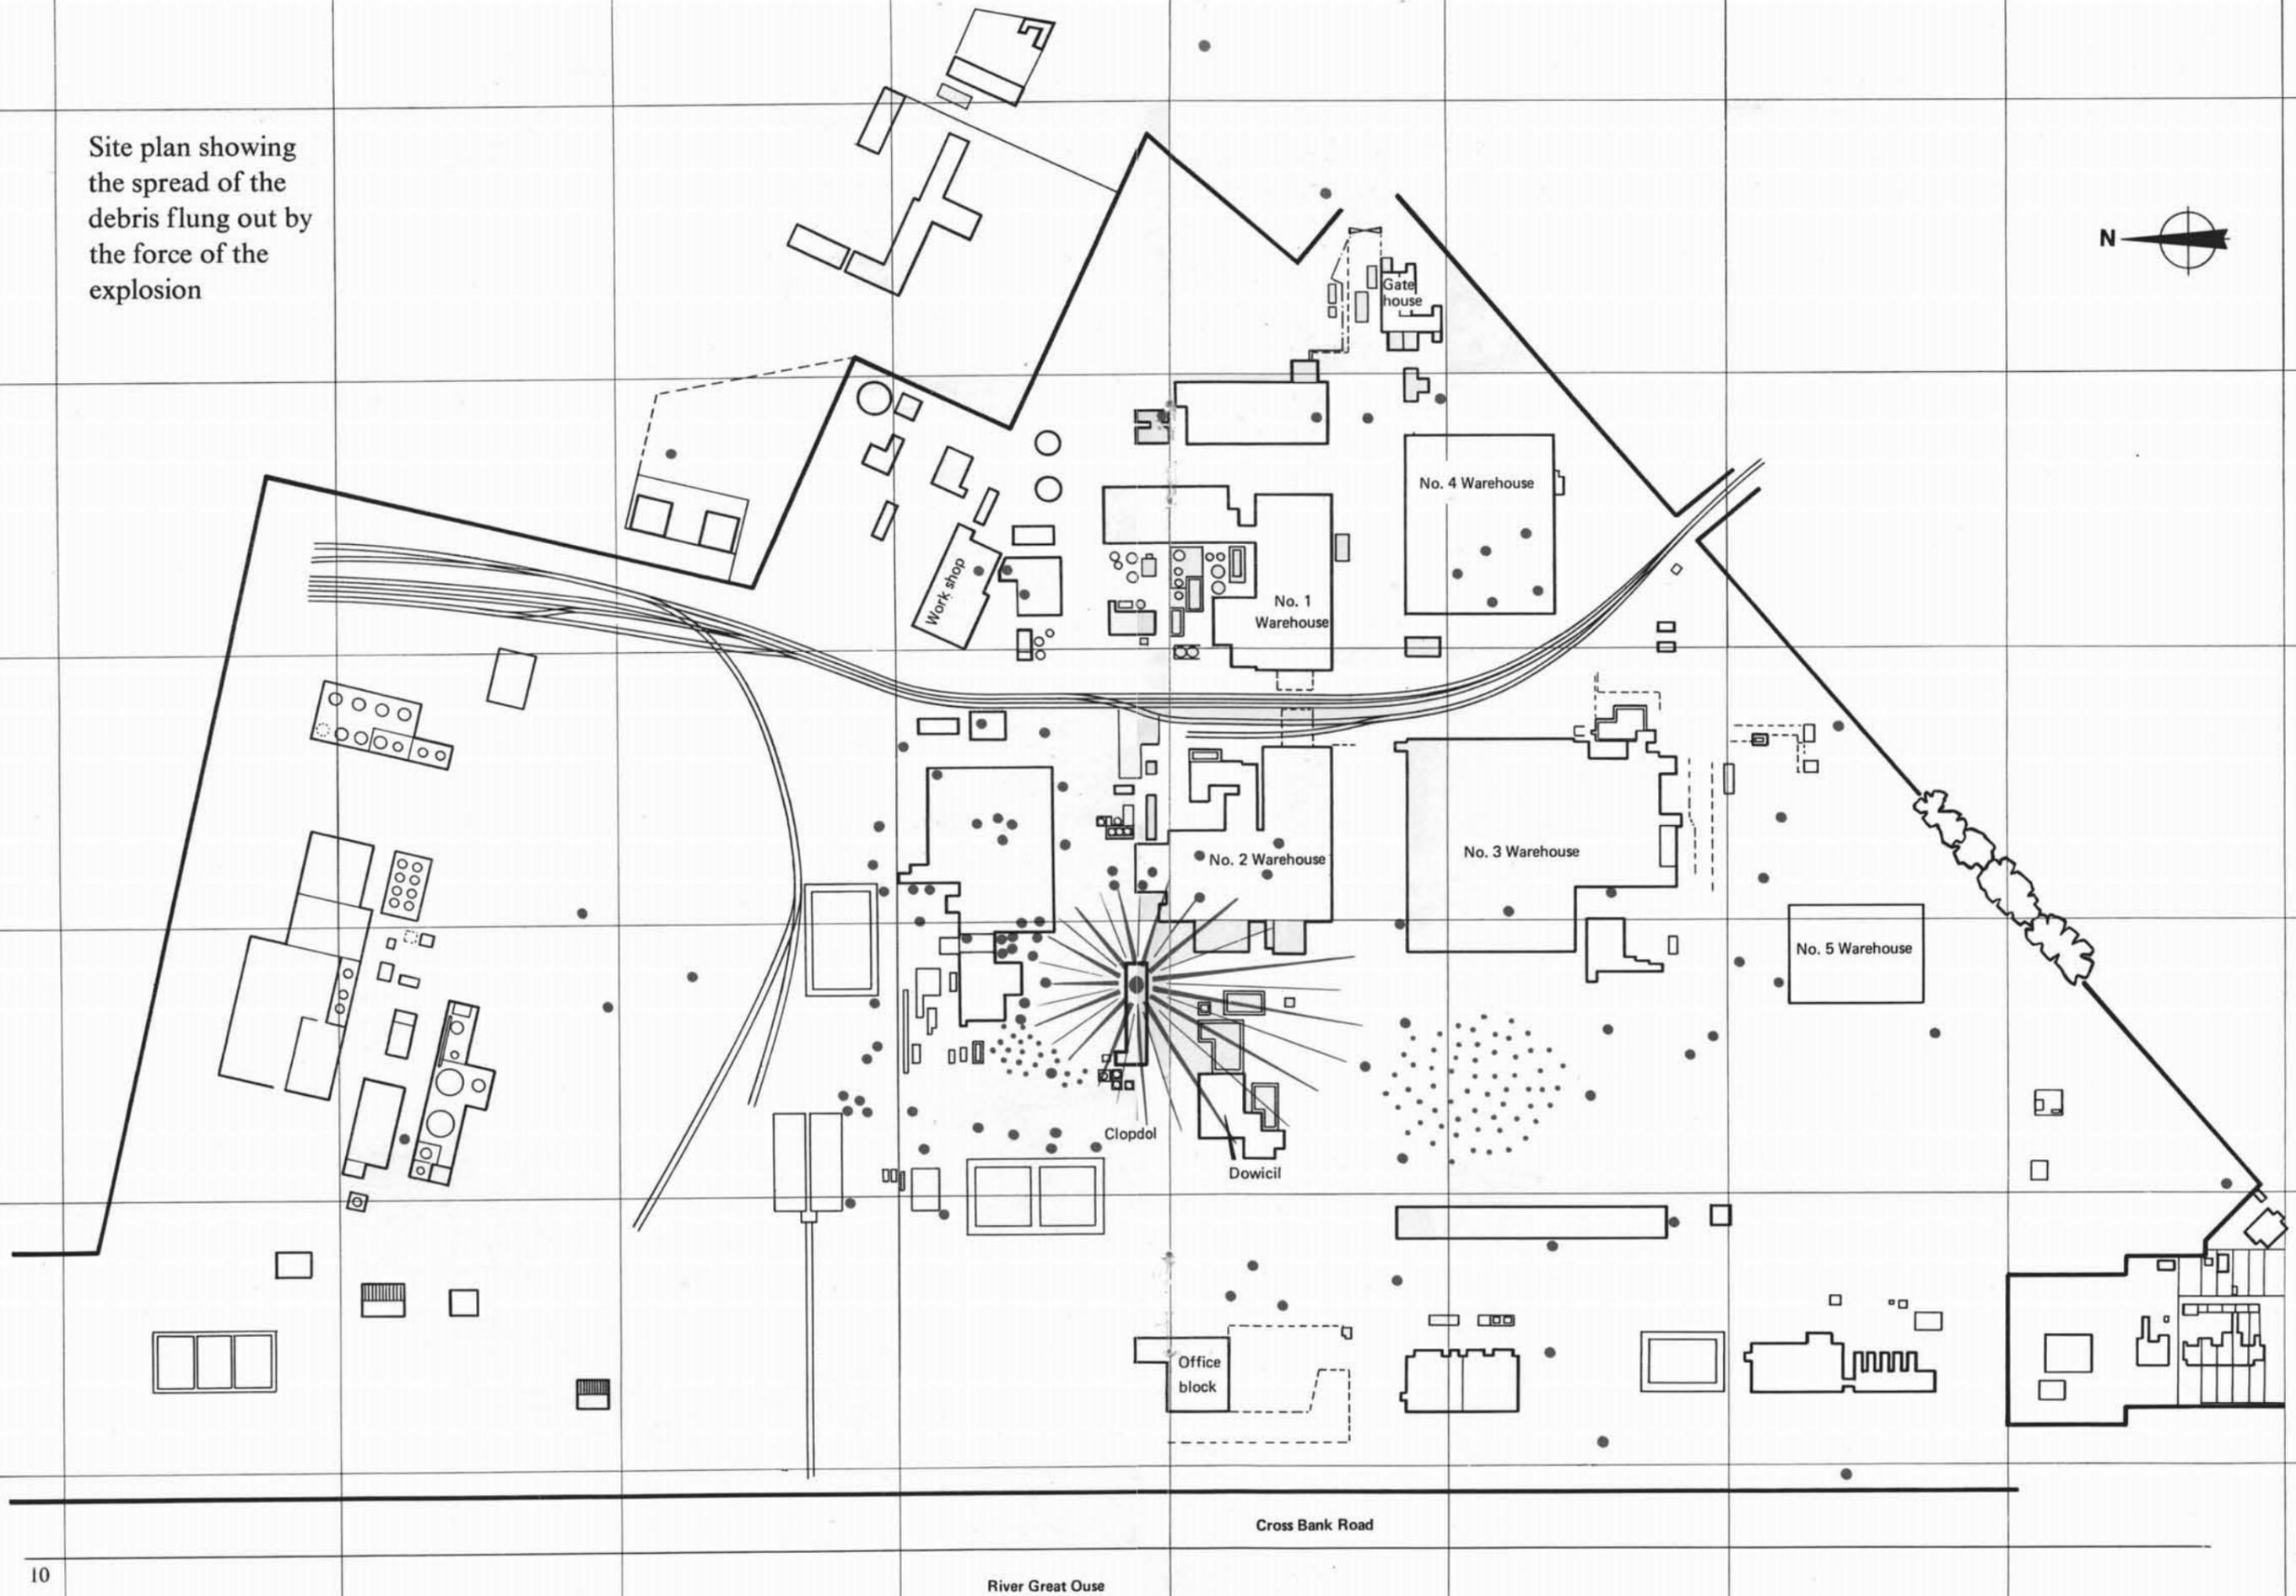
Site plan showing
the spread of the
debris flung out by
the force of the
explosion

fragment weighing about 12 kilogrammes was found outside the factory about 700 metres from the centre of the explosion, while a 13.6 kilogramme piece of $\frac{1}{4}$ inch plate was retrieved from the river bank. Other smaller fragments of metal were found outside the factory. Total plant damage is estimated to be in the region of £1.25 millions.

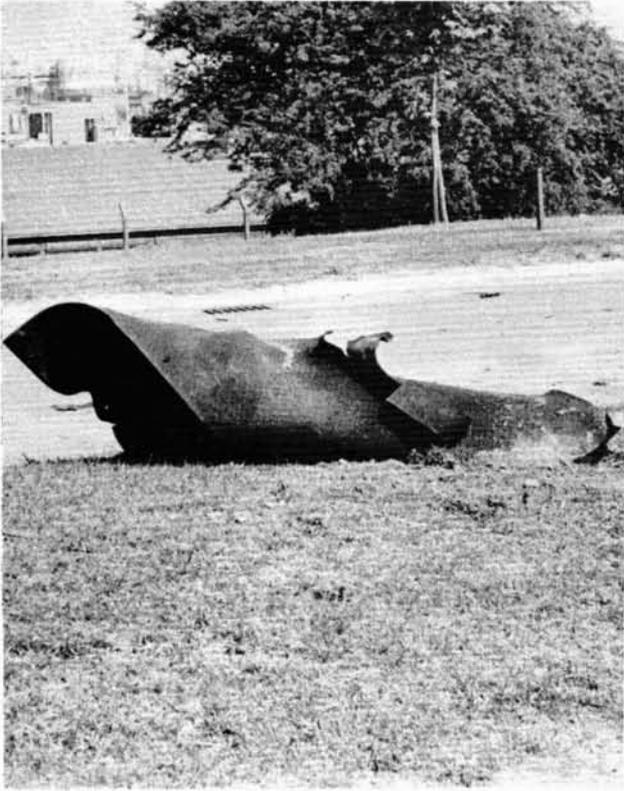
Top left A piece of steel flooring weighing 143 kg which was found over 200 metres from the centre of the explosion.

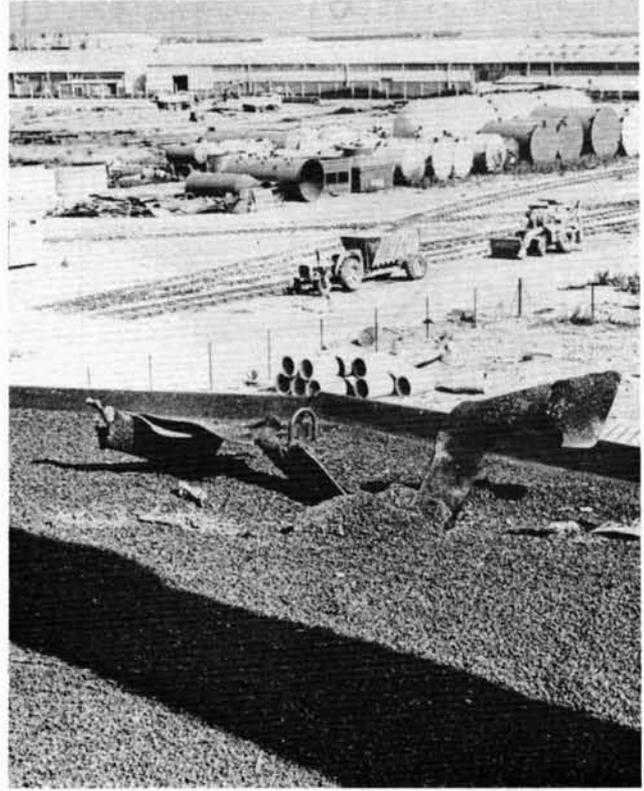
Top right Steel flooring embedded in the roof of the boiler house, 99 metres from the area of the explosion.

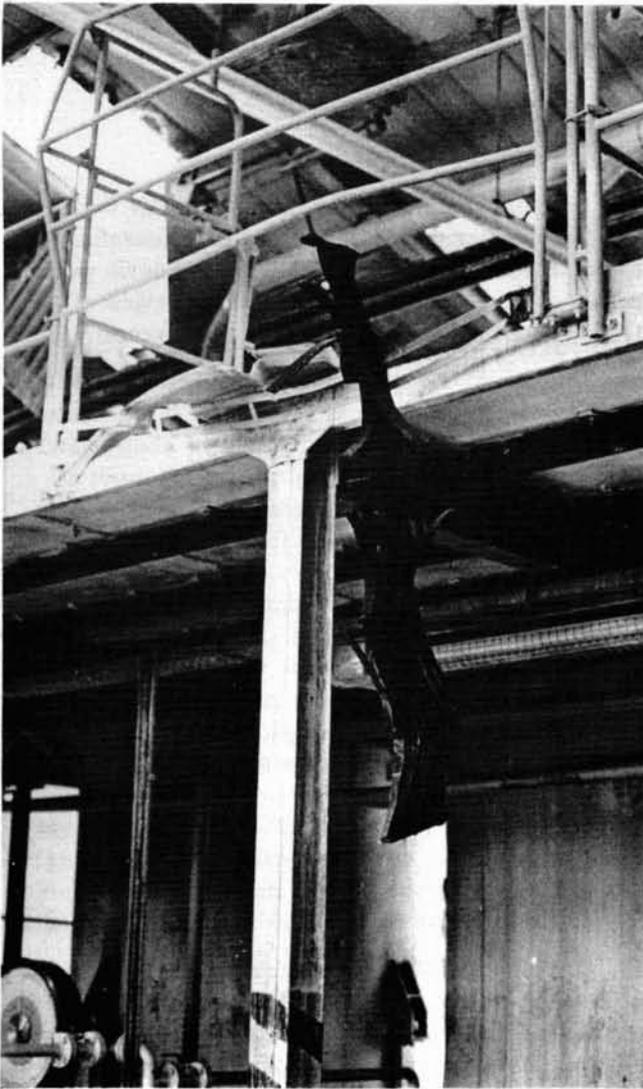
Interior of a room off the No 2 warehouse showing roof damage and a collapsed cable tray.
