The Putney Explosion

A report of the investigation by the Health
and Safety Executive into the explosion on
10 January 1985 at Newnham House,
Manor Fields, Putney

A report by HM Factory Inspectorate

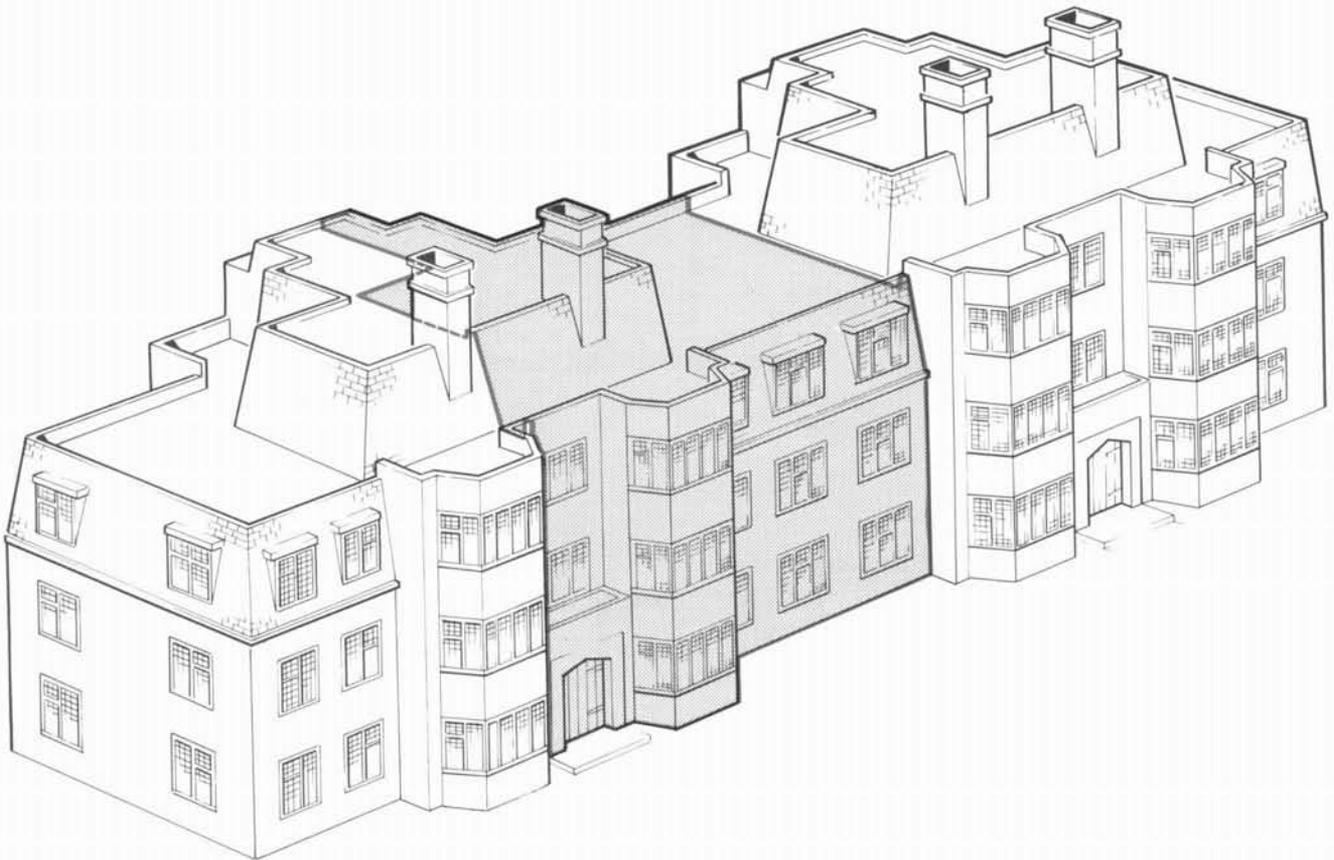
Fig 2 Area of Newnham House destroyed by explosion

1 Early on the morning of 10 January 1985, an occupant of Flat 12, one of the top floor flats in Newnham House, Manor Fields, Putney, noticed a faint smell of gas. He opened the door to his front landing and found the smell was much stronger. At 7.02 am his wife reported a suspected gas leak to Segas while he alerted the residents in the flats beneath him. The assistant porter, delivering a parcel to one of the flats, also noticed a strong smell of gas in the front stairway to Flats 7 to 12. When the occupants of Flat 9 told him that Segas had been informed, he opened the stairway windows before returning to his office. At about 7.15 am, only minutes before the arrival of the Segas emergency engineer, the explosion occurred, demolishing the six central flats and breaking windows in most homes in a quarter mile radius (see Figures 2 and 18 for extent of damage).

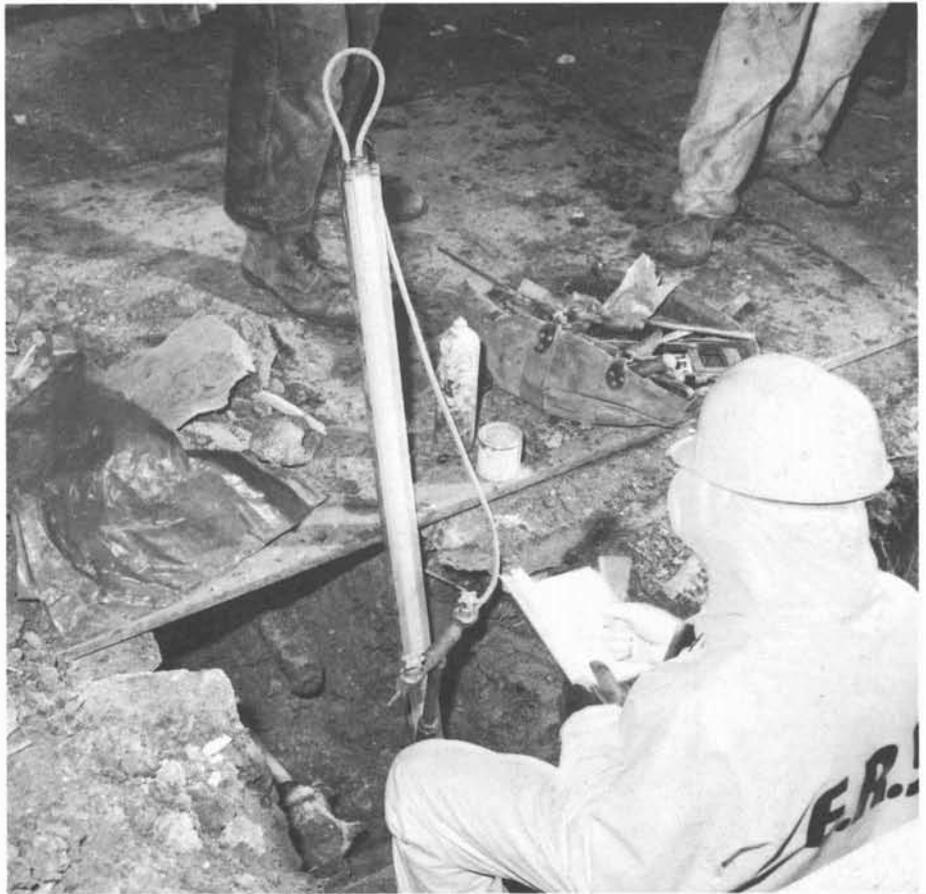
Fig 9 Investigators conduct pressure tests

29 The isolated section of main was pressure tested with the service connections sealed off (Figure 9). The initial test using a hand pump showed a significant leak as pressure sufficient to register on the manometer could not be achieved; compressed nitrogen from a cylinder, introduced at a flow rate of about $4\text{m}^3\text{hr}^{-1}$, also failed to register any increase in pressure in the main. A compressed air line was then connected to the main and this test showed a flow rate of about $55\text{m}^3\text{hr}^{-1}$ was required to maintain a pressure of 25-30 mbar, (ie its normal operating pressure). A flow rate of $55\text{m}^3\text{hr}^{-1}$ of air is equivalent to a leakage rate of about $70\text{m}^3\text{hr}^{-1}$ of natural gas at the normal operating pressure. It is not possible, however, to estimate from these tests what proportion of the gas actually entered Newnham House.

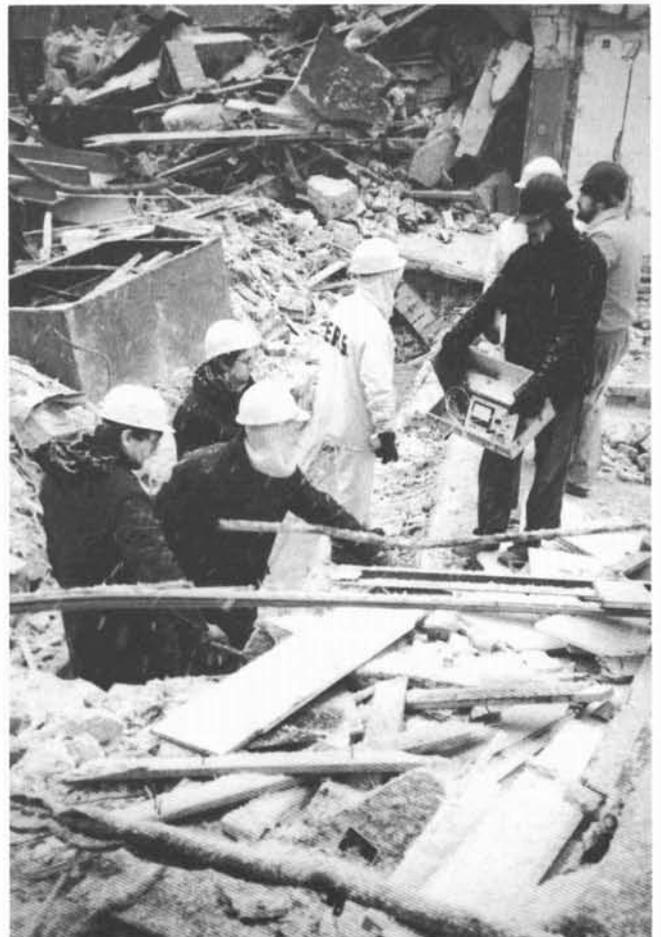
Fig 10 Tracing the gas path

a series of tests using sulphur hexafluoride (SF_6) as the tracer gas were carried out (Figure 10). With a bar, holes were made along each side of the service road and along the branch main behind Ripon House. Nitrogen was used as carrier gas and was introduced into the main from the south end at about $1.4\text{m}^3\text{hr}^{-1}$. The tracer gas (SF_6) in nitrogen was injected through a long capillary tube into the nitrogen stream near to the carrier gas inlet. Initially the SF_6 was detected qualitatively using an electron capture detector with a Ni 63 source. Once the SF_6 presence was detected at the various bar holes a semiquantitative chromatographic detector was used to establish whether high or low concentrations were present. The flow of carrier gas was deliberately kept low to prevent the whole area becoming saturated with tracer gas before it could be detected at the various points along the route of the main. A further test was then carried out by turning off the nitrogen and SF_6 supplies and purging the main with compressed air. The chromatographic detector clearly showed high concentrations of SF_6

along the rear of the building, between the outer load bearing wall and the underfloor concrete raft and where the concrete raft joined the service duct.

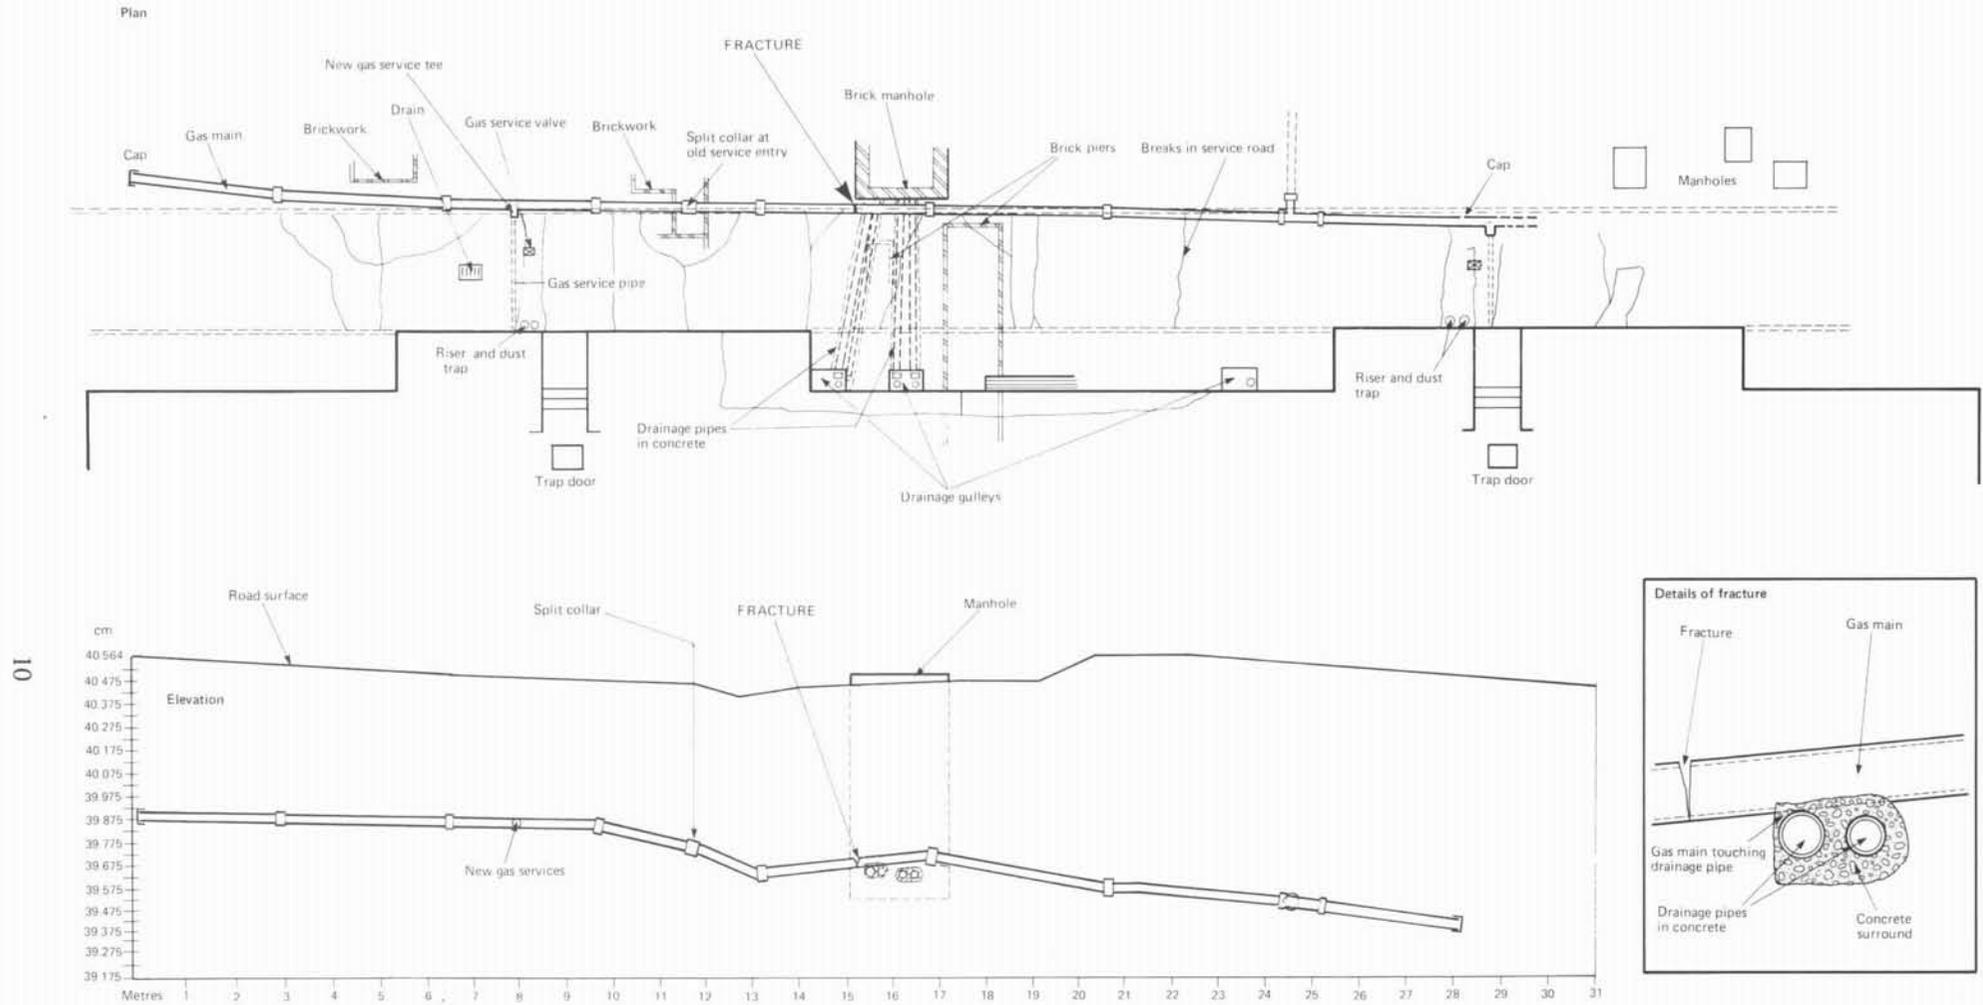
Fig 11 Detailed plan of pipe profile

36 Once the pipe had been removed, the bed was examined. The pipe profile is shown in Figure 11. Variations in the support provided by the soil in the pipe bed may lead to increased stress in the pipe material if external loads such as heavy vehicles are applied. To assess these variations penetrometer readings were taken at intervals along the pipe bed on either side of the fracture. The variations in support are clearly shown in the test results given in Appendix 2.

41 Figure 11 shows levels of the roadway and indicates a local settlement of the surface of up to 180mm immediately south of the fracture. This dip was outside the kitchen window to Flat 7 and evidence from residents and porters indicated it had been there about two years. It frequently filled with water after heavy rain and one resident had complained to the estate office some 12 months previously because of the difficulties he had when taking his dog for its morning walk. Tests established that there were no substantial leaks in the outlet drainage to Newnham House, but there were indications that the gullies had been blocked and had been overflowing causing local flooding.

44 These conditions have resulted in road settlement developing from nothing immediately north of the gas main fracture to between 100 and 200mm some 3 to 5m to the south.

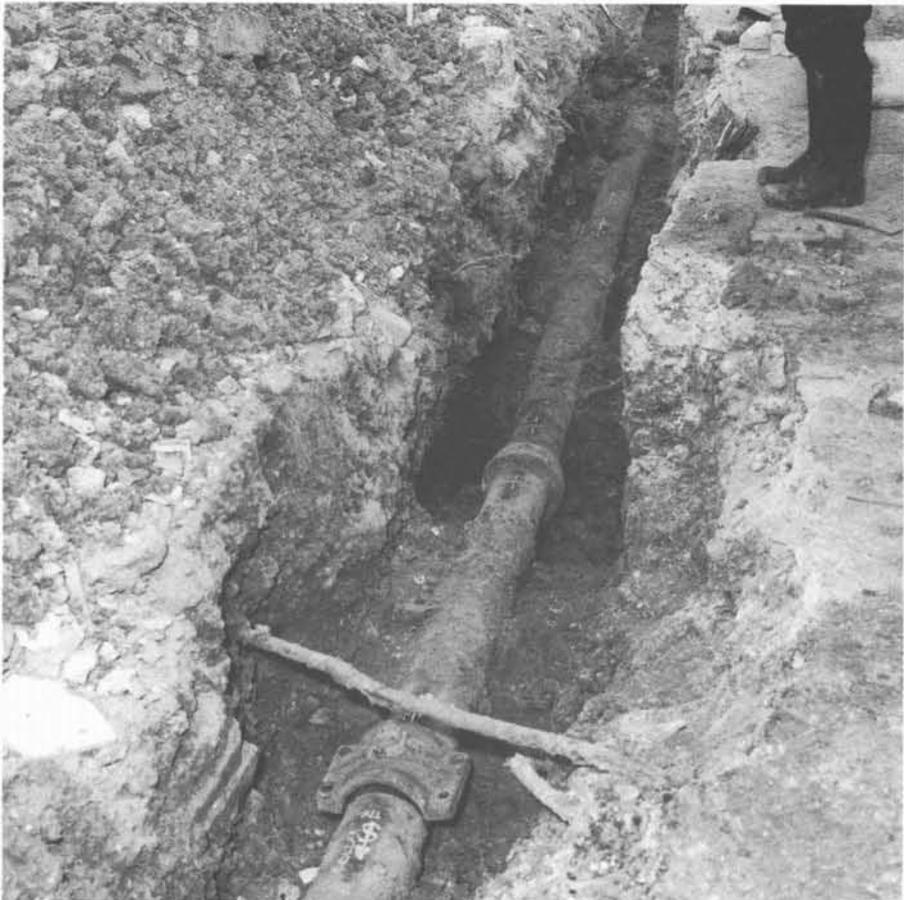
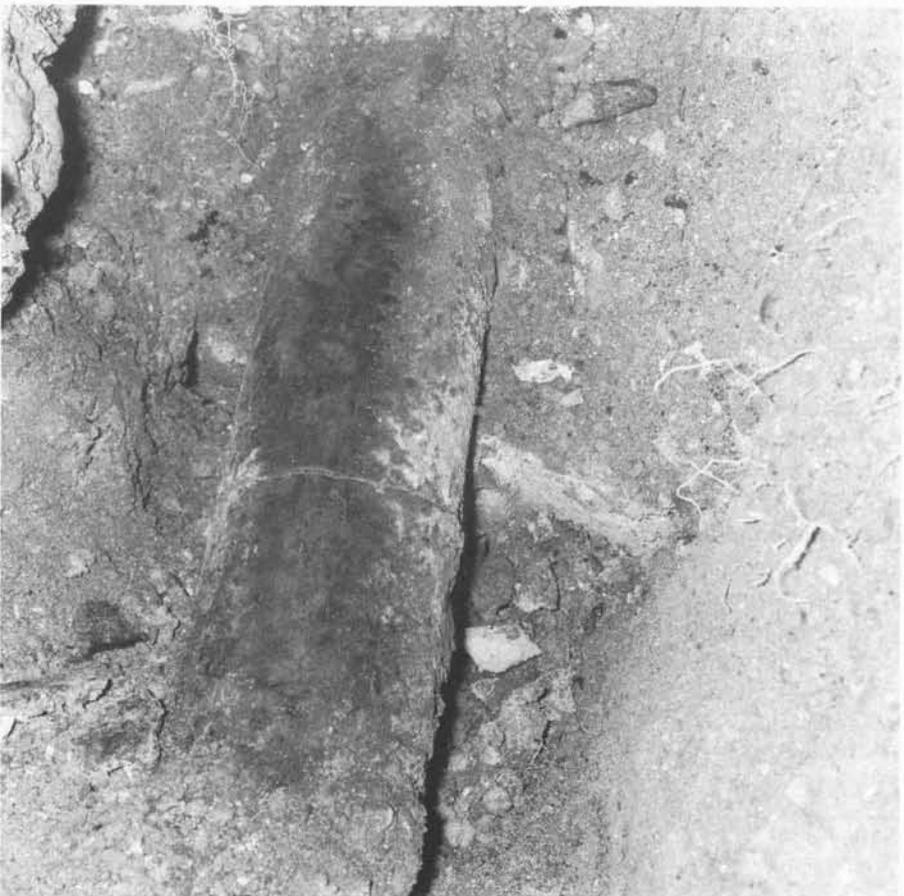
Figs 13 and 14 Views of the fractured pipe

35 After exposing the full length of main a split-collar was found approximately 5m to the south of the fracture described above (Figure 14). When the split-collar was removed a 44mm diameter tapped hole was revealed in the top of the main, with a partial circumferential fracture running from it in either direction. It is not unusual for fractures to occur at

such 'tapping' points where the pipe would be normally weakened. Segas confirmed that this fracture had been the source of a gas leak in 1982 and had been repaired by fitting the split collar. The fracture was extended to full circumference by longitudinal loading and lengths of pipe measuring 1.5m and 1.9m north and south respectively were retrieved for examination by RLSD.

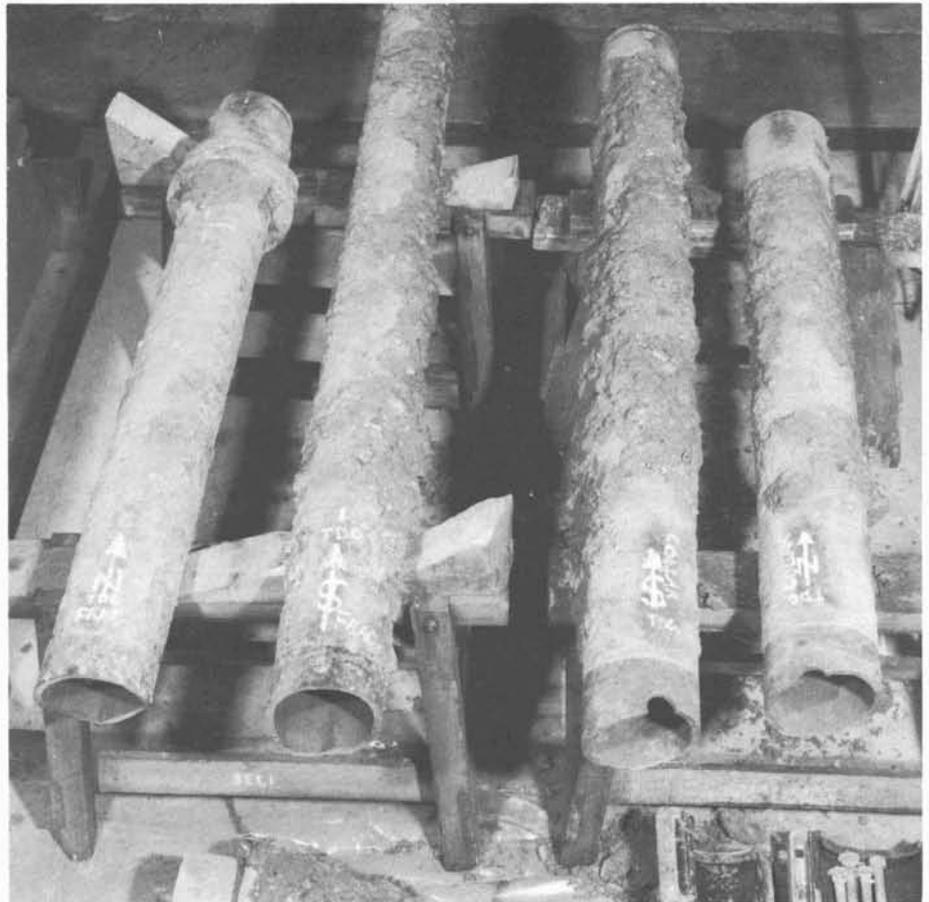
Fig 15 Fracture faces of all pipes

37 The detailed report of the examination is given in Appendix 3 and the chemical analysis in Appendix 4. The conclusion of the examination of the 1985 fracture was that the probable origin of the failure was on the outer surface of the pipe between 0 degrees and 30 degrees clockwise from top dead centre, viewed on the south face of the fracture. At this point the original thickness of the pipe was at the lower limit of specification and the strength of the pipe had been

reduced by porosity in the casting and progressive graphitic corrosion in service. The effective wall thickness in this region was 6mm compared with an original nominal thickness of 10.9mm. It is considered however that the pipe was in relatively good condition for its age and would have withstood the internal gas pressure.

38 The appearance of the fracture and the proposed origin of failure are consistent with the pipe having been subjected to cantilever bending at a point close to the fracture position. There was also evidence that the length of pipe immediately south of the fracture had been poorly supported.

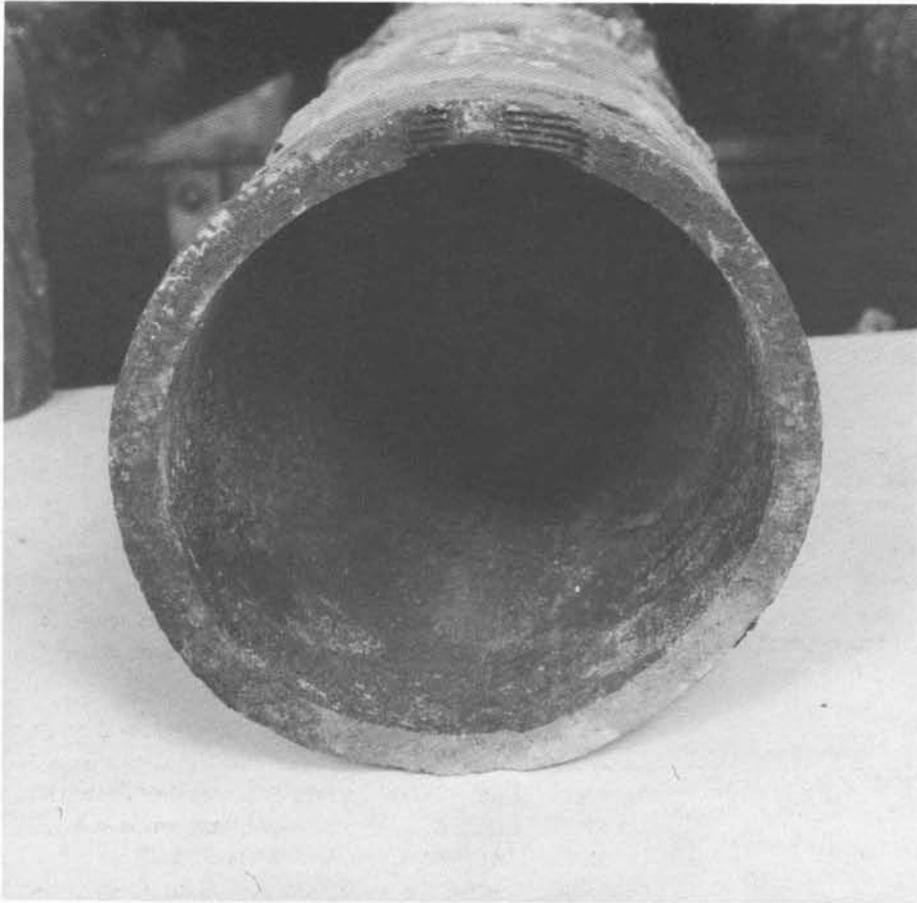
Fig 16 South face of 1982 fracture

39 Examination of the 1982 fracture indicated that the origin was probably at the threaded hole. Stressing of the pipe in this area could have been caused by a downward bending moment at the pipe (ie loading) or possibly by the overtightening of an insert in the threaded hole, or by a combination of both. Generally there was less graphitic corrosion at the site of the 1987 fracture (Figure 16) than at the 1985 one (Figure 17).

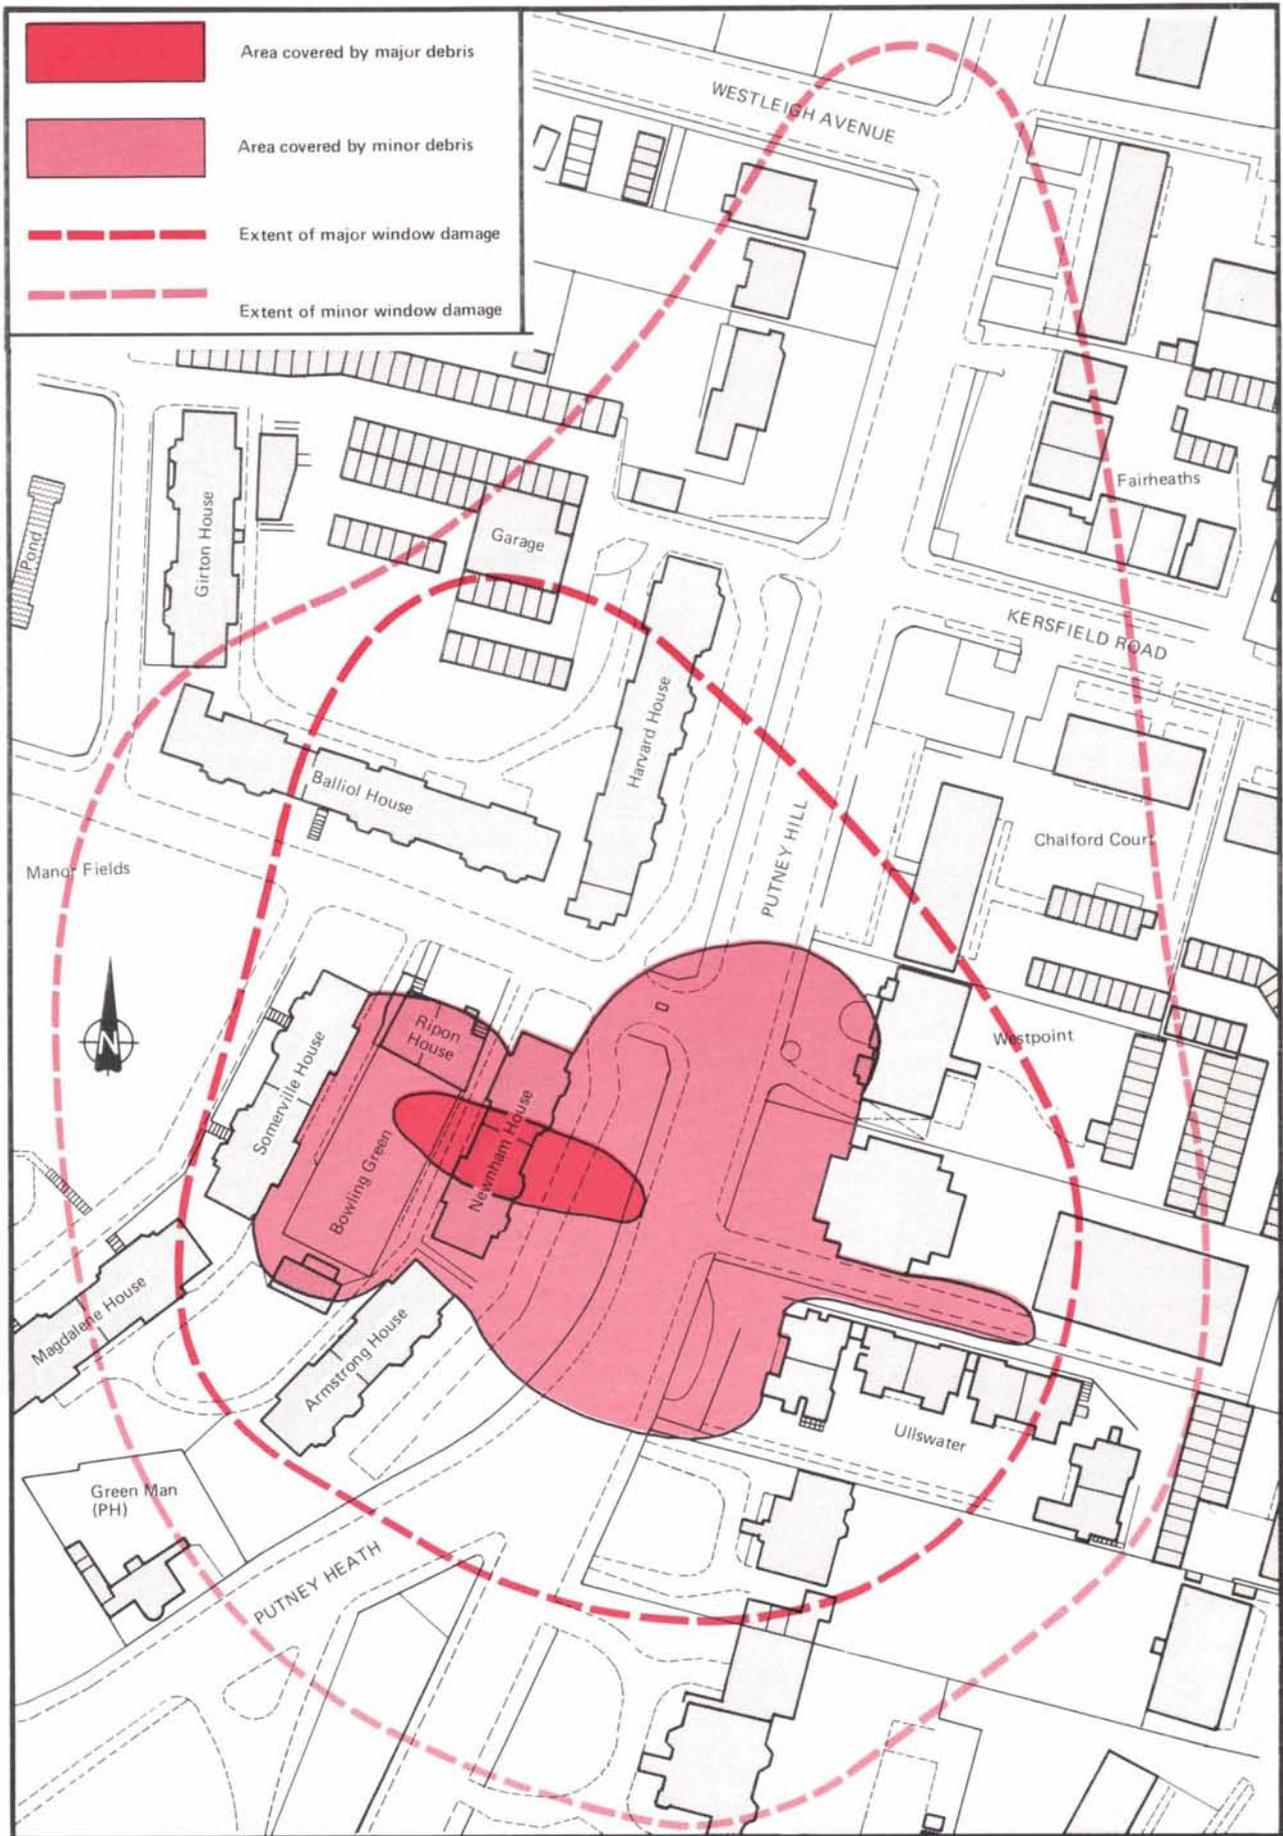
Fig 18 Extent of blast damage

53 It is a common practice in the investigation of major explosions to plot regions of common damage. The damage profile (Figure 18) shows the major structural damage to Newnham House as centering on the middle of the building with little favour to the back or front. The extent of the off site damage indicates that the explosion had involved a large volume of a flammable gas-air mixture.

The explosion damage within the building, the nature of the building collapse, the extent of window damage around Newnham House and the physical conditions needed in diluting natural gas to a flammable gas-air mixture strongly indicate that the explosion was centred on Flat 7.
