The chemical release and fire at the ASSOCIATED OCTEL COMPANY LIMITED

A REPORT OF THE INVESTIGATION BY THE HEALTH AND SAFETY EXECUTIVE INTO THE CHEMICAL RELEASE AND FIRE AT THE ASSOCIATED OCTEL COMPANY, ELLESMERE PORT ON 1 AND 2 FEBRUARY 1994

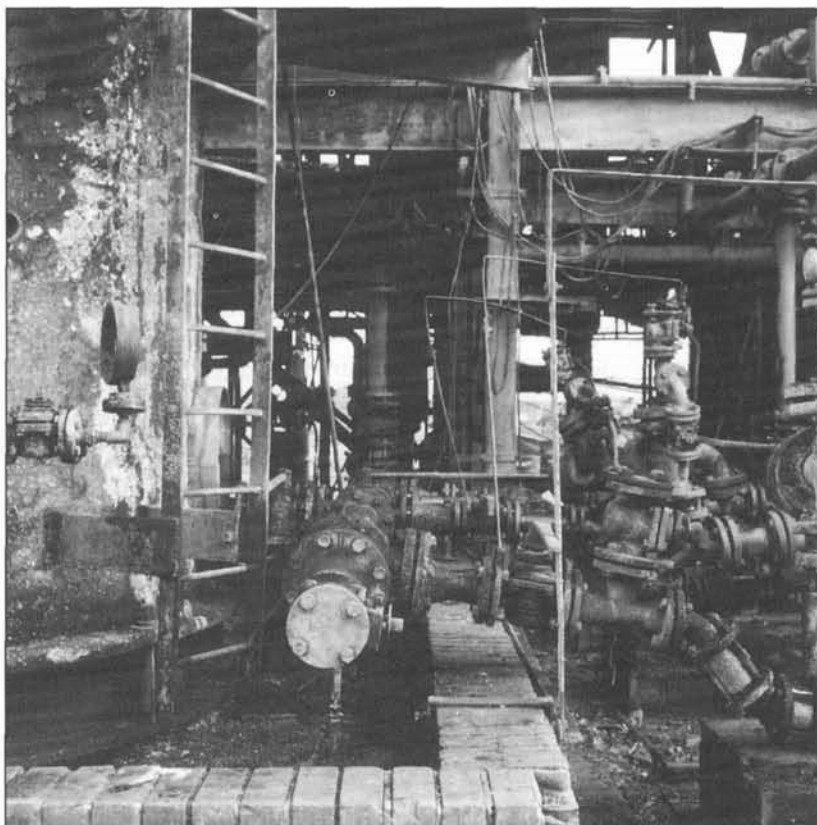
Figure 6 Photograph of Reactor R251 outlet valve to P251 pump manifold at base of reactor

- 36 Two fire fighters, guided by an Octel employee, then entered the cloud in an attempt to isolate the plant and stop the flow. The fire fighters were dressed in chemical protection suits and the Octel employee in a PVC suit and all wore breathing apparatus. One of the fire fighters closed the reactor outlet valve to the pump manifold at the base of the reactor (Figure 6). A second team of fire fighters went in to close the discharge valves of the polymer pumps P251/1 and slops pump P251/2 guided by the same Octel employee and succeeded. There was no time to close any further valves before the air supply in their breathing apparatus ran out. The fire fighter who closed the valves had to be led out of the cloud because his face mask was completely opaque as a result of external corrosion. He reported that he was facing P251/3 and that he was hit in the chest by liquid as he was closing the valve on P251/2. These actions did not stop the leak and a pool of liquid could clearly be seen. At this stage consideration was given to isolating the outlet valve at the base of the slops

drum and the slops inlet valve halfway up the reactor. Because of their height, as well as the cloud, they were difficult to reach. During these attempts, the Fire Brigade maintained the water curtain.

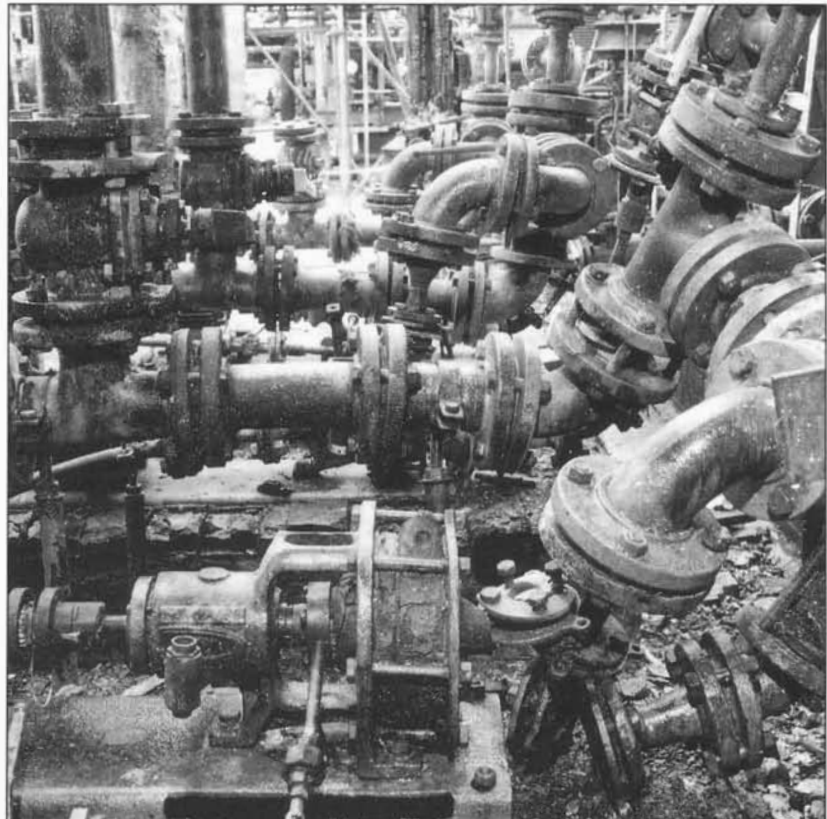
Figure 7 Photograph of 251 pump area showing complex pipework and multiple flange connections

- 58 As so much of the EC plant was extensively damaged in the fire, investigators initially had to establish the source of the release by building up a picture from eye witness reports. Even this was difficult because the vision of operators and fire fighters at the scene had become severely restricted by the cloud and deposits on the masks of their breathing apparatus. The gas cloud had appeared thickest around the base of the EC reactor and Octel staff had soon identified the leak was at ground level in the P251 pump area. The pipework in this area was complex and congested and there were a number of flange connections which were all potential leak sources (Figure 7).

- (c) this was a sudden large release which is characteristic of a catastrophic failure of a joint assembly rather than a gasket or seal failure; and
 - (d) the horizontal release pattern described was more typical of a leak source from a horizontal joint.

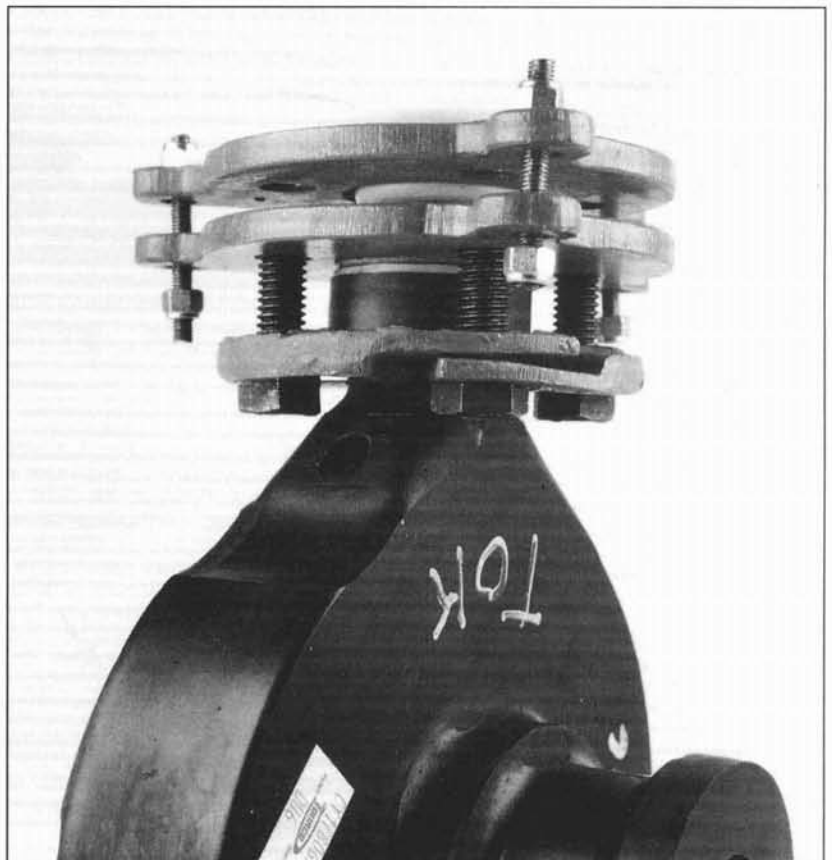
Figure 8 Photograph of replica pump casing, bellows and flange assembly

- 61 The original casings of the pump itself were made from silica-filled epoxy resin and these, together with the bellows, had been consumed in the fire. RLSD constructed a 'replica' of the original pump casings, bellows and flange assemblies from new components supplied by Octel or the manufacturers (Figure 8).

- 65 The flexible joints consisted of two steel flanges with a small PTFE bellows between (Figure 8). No fragments of the original PTFE bellows were found. Each joint was approximately 3 cm long, the whole joint being specified as suitable for a working pressure of approximately 100 psig at 100°C. This was well within the normal operating conditions of the plant. However, joints are a relatively weak part of the system and liable to failure if subject to mechanical stresses outside design parameters. A high standard of inspection and maintenance is demanded when they are used.

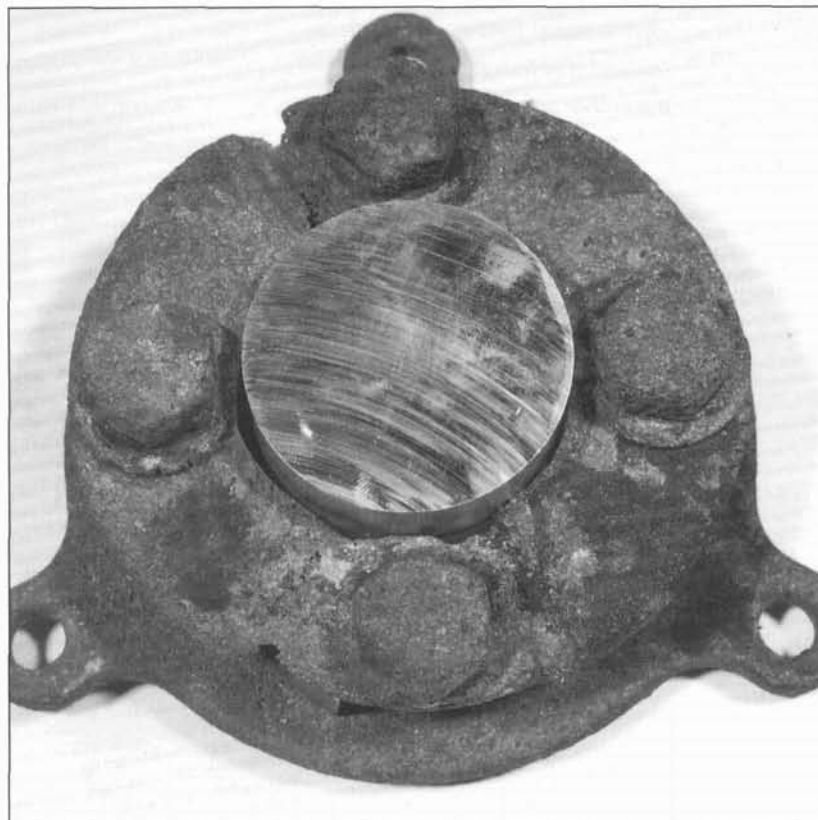
Figure 9 Photograph of corroded split flange from P251 with 50 mm brass cylinder to simulate pump discharge port

- 60 Scientific examination of the P251 pumps and pipework by RLSD revealed that a split flange on the discharge port of pump P251/2 was severely corroded and in a worse condition than either the flange for the suction port of the same pump or other split flanges on adjacent pumps. This flange had been used to secure the flexible joint to the discharge port of the pump. The two halves of the split flange overlapped. The overlapping sections were half the thickness of that of the main sections of the flange. In some areas of the overlapping sections, the flange material had been completely corroded away. All of the bolt holes appeared to have been enlarged by corrosion and were found to be approximately 19 mm in diameter, whereas the major thread diameter of the bolts was between 10 and 10.5 mm.

62 When the original split flange was mounted on the discharge port of the new pump casing the extent of the corrosion became evident. The wasting of the flange was such that its bore was almost equal to the diameter of the discharge port (Figure 9). The evidence suggested that:

- (a) any movement of the flange halves allowed by the securing bolts in the corroded bolt holes would have allowed the flange to slip along the port of the pump;
- (b) there was a high risk of a significant leak occurring without the split discharge flange completely disengaging from pump P251/2; and
- (c) such a leak would be through an annular gap between the flange and bellows faces, ie in a horizontal plane.

63 A complicating factor was that during the incident the flange would have been subject to corrosion from escaping HCl, the rate of corrosion possibly being increased by the raised temperature. It was therefore difficult to establish the

extent of corrosion before the incident. However, RLSD conducted some corrosion tests and from the results of these formed the opinion that the difference in the degree of corrosion between the discharge split flange on P251/2 and those on the other pumps could not be wholly accounted for by these effects and that the flange had been in a seriously corroded condition before the incident.

- 66 The investigation team concluded that the release occurred at a point between fixed pipework and the discharge port of pump P251/2 as a consequence of either (a) a corroded securing flange on the pump working loose; or (b) the failure of a PTFE bellows. On the basis of their evidence and on the balance of probabilities, HSE formed the view that (a) was the cause of the release.

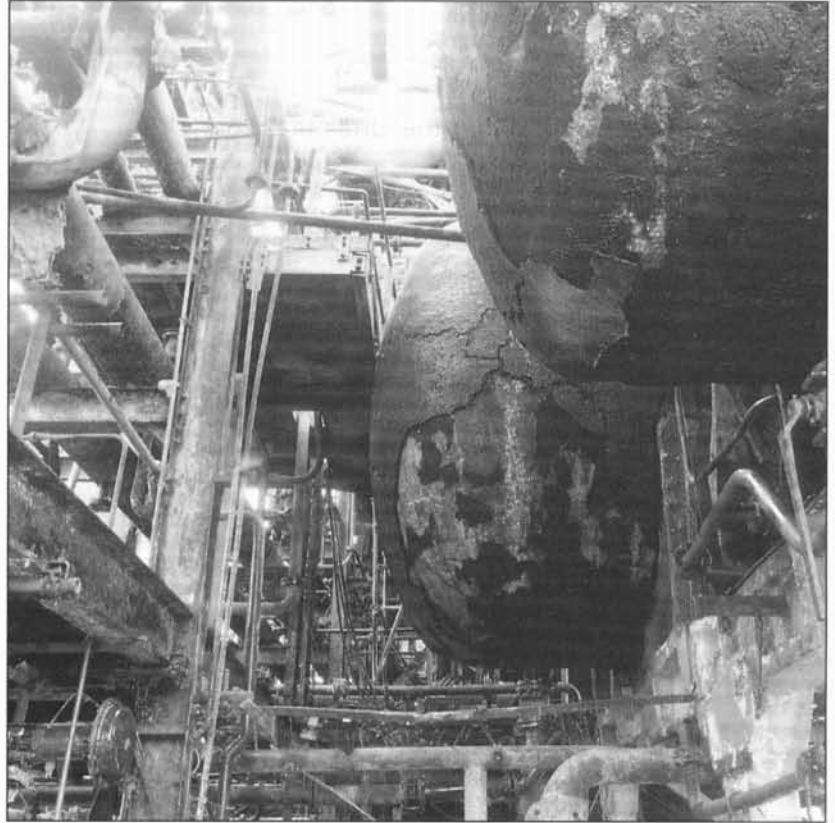
Figure 10 View of slops drum (foreground) and stabiliser feed drum (seen from the west)

- 40 Also at 11.00 pm a major foam attack was organised to fight the fire at the slops and stabiliser feed drums as it was decided the cladding on these vessels allowed a sufficient safety margin to attack these vessels and that this was safer than allowing the fire to burn uncontrolled. To support this, increased transfer of foam was needed requiring a further 10 pumping appliances. Also supporting were Octel and Shell foam tenders using their roof mounted monitors which were very effective in attacking the fire on top of the vessels.
