## Part H

### HISTORIC INCIDENTS THAT ILLUSTRATE THE BREACHES IN DEFENCE IN DEPTH

#### Incident Studies and Illustrated Safety Teaching Examples for ChemEngers

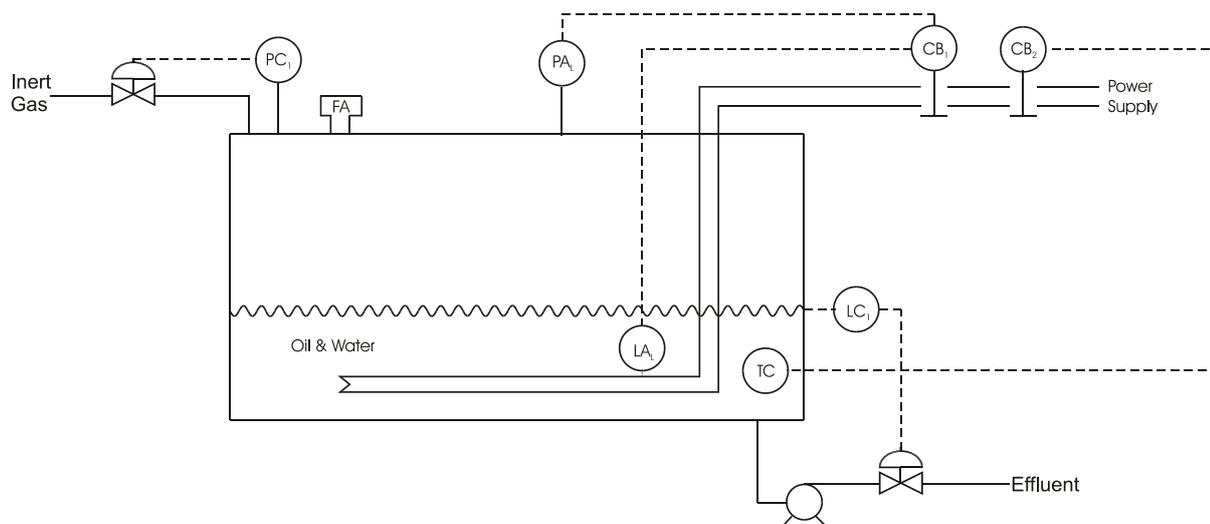
**Figure 2.1**

About 1 year after the start-up there was a violent explosion in the tank. The electrical heater was ejected with such violence that it damaged structural steel on which it impacted. The likely over-pressure was

about 4 bar<sub>g</sub>. (This was assessed from the UTS [ultimate tensile strength] of the steel and the root area of the bolt threads of the restraining bolts).

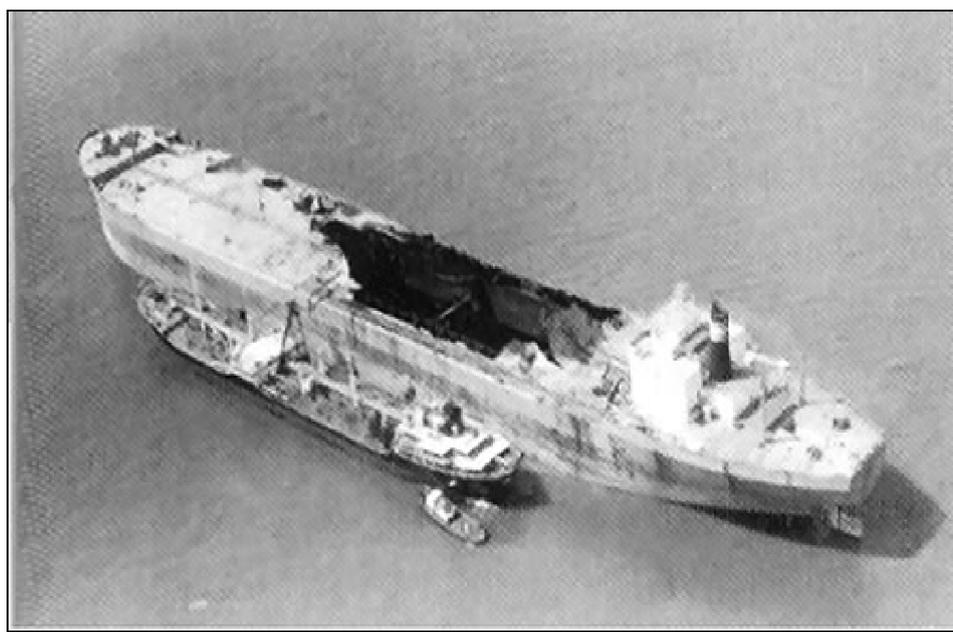
Kong Haukkon after the explosion

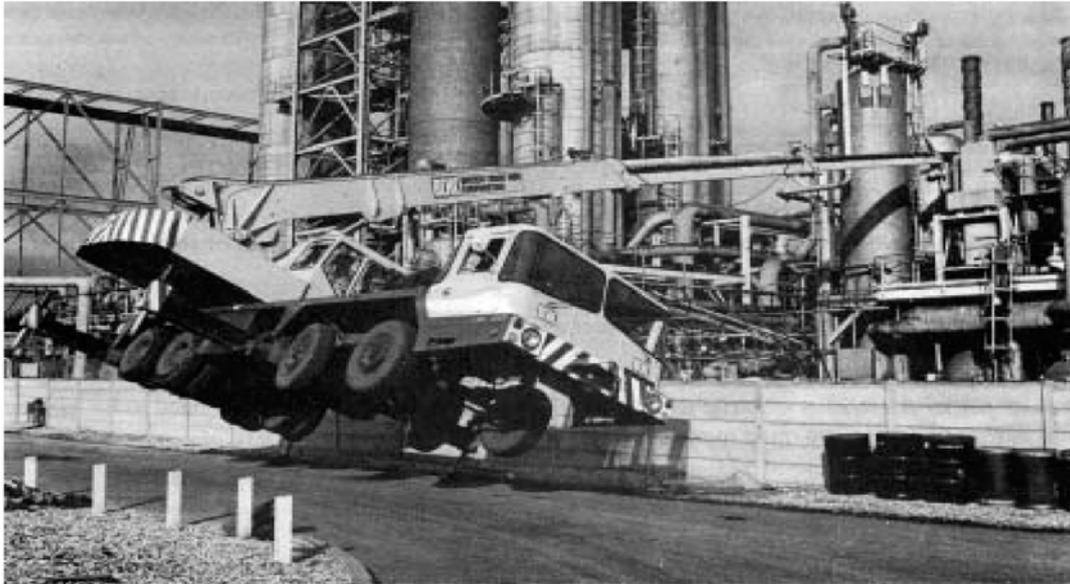
1. Had a “statics” study been carried out – MOMENTS about a point – simple “A” level Physics. NO!

2. What made the new Manager deviate from the original intent? Lifting over live plant was a definite “*no-no*” on that Works but it was not recorded in writing! Ignorance? Bravado? “*I know best!*” Had a Risk assessment been carried out? Obviously NO! (See notes on Human Failure and Audits)
3. Was the crane driver fully briefed/trained/supervised? NO!
4. Had a full “risk assessment” been executed on the job to be carried out? NO!

**Photo 3.1 The “toppled crane” from ICI Safety Newsletter**

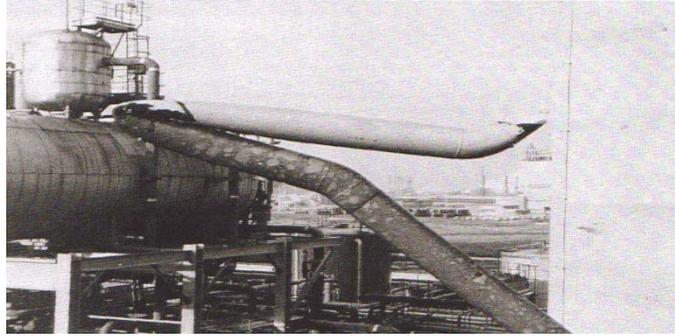
1. If the drain hole is choked any slight steam leakage generates condensate which builds up as a column of water, the column is heated by conduction from the PRV internals or the leakage of steam. There must be a balance point of heat gain against suppression of the boiling point of the condensate
2. More importantly the drain hole is actually a safety system – who checks it? In many cases the answer is “no-one”.
3. Figure 3.2.2 (below) shows what happens when the line is not properly supported against jet reaction.

**Photo 3.2.2 A bent steam vent line taken from ICI Safety Newsletter.**

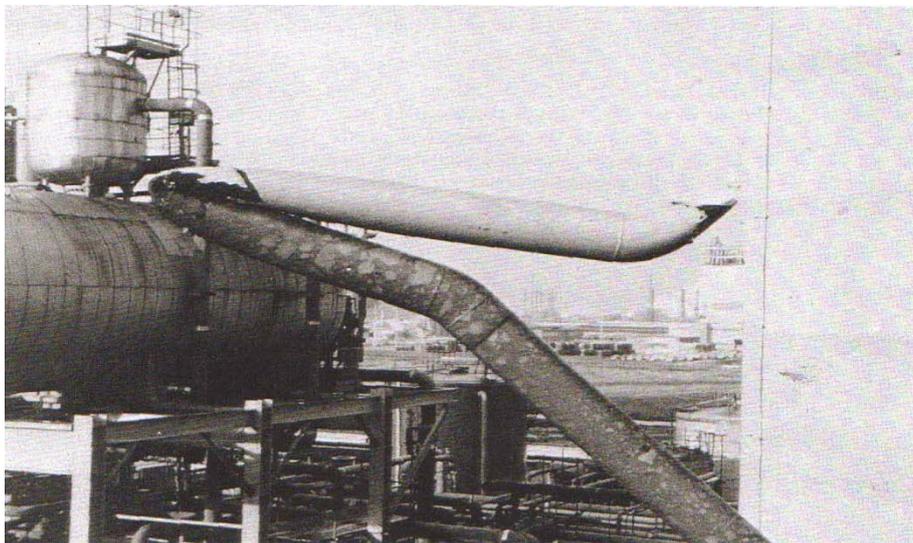
Photo 5.3 shows the the tail pipe from a Pressure Relief Valve some 12” diameter which has been bent double. VERY FORTUNATELY the PRV reseated within a second or two as in the state shown in the photo the outflow would have been cut off and at best the PRV would not have protected the system and at worst the piping might have ruptured!

**Photo 5.3 A bent vent line from ICI Safety Newsletter**

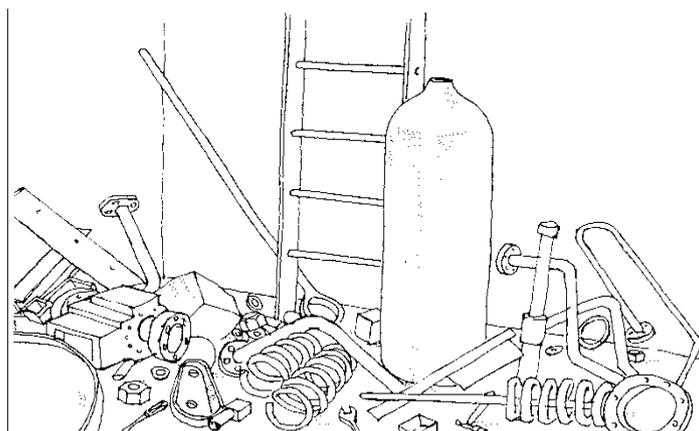
**Sketch 5.4 Clutter (taken from ICI Safety Newsletter)**
