The Buncefield Incident

11 December 2005

The final report of the
Major Incident Investigation Board

Volume 2

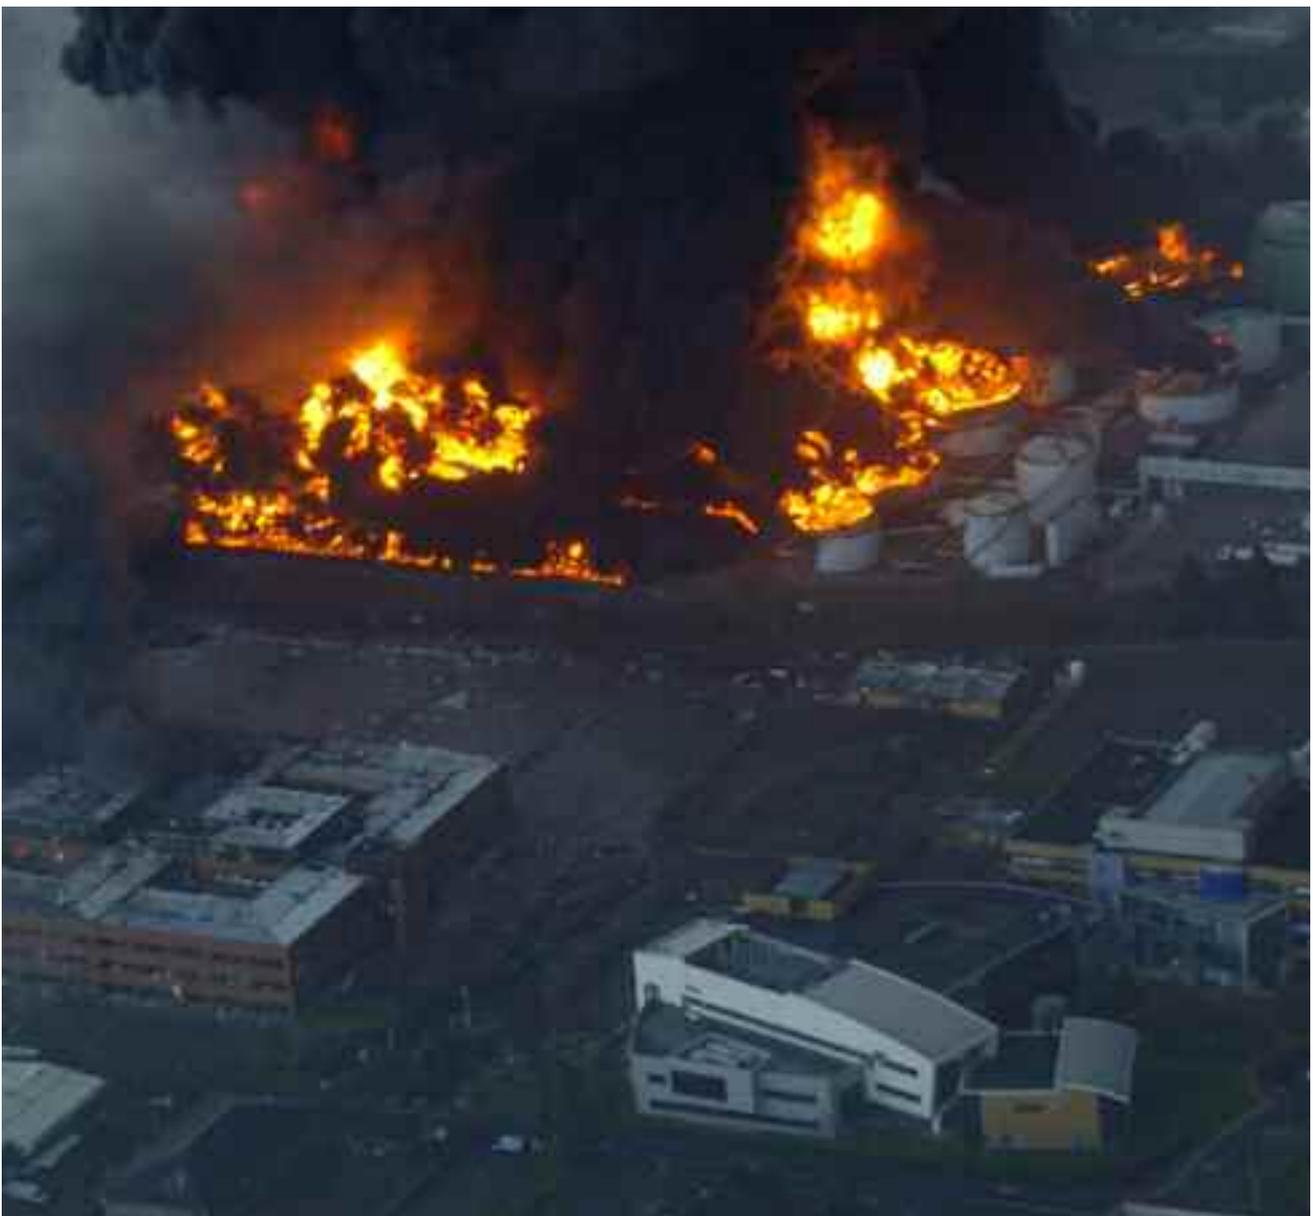
Figure 1 This photograph shows the Buncefield site on the first day of the fire. The Northgate building can be seen burning towards the lower left corner of the photograph.

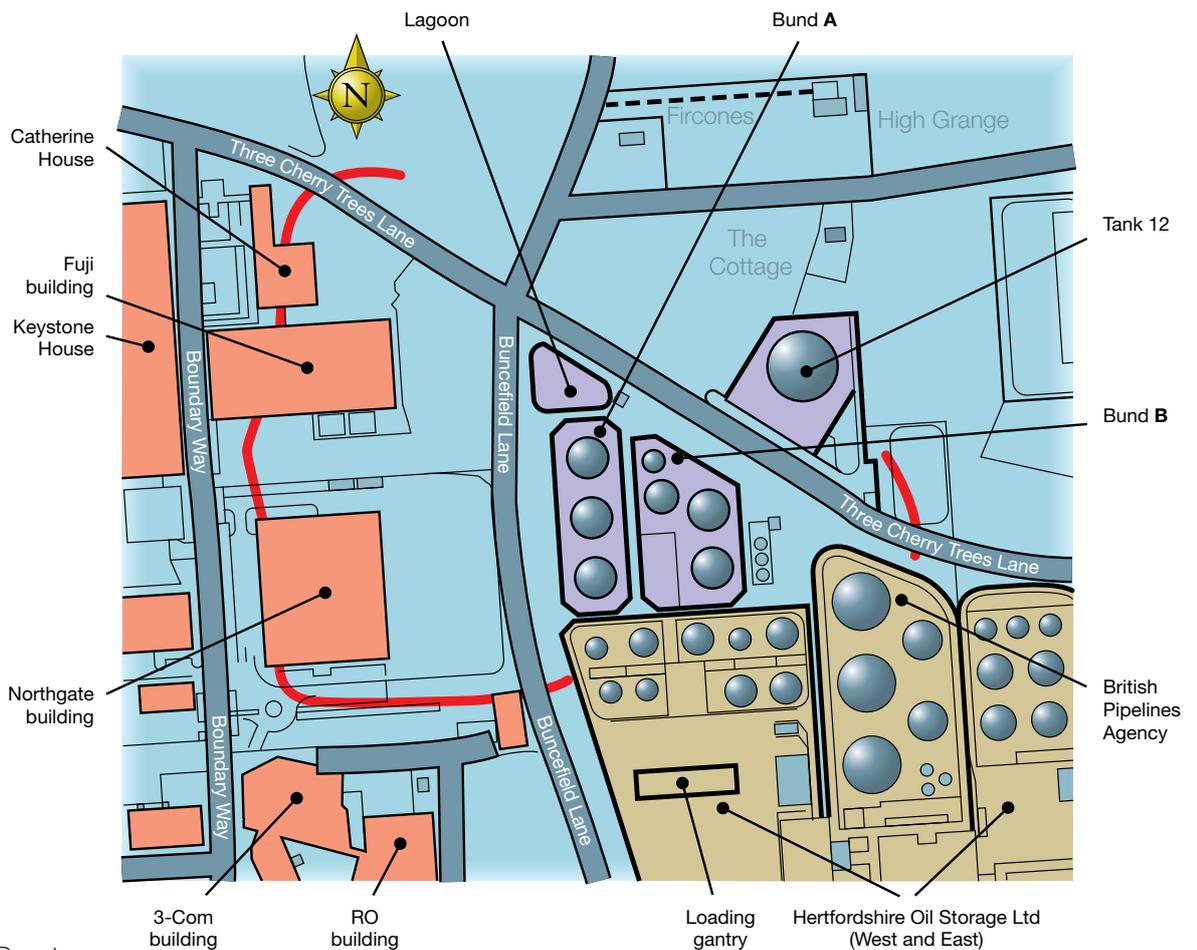
Figure 5 Layout of Depot and surroundings also showing limit of flammable mixture indicated by burned material

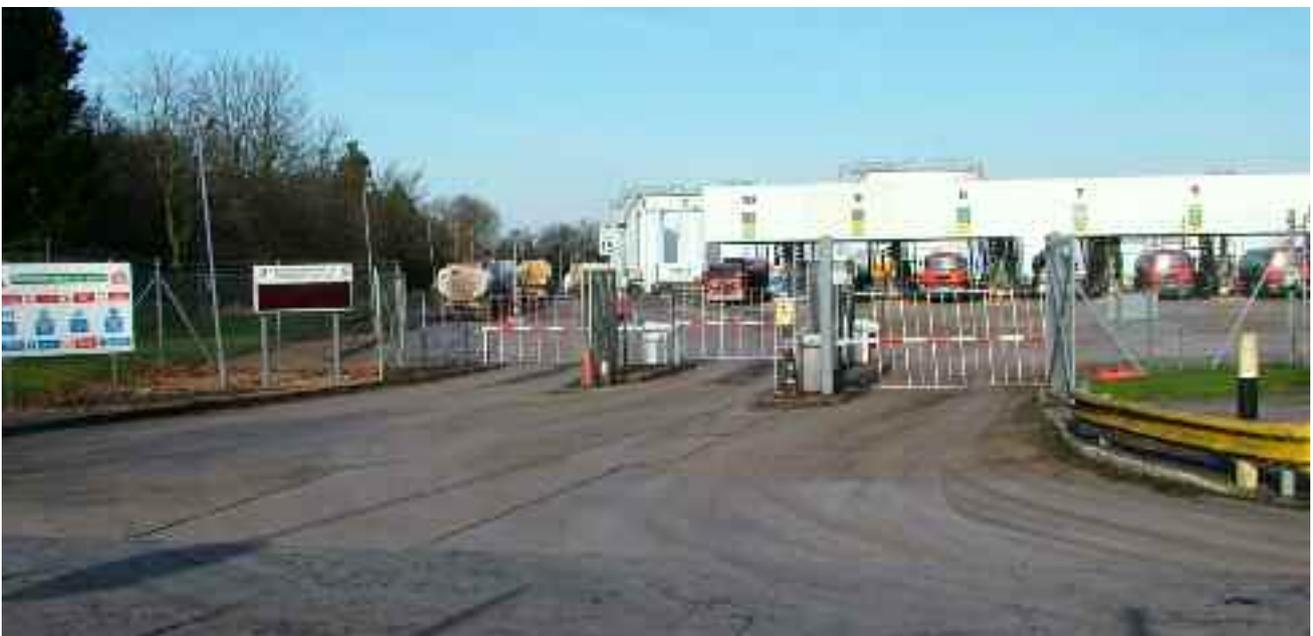
Figure 6 HOSL West gates

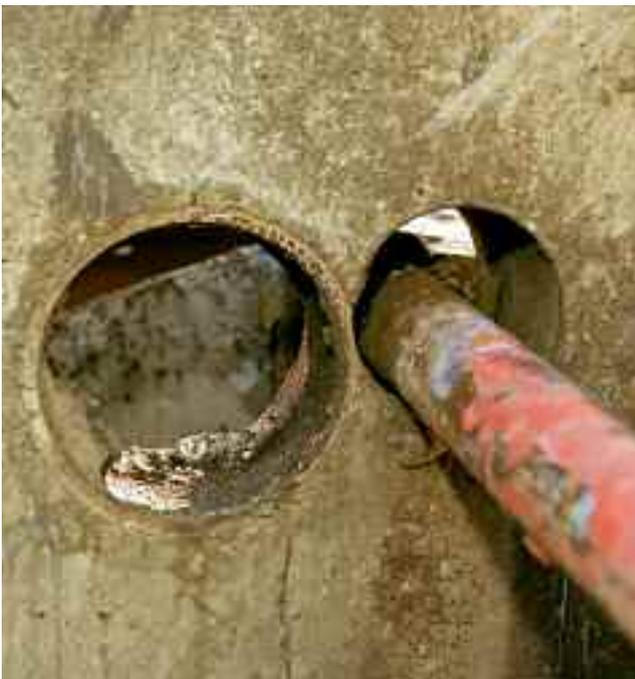
20 Figure 9 shows the inclusion of penetrating pipework in the construction. Here the sealing material surrounding the pipes has been lost.

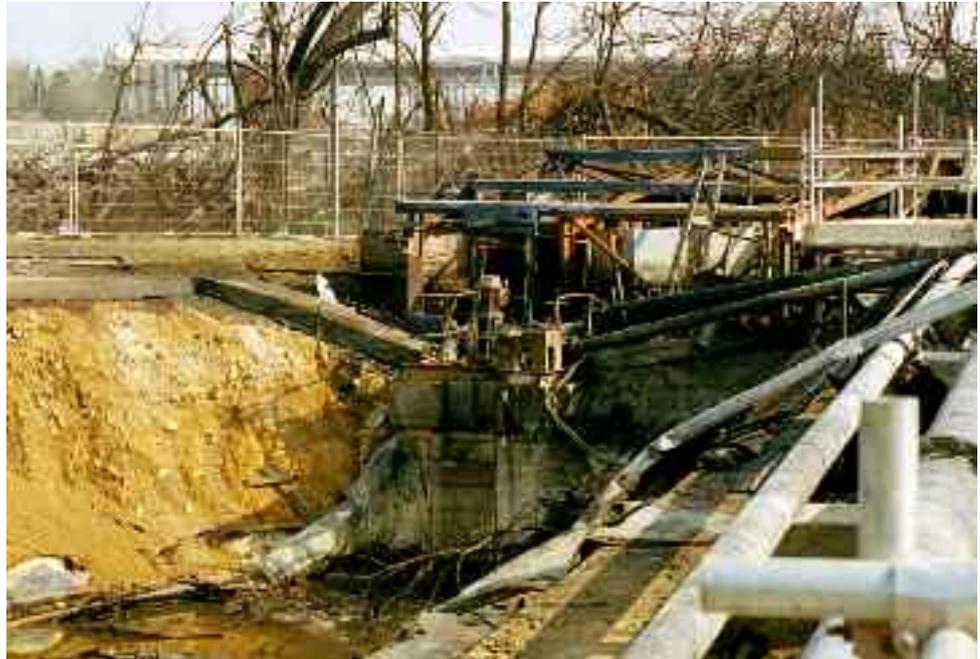
26 During the incident, the internal roadways were submerged by fire water and fuel flowing to the lowest point. Fire water and fuels flowed through the site drainage and along the roads within the site perimeter. At the low point on the site perimeter the flows overtopped the road edge, which was not kerbed, and flowed into Cherry Tree Lane.

Figure 11 The three parallel bars show where the pumphouse stood before the incident

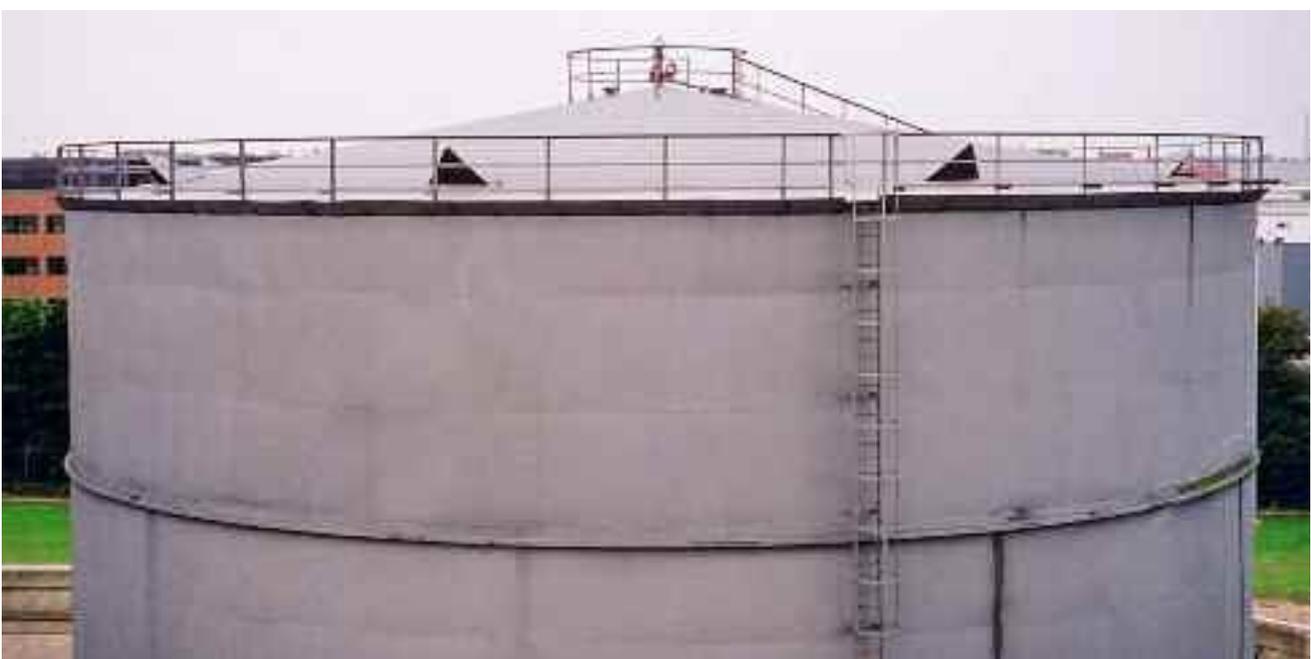
Figure 3 Tank top details before the incident

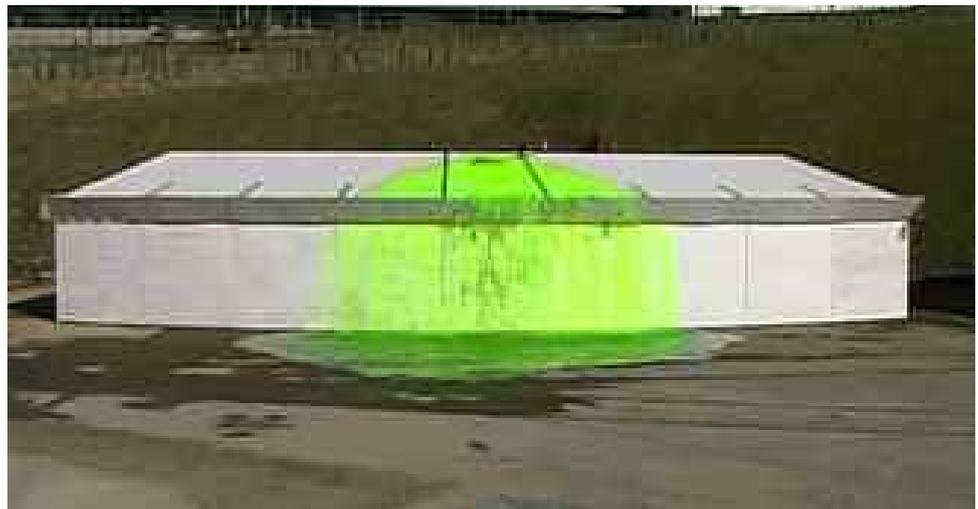
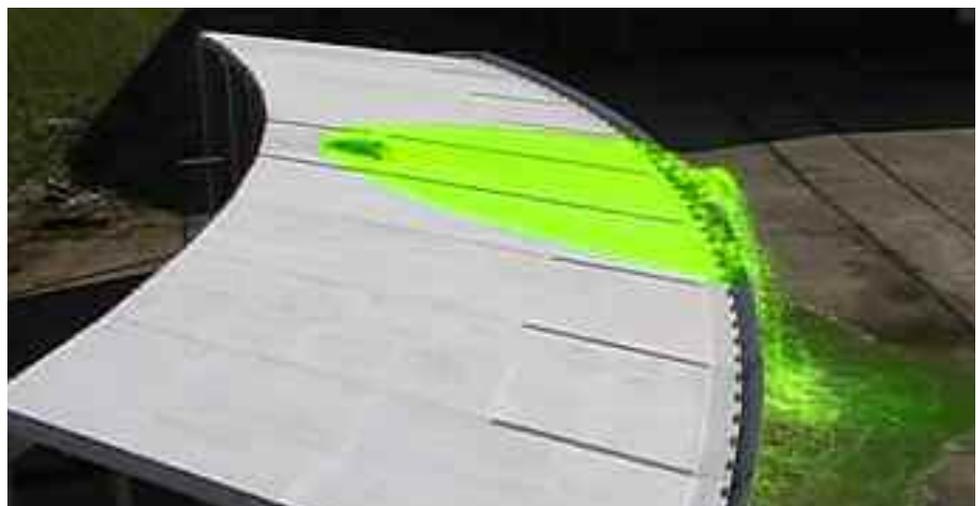
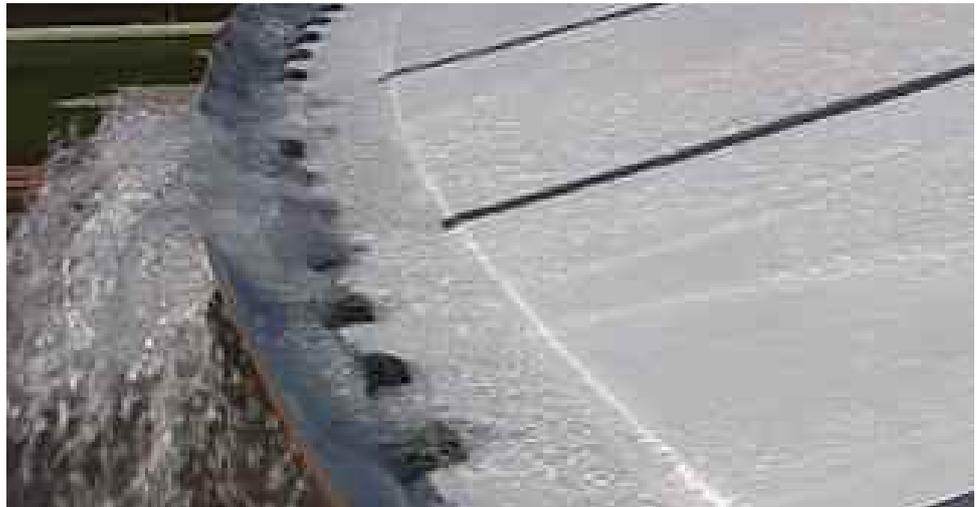
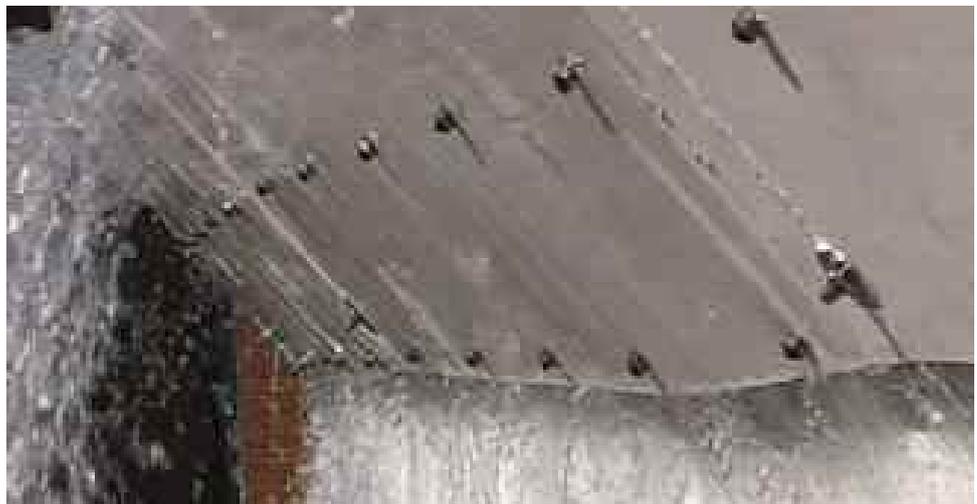
Figure 4a-d Liquid flow from the breather holes on the tank top

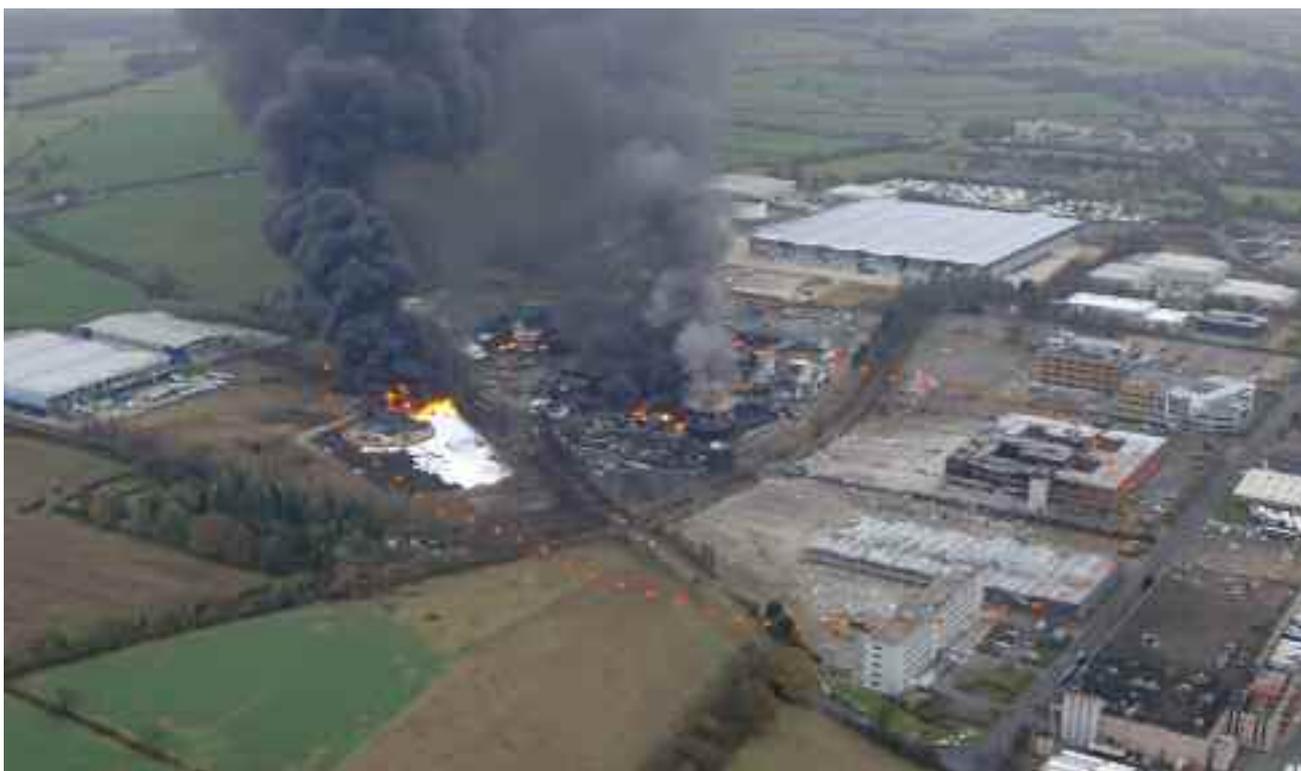
Figure 6 Extent of burn damage (indicated by dotted line)

HOSL East site. This is a little way beyond the extent of the burn damage shown in Figure 6. According to witnesses, the depth of the visible mist varied from about 1 m in the area between bund A and the loading gantry to between 5 and 7 m in Three Cherry Trees Lane.

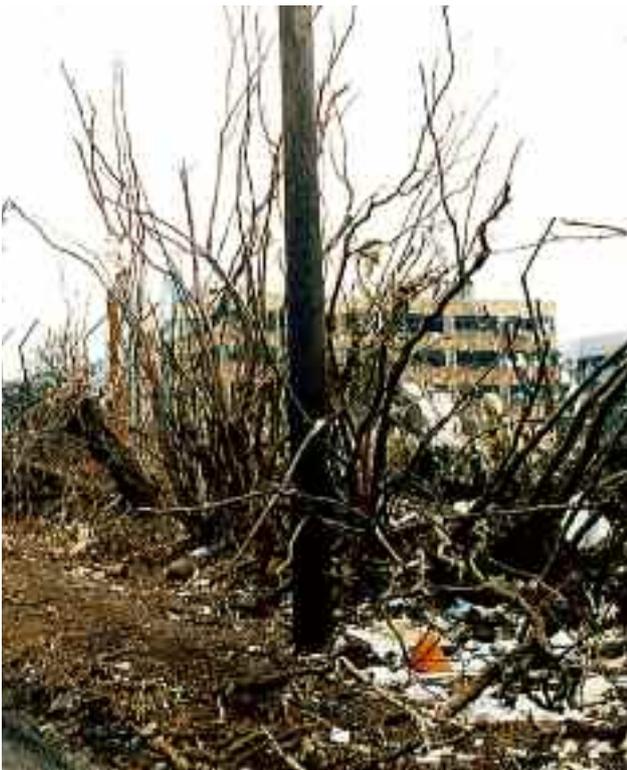
Figure 7 A telegraph pole in Buncefield Lane, showing sooting on lower half

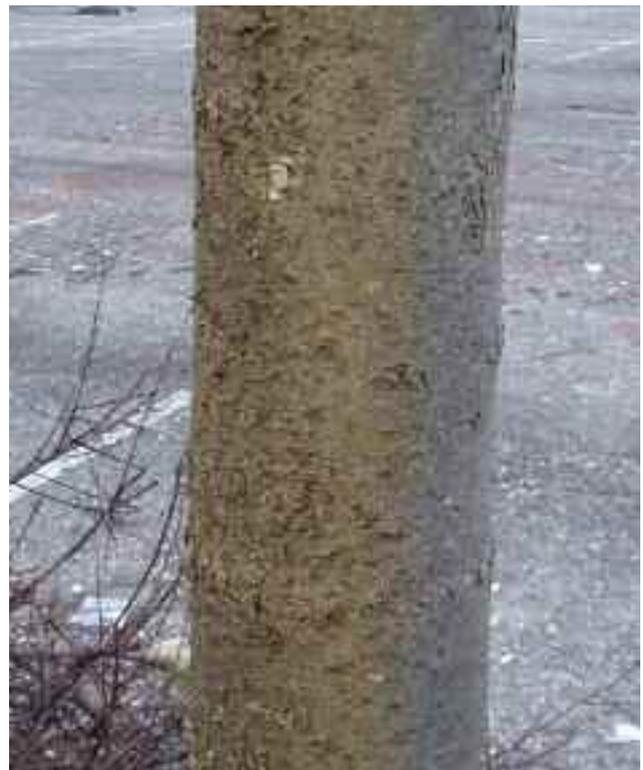
Figure 8 Part of a tree trunk in the Northgate car park showing abrasion

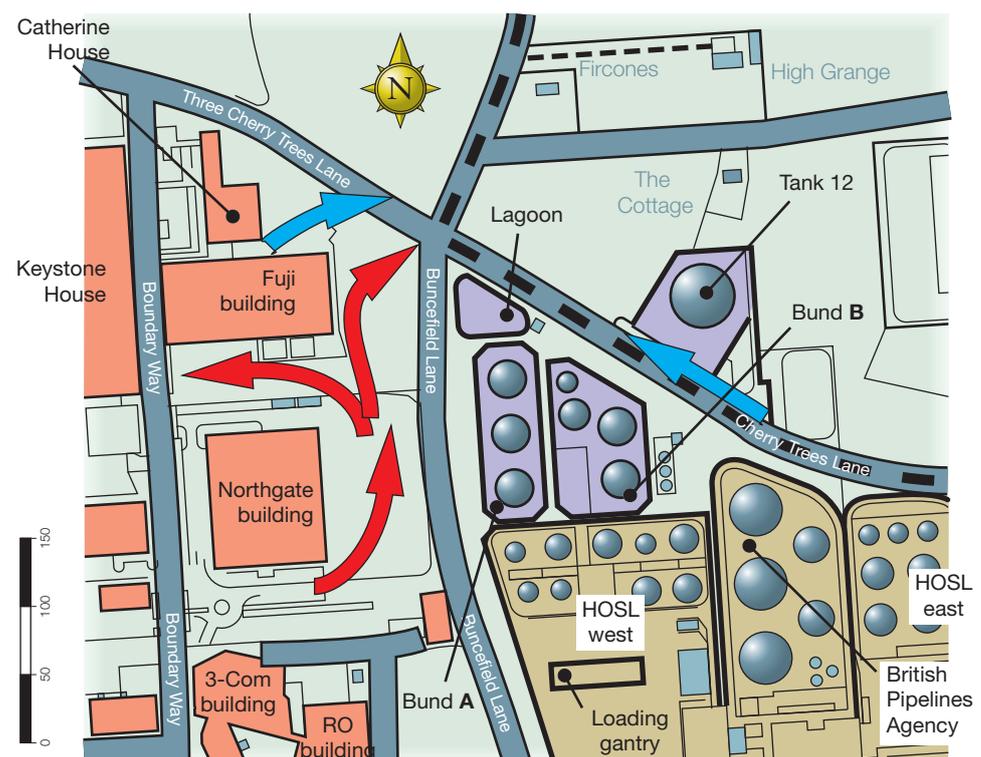
Figure 9 Showing main and secondary explosion propagation

56 Furthermore there is evidence, from erosion/abrading on just one side of posts and tree trunks, of a powerful explosion having propagated northwards across the Northgate and Fuji car parks, as shown in Figure 8. The movement of objects like fence posts, tree branches etc indicate explosions of lesser magnitude having propagated through other areas bordering on the Buncefield site. The directions of explosion propagation are shown on Figure 9. The main explosion propagation is shown in red with secondary effects in blue.

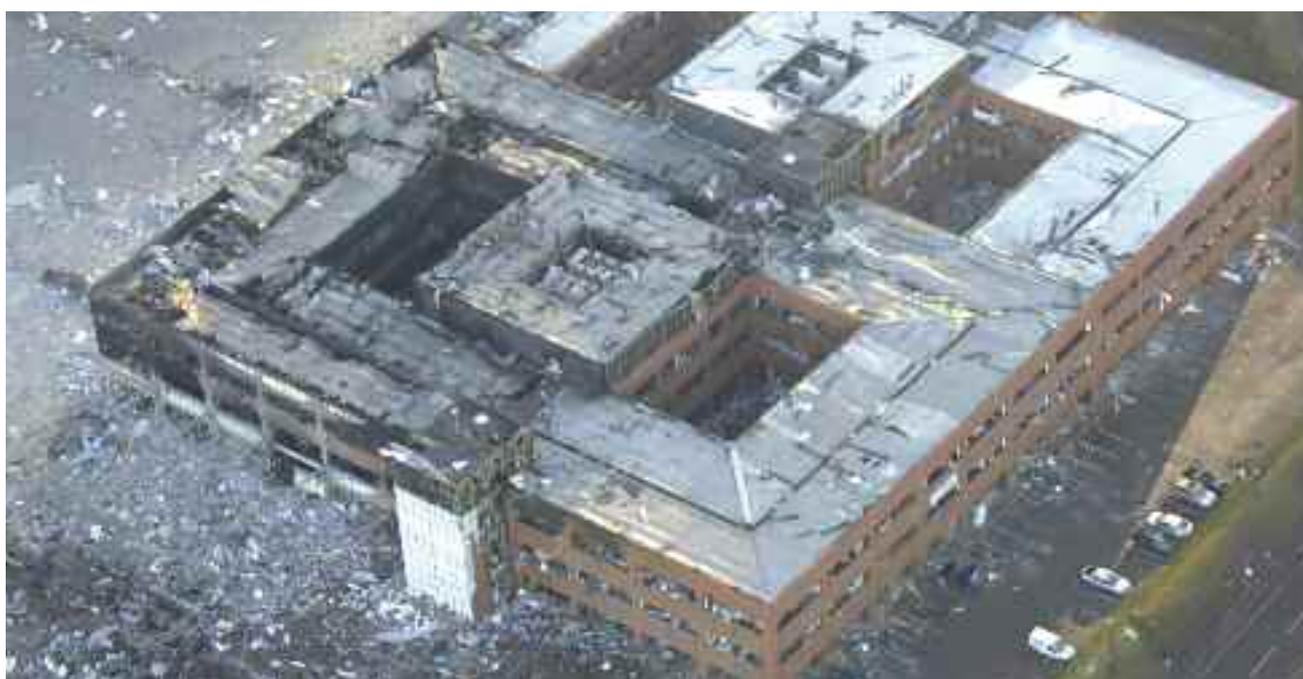
Figure 3 Damage to property on the Maylands estate adjacent to Buncefield
