# Selection and Deployment of Non-Destructive Testing for Through-Life Integrity Assurance of Composite-Repaired Pipes

Adam Bannister, HSE Science Division, Harpur Hill, Buxton, SK17 9JN, UK  
 Aneta Nemcova, HSE Science Division, Harpur Hill, Buxton, SK17 9JN, UK  
 David Johnson, HSE Science Division, Harpur Hill, Buxton, SK17 9JN, UK  
 Matthew Blackburn, HSE Energy Division, Lord Cullen House, Aberdeen, AB25 3UB

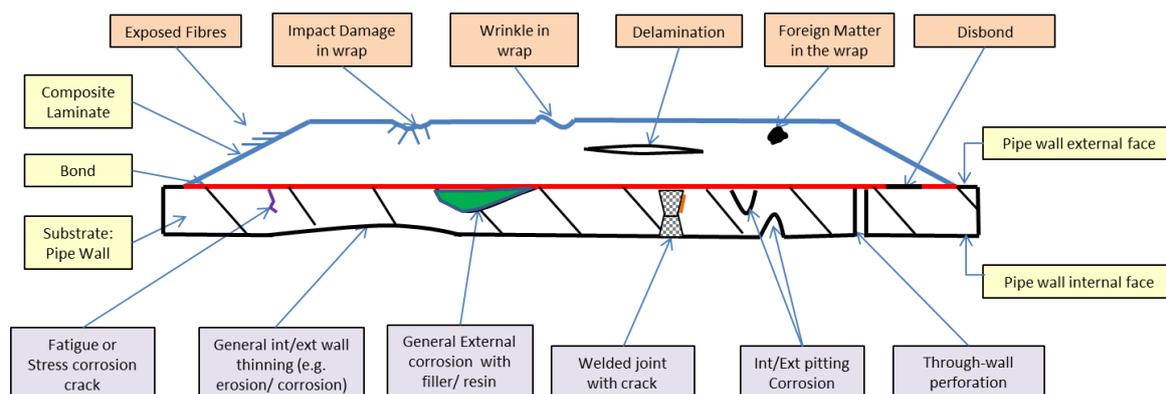
The types of defects in the substrate that may lead to the installation of a composite repair are varied, Figure 1, and include general or local wall-thinning due to corrosion or erosion, pitting, cracking or through-wall penetrations. Once repaired, the extent and periodicity of any inspection will depend on a range of factors including the criticality of the application and consequences of failure. In some cases, there will be a need to inspect the substrate, repair laminate and the bond, Figure 1. The integrity of the bond is particularly important for safety critical repairs where the repair affords primary containment. The application of an engineered composite repair typically changes the potential mode of failure from rupture of the substrate to a leak, and the consequences of failure are therefore reduced. Nevertheless, the ability to monitor the evolution of flaws or changes in degradation mode in the repaired system is critical to integrity management.

**Figure 1: Types of degradation and flaws that may occur in composite wrapped pipework**

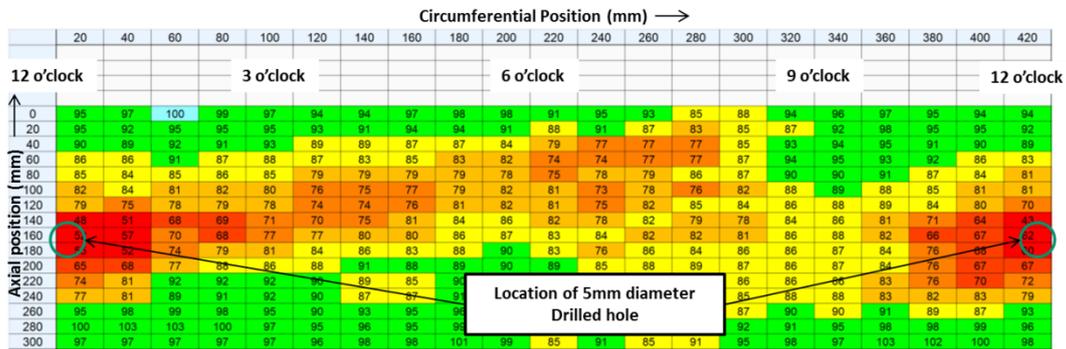
a. Example of PEC averaging effect when measuring substrate features less than probe size (Spool 17532)

Areal averaging, based on footprint area, and increased area of averaging with stand-off distance (wrap thickness) are well known limitations of PEC. These limitations were observed in the trials, where the method showed limitations in its ability to detect localised features such as corrosion pits and through-wall perforations that were less than the size of the probe. Enhanced use of the compensated wall thickness (CWT) approach, implicit in most PEC analysis software, can limit the measurement inaccuracies in areas of localised wall thinning. The method is not able to differentiate between internal and external wall thickness loss. For the case of features of size similar to or larger than the probe footprint, the trials on PEC showed that it can be effective for general loss of thickness in the substrate.

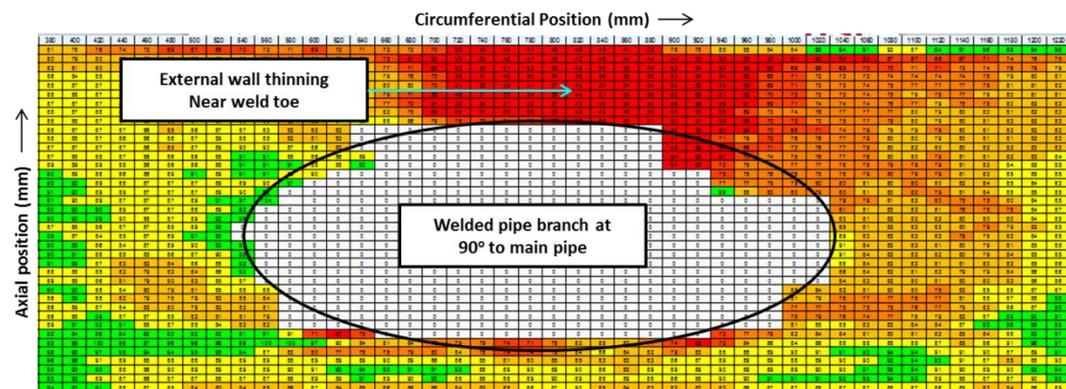
b. Example of PEC correctly capturing minimum wall thickness region larger than probe size (Spool 16766)

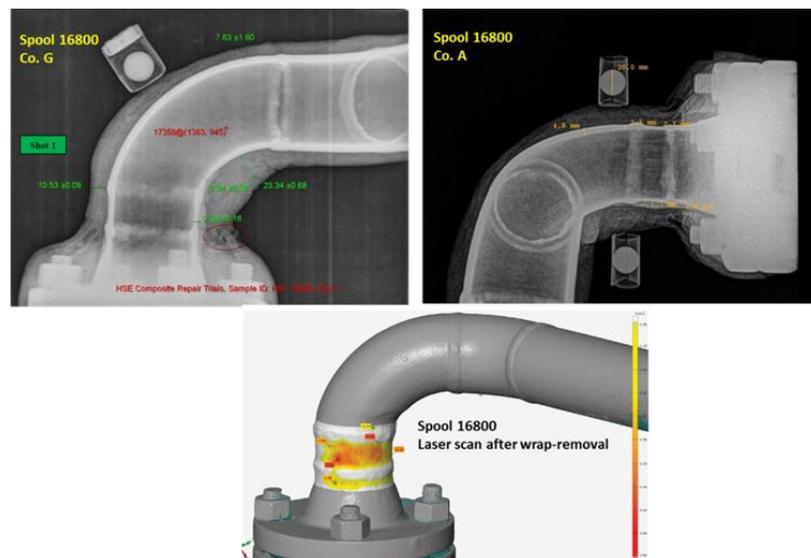
For spool 16800, the wrap thickness varied significantly around the elbow and bolted flange region of the joint. The substrate wall thickness was measured at between 1.3 mm and 3.8 mm, with the minimum value measured after wrap removal of 2.0 mm using radiography and 1.35 mm using external laser scanning. The radiographs also clearly showed the variation in wrap thickness and the different features present in the wrap at the transition from the pipe cross section to the bolted joint, Figure 4.

Figure 4: Comparison of two radiographic inspection results on spool 16800 with laser scan after wrap removal

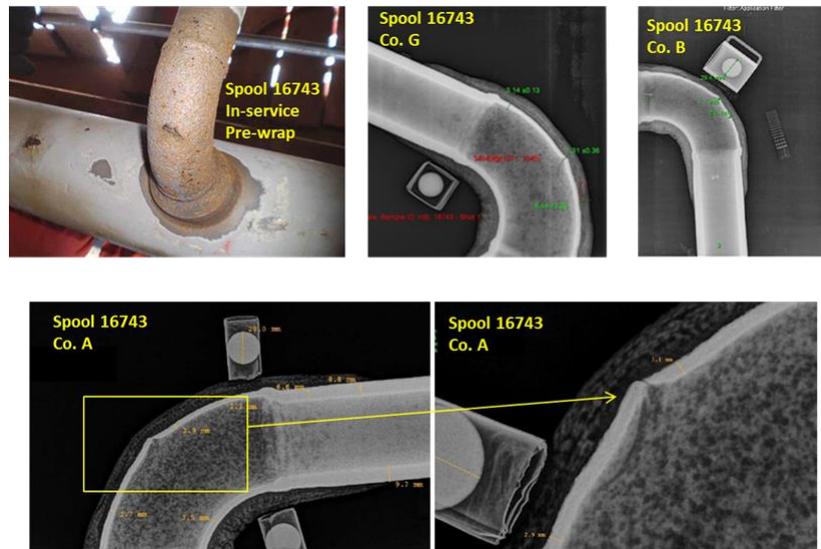
Spool 16743, Figure 5, contained severe external pitting in the elbow attachment coupled with a through-wall defect located on the pipe extrados. Radiographic inspection by three companies identified the thinnest region of the pipe at the extrados and the severely pitted nature of the external surface was also discernible. Excluding the through-wall defect, the minimum substrate wall thickness was measured at 1.1 mm with the wrap on, and 0.6 mm with the wrap removed. The wall thicknesses measured with wrap on for the intrados and extrados of the spool showed good correlation with those measured by laser scanning after wrap removal. The wall breach is clearly visible in the radiograph from Company A.

**Figure 5: Comparison of radiographic inspection results on spool 16743 with wrap with condition in-service prior to wrapping**

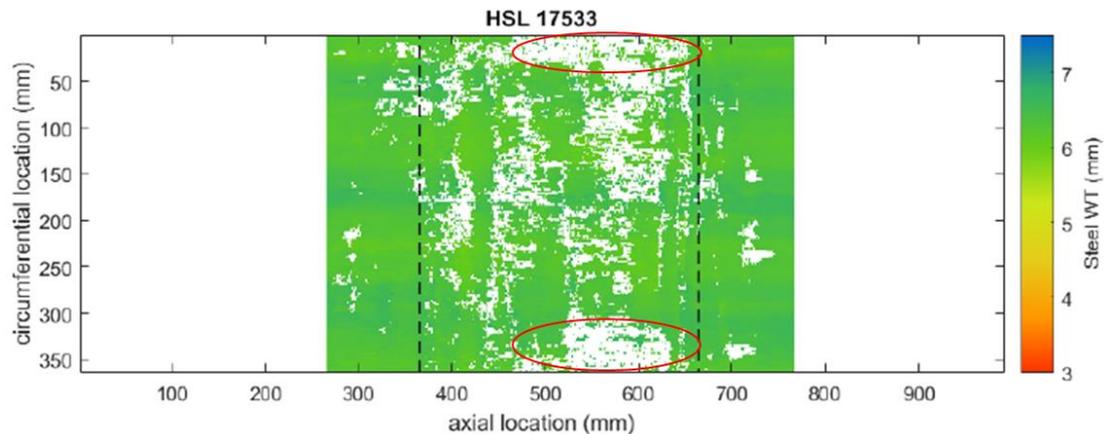
**Figure 7: Dynamic Response Spectroscopy results for pipe spool 17533 after hydrostatic testing**

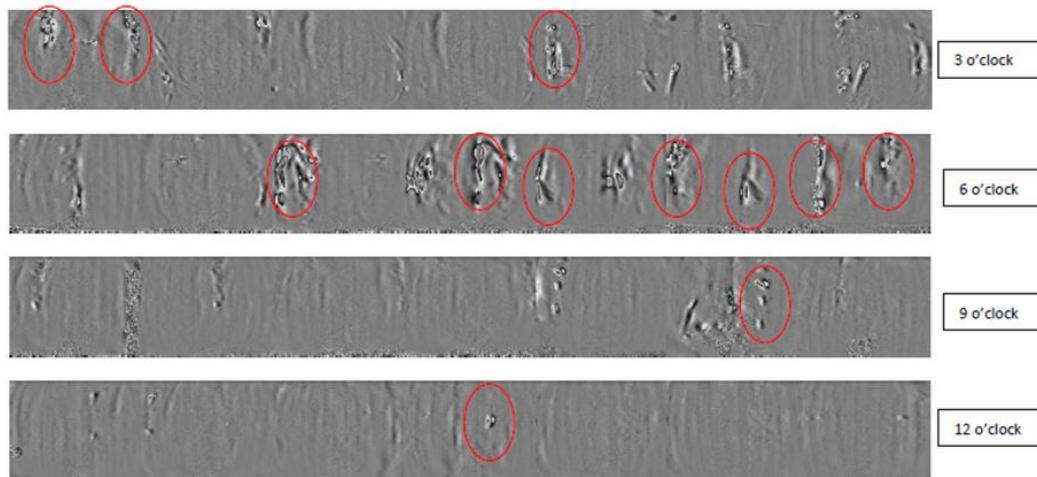
Free-standing laser shearography using thermal excitation was carried out on five pipe spools. Multiple shots were taken at the 12, 3, 6 and 9 o'clock positions, which together captured all the surfaces of the pipe wrap. Laser shearography results for spool 16872 are shown in Figure 8, where each of the four images is taken at one of four positions around the circumference and the pipe's longitudinal axis is in the x-direction. The areas circled in red show regions of differing isostrain, which is

indicative of stronger/weaker areas within the composite wrap. A significant proportion of the wrap was reasonably well consolidated. However, a number of indications can be seen which are characteristic of disbonds and/or delaminations, with a high concentration of such features at the 6 o'clock position.

**Figure 8: Laser Shearography output from inspection of pipe spool 16872**
