Investigation into a Microbiologically Induced Corrosion (MIC) failure of an onshore pipeline

Birkitt Keith, Science Division, Health and Safety Executive, UK

Onshore Incident

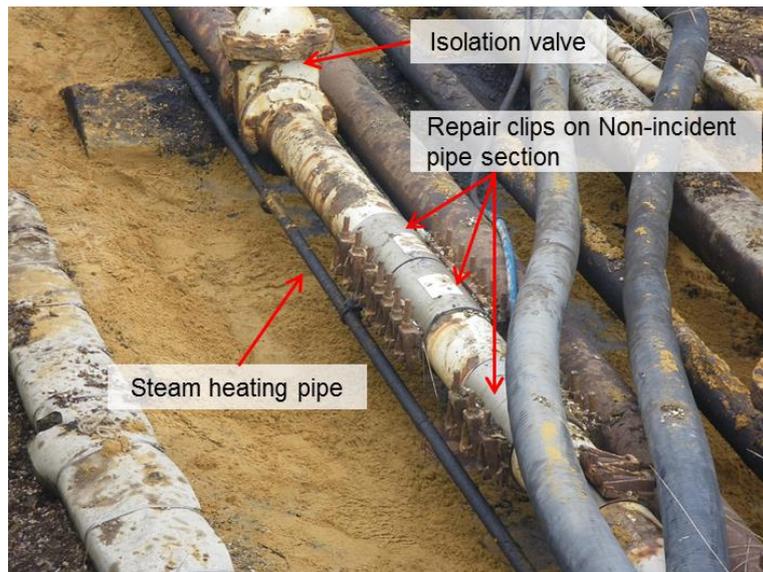
A small bore steam line running parallel to the parent pipe shown in Figure 2 suggested that the pipework route had previously been steam trace heated. Therefore it can be assumed that the line had been originally insulated and that it had been removed.

Figure 2 Steam heating pipe and temporary repair clips installed on non-incident pipe

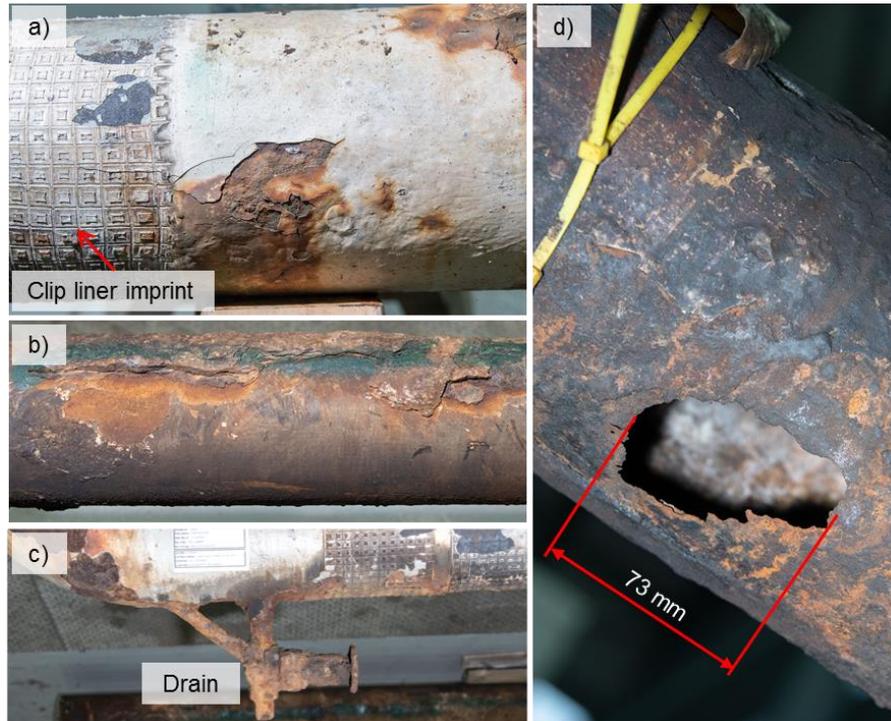
The pipes had originally been painted, however the presence of external corrosion products indicated that the protective paint layer had been breached some time previously, Figure 3a. The protective coating was multi-layered on both pipes. The outer layer had the appearance of paint, the middle layer appeared metallic and the inner layer was a grey paint-like base. In some places, the coating had peeled off, with signs of blistering and corrosion attack underneath. The incident pipe showed significantly less of the remaining coating compared to the non-incident pipe.

Both pipes were heavily corroded, with corrosion products reaching a thickness of up to approximately 10 mm on the outer surface

(Figure 3b). Delamination and spalling of the corrosion products, blistering and a number of through-wall perforations were observed on the external surface of both pipes. External corrosion is common at the six o'clock position due to increased moisture content underneath pipework due to poor ventilation and shading. The size of the holes on the non-incident pipe were larger compared to the perforations on the incident pipe. The holes were located at the 6 o'clock position under the temporary repair clamps.

The vent on the incident pipe and the drain on the non-incident pipe were both heavily corroded. The amount of corrosion product observed would have significantly restricted their function and purpose. A photograph of the drain is shown in Figure 3c.

Figure 3d shows the defect associated with the loss of containment. Its length was 73 mm. The wall in its surroundings was very thin with a tendency to break.

Figure 3 a) Remaining coating on non-incident pipe, b) Thick layer of corrosion product on incident pipe, c) Drain on non-incident pipe, and d) Defect associated with loss of containment on incident pipe

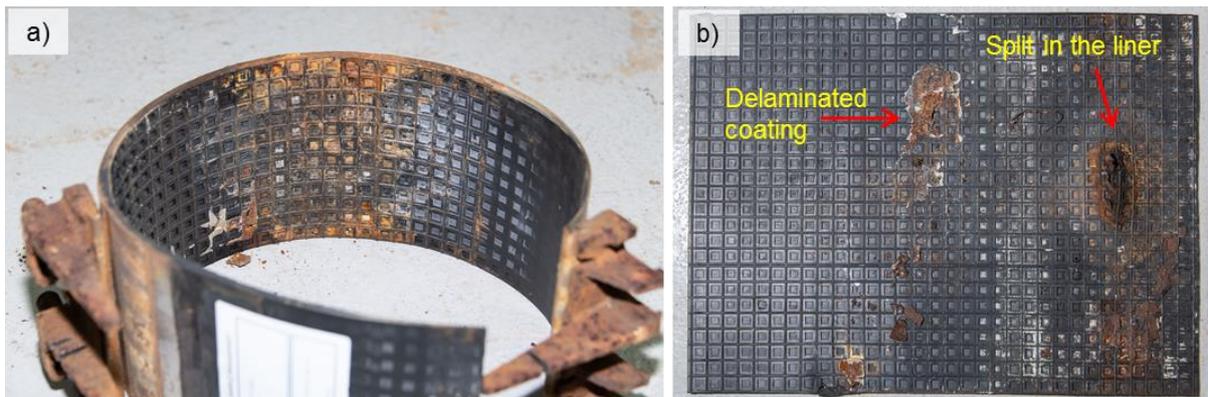
Six temporary repair clips of various widths had been installed on the non-incident pipe. Two of them were placed next to each other leaving no gap between them. The clips were removed after arrival at the laboratory. An example of the removed repair clip is shown in Figure 4a. Where the clips were removed, the top paint layer had the imprint of the pattern from the polymer liners used between the pipe and the clip, see Figure 3a. This suggested either that at the time when the clips were installed, the paint was not fully cured, or that the paint had been softened by chemical reaction/temperature or other external effect during the lifetime of the temporary repair clamps. The coating under the clamps had partially delaminated and stayed attached to the polymer liners when they were removed. Some of the polymer liners had splits in them, presumably due to reaction with the oil/water mixture and/or acidic conditions created by microorganisms, Figure 4b.

Figure 4 a) Temporary repair clip removed from non-incident pipe, and b) Inner side of a pipe clip liner showing split at hole location and pick-up of paint

Temporary repair clips had been installed on the non-incident pipe. The condition of the clips and the size of the holes underneath suggested that they had been in-situ for a prolonged period of time. Some of the polymer liners under temporary repair clips had cracked in the location of the holes.

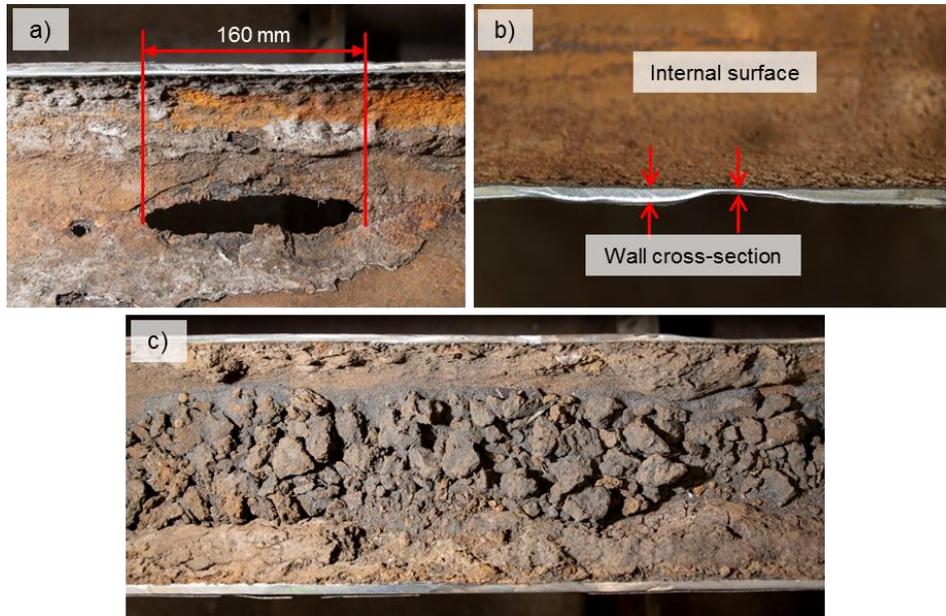
Both pipes were cut in the horizontal plane at the 3 and 9 o'clock positions (giving two half pipes, i.e. upper 180° and lower 180°) to allow observation of the inner surfaces. The examination of the internal surfaces showed the extent of degradation under the temporary repairs. Some of the pin holes on the non-incident pipe caused by internal corrosion appeared only after disturbing corrosion products. The length of the holes reached sizes of up to 160 mm, Figure 5a. Wall thinning was observed

on the incident pipe in the horizontal plane at the 3 and 9 o'clock positions. Wall loss to a thickness of less than 2 mm is shown in the horizontal cross-section of the incident pipe in Figure 5b. Figure 5c shows a presence of large quantities of solid debris inside the incident pipe. The layer of attached and loose product/sediment was approximately 30 mm thick, which would create a significant change in the effective pipe bore diameter and restrict flow.

Figure 5 a) Internal corrosion with perforations on the non-incident pipe, b) A photograph of wall thinning shown on the cross-section of the incident pipe, and c) Solid debris inside the incident pipe

The non-incident pipe had a larger area protected by the remaining paint. The greatest extent of the corrosion was at the 6 o'clock position, which had created an internal groove leading to through-wall perforation of up to 160 mm long. The internal corrosion was accelerated by the presence of liquid hydrocarbon and sea water mixture.

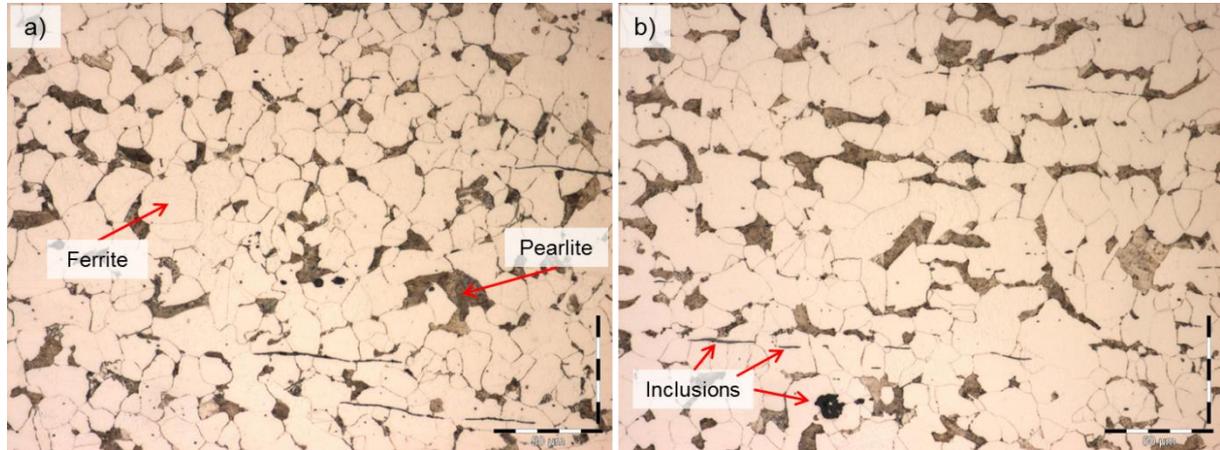
The microstructures of the incident and non-incident pipes are shown in Figure 6a and Figure 6b respectively. Both microstructures consisted of ferrite/pearlite grains in the range between 10 μm and 40 μm . The ratio of pearlite to ferrite was approximately 20%, which is in agreement with the carbon content of 0.15%.

Both materials contained at least two types of inclusions. One type was globular and the other elongated in the rolling/drawing direction. These were not analysed in detail but it is suspected that the elongated inclusions were manganese sulphides and the globular inclusions were oxides, which are typical for this grade of material.

Figure 6 Microstructure of a) incident and b) non-incident pipes

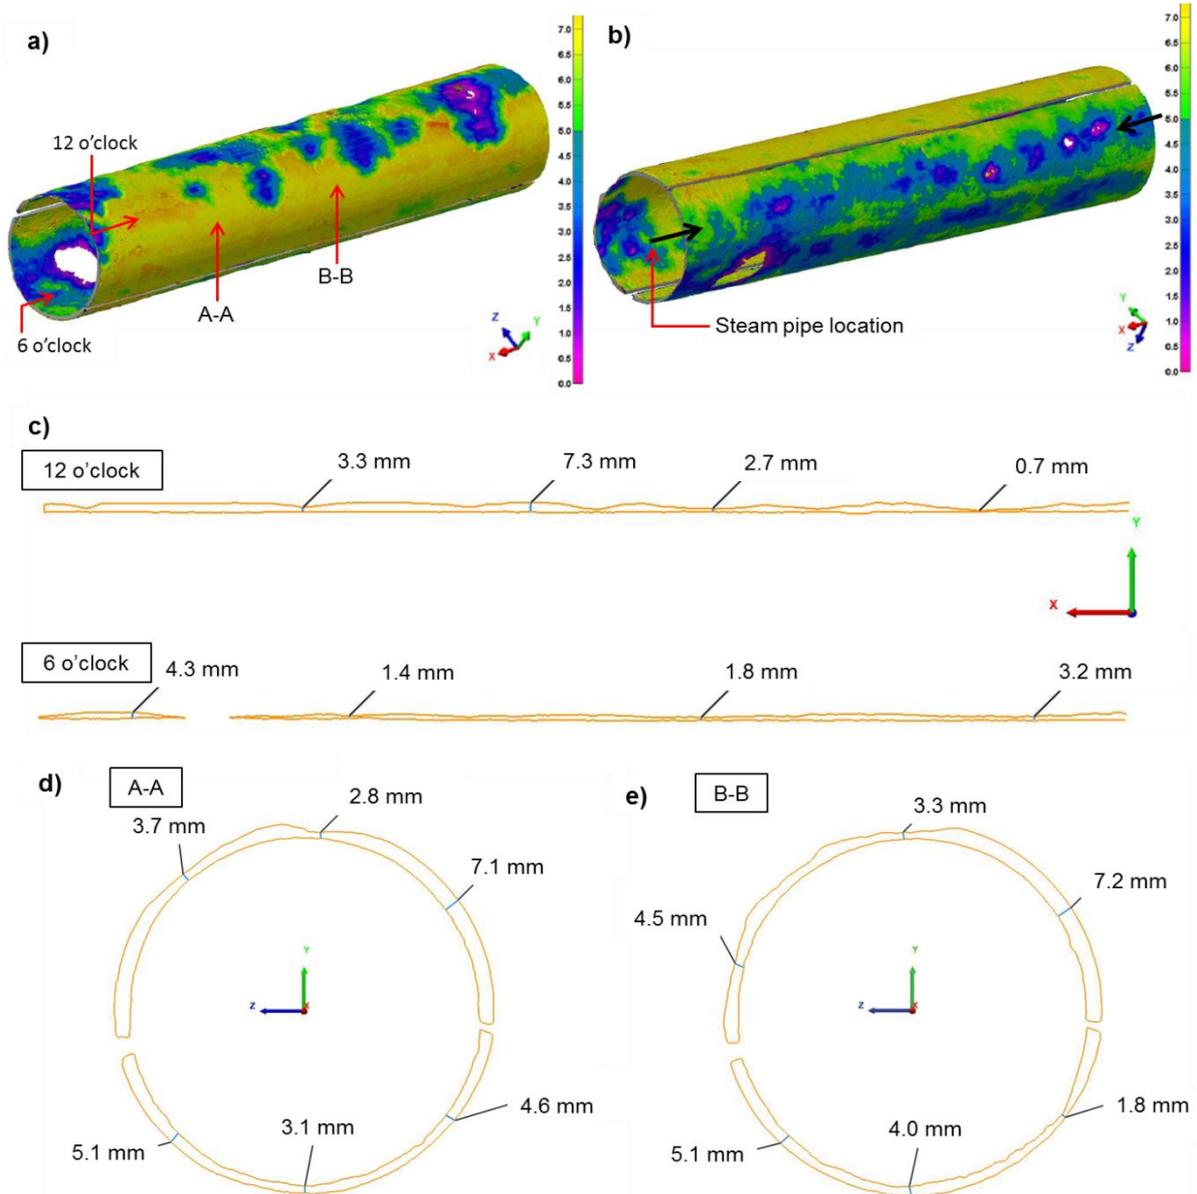
Two sections from each pipe approximately 800 mm long from the upper 180° and lower 180° were laser scanned. Reconstructions of the representative top and bottom sections of the incident pipe after removal of corrosion products are shown in Figure 7. The results were compared with laser scans taken before the corrosion had been removed (not included in this paper). Thickness of the corrosion products was over 12 mm.

The through-wall defect, 73 mm x 55 mm in size, associated with the loss of containment at the position between 6 and 8 o'clock on the incident pipe is shown in Figure 7a and Figure 7b. The area adjacent to the incident perforation showed wall thickness less than 1 mm. Localised wall thinning and perforations were observed at the 4 o'clock position in the axial direction to the pipe axis. This area, marked in Figure 7b with black arrows, was adjacent to the steam heating pipe that had been used on this line under insulation in the past. Additionally, there was significant wall thinning leading to perforations at the location between the 11 and 1 o'clock positions associated with external corrosion.

Longitudinal sections at the 12 and 6 o'clock positions (Figure 7c) and two cross-sections (Figure 7d and Figure 7e) of the reconstructed incident pipe, showed minimal remaining wall thickness of 0.7 mm at the 12 o'clock position of the longitudinal section. The cross-section B-B in Figure 7e showed a remaining wall thickness of 1.8 mm at the 4 o'clock position.

The loss of material was observed locally, i.e. large perforation and pin holes, as well as uniform loss of material at the bottom section. The wall thinning was due to both external and internal corrosion.

Figure 7 a) and b) Reconstructed top and bottom sections of the incident pipe without corrosion products in two different orientations, c) longitudinal sections at the 12 and 6 o'clock positions, d) and e) cross-sections marked in figure a)

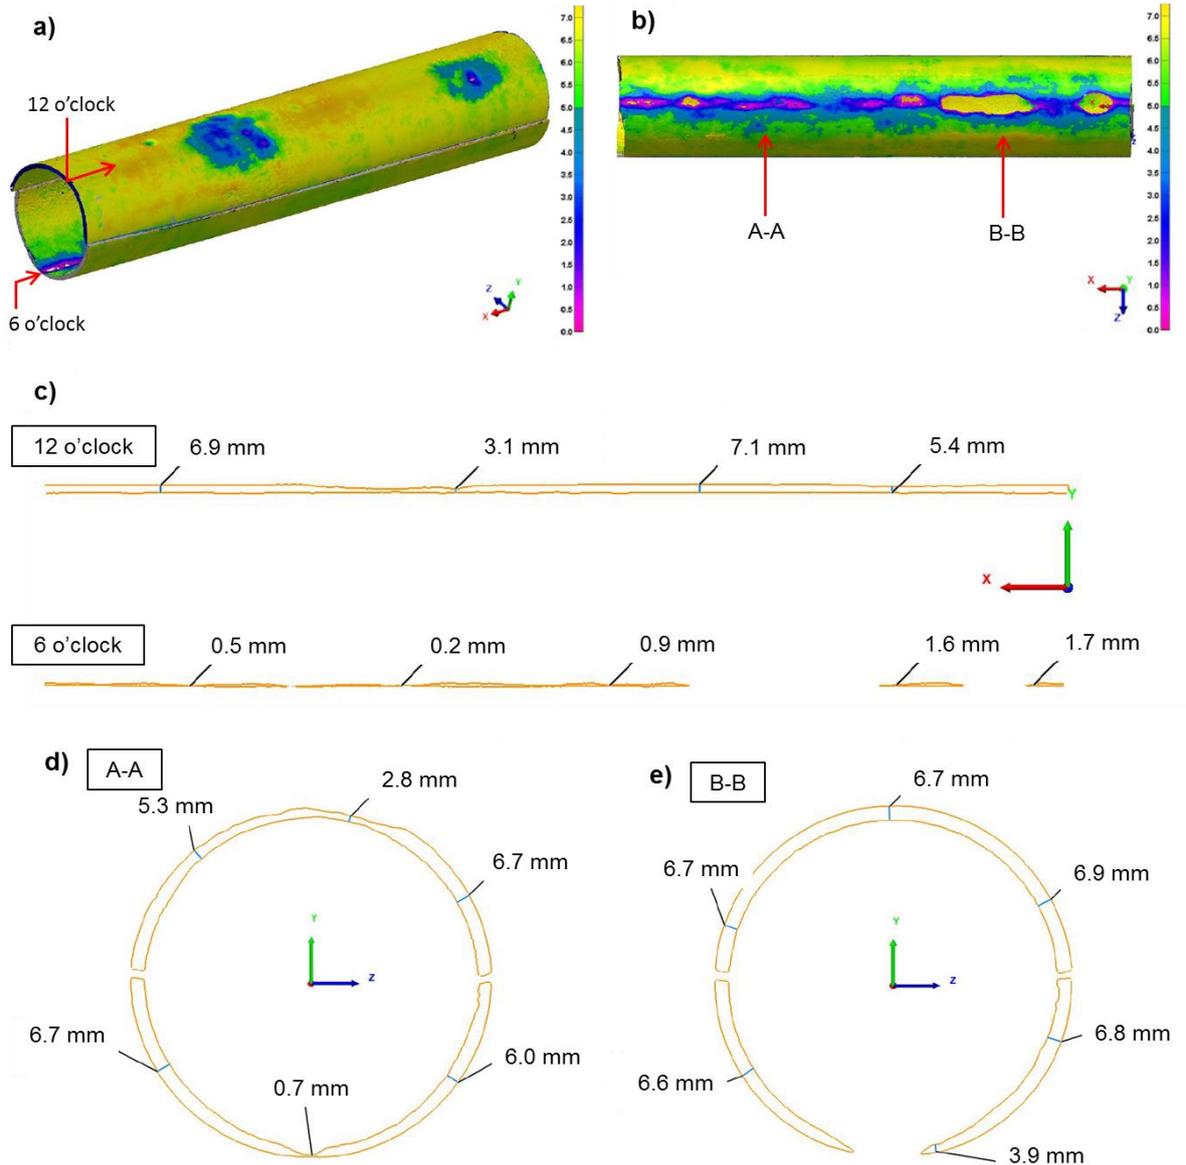
Reconstructions of the representative top and bottom sections of the non-incident pipe after removal of corrosion products are shown in Figure 8a) and Figure 8b). The surface area covered by remaining paint was larger on the non-incident pipe compared to the incident pipe. Therefore, it had better protection against external corrosion compared to the incident pipe. Longitudinal sections are shown in Figure 8c), and cross-sections in Figure 8d) and Figure 8e). The remaining wall thickness measured on the longitudinal section at the 6 o'clock position was less than 2 mm. Holes of size up to 160 mm long and 25 mm wide were present at the 6 o'clock position. These had been covered with the temporary repair clamps. A groove was found at the 6 o'clock position along the whole length of the two laser scanned sections of the non-incident pipe. Additionally, localised areas of material loss were found at the top of the pipe.

Figure 8 a) and b) Reconstructed top and bottom sections of the non-incident pipe without corrosion products in two different orientations, c) longitudinal sections at the 12 and 6 o'clock positions, d) and e) cross-sections marked in figure a)
