Deepwater Horizon disaster

Lauren Averill, Brady Durkin, Michael Chu, Usaamah Ougradar, Alexander Reeves, University of Bradford, UK

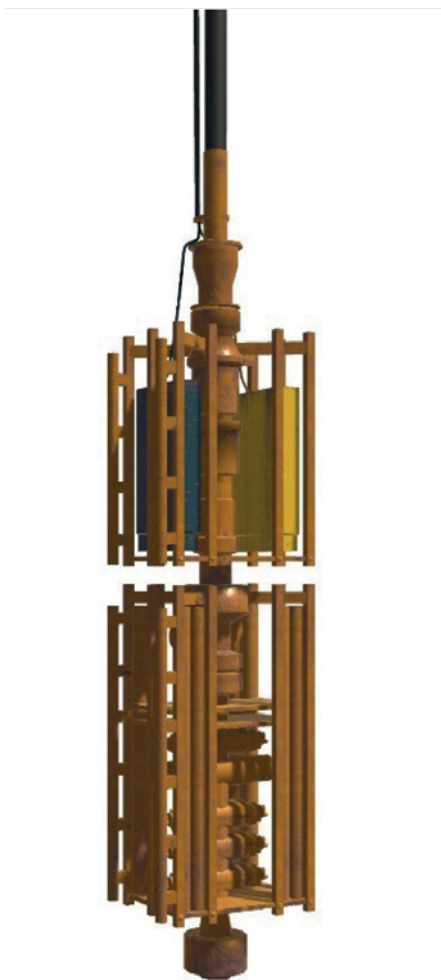
Figure 4 – Model of the BOP

Deepwater Horizon utilised a BOP with two annular preventers and five sets of metal shear rams to cut through the drill pipe in an emergency situation⁸. Due to the lack of preventative maintenance onboard the rig, three out of the four backup systems within the BOP, failed. This was due to defective solenoid valves and low battery charge.

Firstly, the backup system, the AMF (Automatic Mode Function) Deadman, was operated by two control systems known as the yellow and blue pods, comprised of identical enclosed computers and sets of solenoid valves. These pods contained a backup 27-volt and two 9-volt batteries to power the solenoid valves and the computers which activate them respectively. However, evidence indicated that the blue pod had been mis-wired before the BOP was lowered onto the seafloor, causing the 27-volt battery to drain and render it impossible to operate the solenoid valve, in order to activate the blind shear ram²⁰.

Secondly, within the redundant yellow pod, the coils within the solenoid valve were mis-wired causing the coils to oppose each other, which meant the wires were unable to generate a magnetic field, thus leaving the valve paralysed. Only a third, unplanned failure, within the AMF Deadman allowed the yellow pod to operate. One of the 9-volt batteries, used to power the solenoid valves computer, had failed. As a result, the affected computer system could not initiate the command to energise the mis-wired coil and rendered one coil inoperable. This allowed the other coil to open the solenoid valve by itself and in turn, initiated the closure of the blind shear ram²⁰.

Finally, despite the fact the blind shear ram activated, it was unsuccessful at cutting the pipe, due to the large differential pressure otherwise known as 'effective compression'. Although pipes used in oil rigs appear to be perfectly straight, they have minor bends and irregularities, invisible to the naked eye, designed to give the longer side of the pipe a greater surface area. When there are large differences in pressure between the inside and outside of the pipe, the longer side experiences a larger bending force which can buckle even heavy pipes. During the events of Deepwater Horizon, this occurred, and the drill pipe buckled, essentially bending the pipe off-centre pushing sections of the drill pipe outside the reach of the blind shear ram²⁰. This created an insufficient seal of the well, allowing oil and gas to flow up towards the rig, resulting in the second explosion¹⁶. Secondly, the manually activated emergency disconnect sequence (EDS) should also have closed the blind shear ram, and caused a successful closing of the pipe, securing the wellbore. Although the EDS was initiated, and successfully activated the blind shear ram, it was ineffective partly due to the damage to the electrical instrumentation and hydraulic cable from the first explosion⁸, and partly due to effective compression, as the blind shear rams could not seal the well properly. If working correctly, this would have severed the drill pipe riser, sealed the well and completely disconnected the rig from the BOP.
