Failure of a 30 inch diameter oil pipeline due to atmospheric corrosion

Birkitt Keith, Science Division, Health and Safety Executive, UK

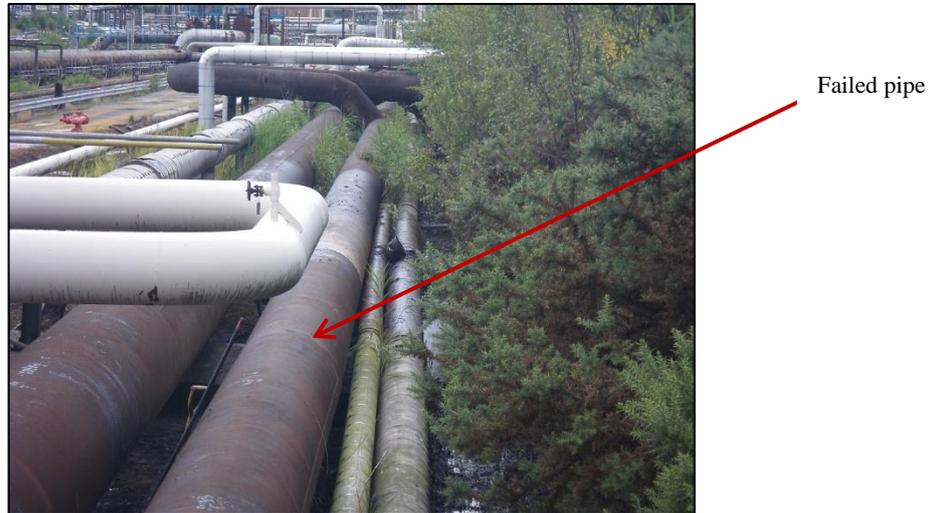
The failed pipe is shown in-situ in Figure 1.

Figure 1 Location of incident and non-incident pipe sections

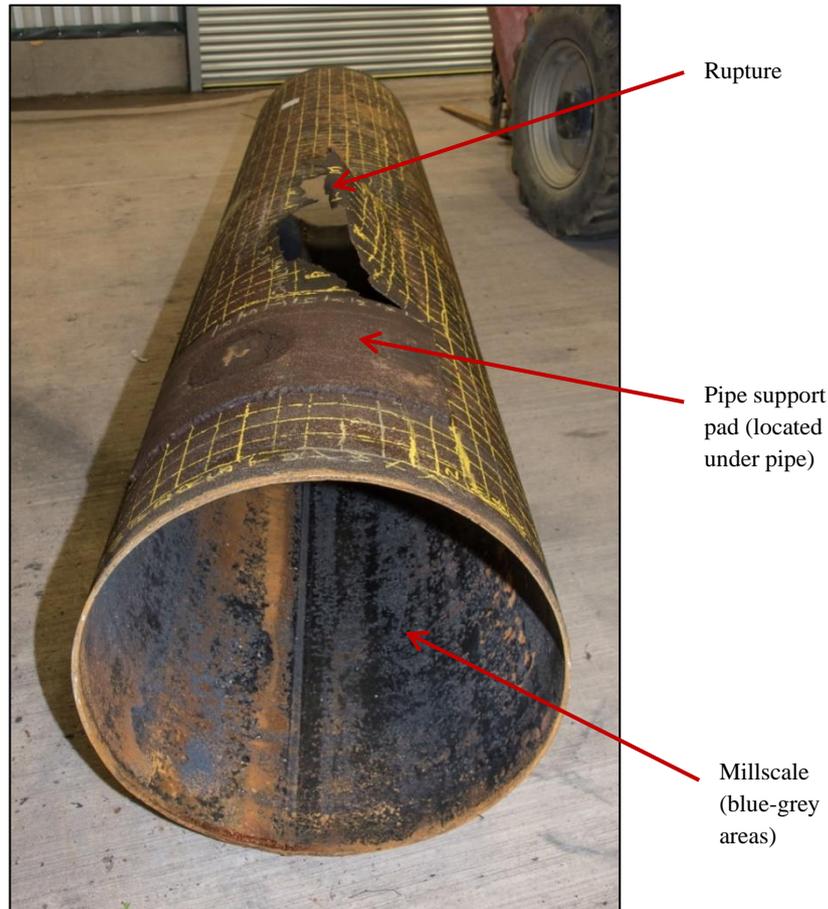
The pipe had failed on the underside as shown in Figure 2. The failed pipe section shows minimal protective paintwork and general corrosion of the external surface, Figure 3. The fractured region appeared to be considerably thinner than the general wall thickness, which was approximately 9.5 mm thick. The internal surface of the pipe showed minimal corrosion and the original mill scale from the manufacturing process was still clearly visible, Figure 2. On closer inspection a number of small perforations of the order of a millimeter in diameter were visible.

Figure 2 Failed pipe section as received. Note: pipe is shown upside down

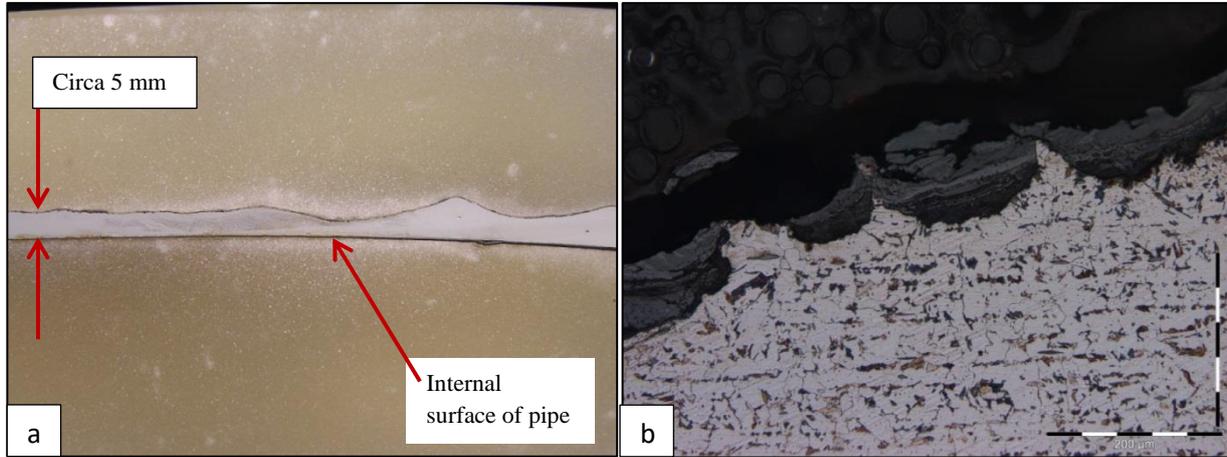
The metallographic section remote from the failure revealed external thinning, Figure 3a, with evidence of shallow pitting corrosion, Figure 3b. The microstructure of the pipe consisted of ferrite with small islands of pearlite, consistent with the chemical analysis.

Figure 3 Metallographic sample remote from the failure showing general thinning (a) and external surface corrosion pitting and ferrite/pearlite structure (b)

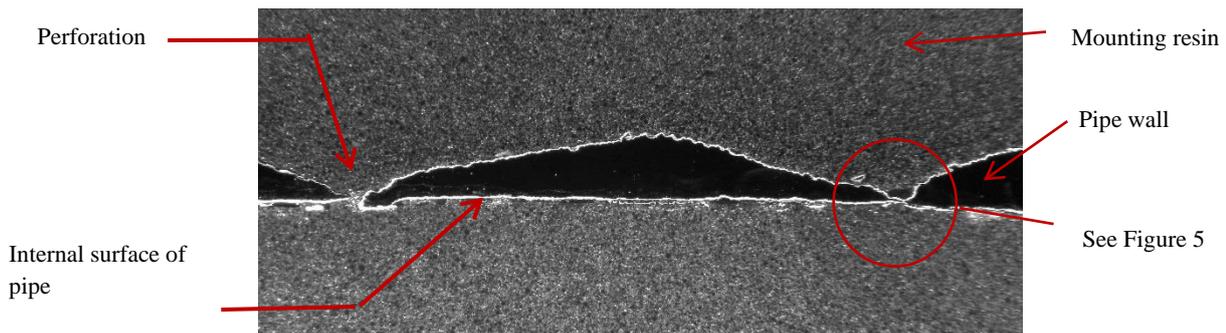
The metallographic section through the failure region revealed a perforation through the wall, Figure 4, and an adjacent area of wall thinning that measured 0.04 mm, Figure 5. The measurement was made using a Mitutoyo traversing microscope with calibrated micrometer scales.

Figure 4 Metallographic section through failure region showing wall thinning away from the burst. The left-hand thinned region has perforated the wall and the right-hand thinned region is 0.04 mm thick.

A few millimetres away from the rupture, the pipe wall thickness was approximately 1 mm. At the point of fracture the wall thickness was well below 1 mm. On a metallographic cross section adjacent to the fracture, a section of wall was measured and found to be 0.04 mm. The area of the very thin wall at this location was quite small and was surrounded by thicker material. Examination of the fracture surface showed it to be a ductile shear failure with a small region of ductile tensile failure, caused by a localised overpressure as a result of wall thinning.

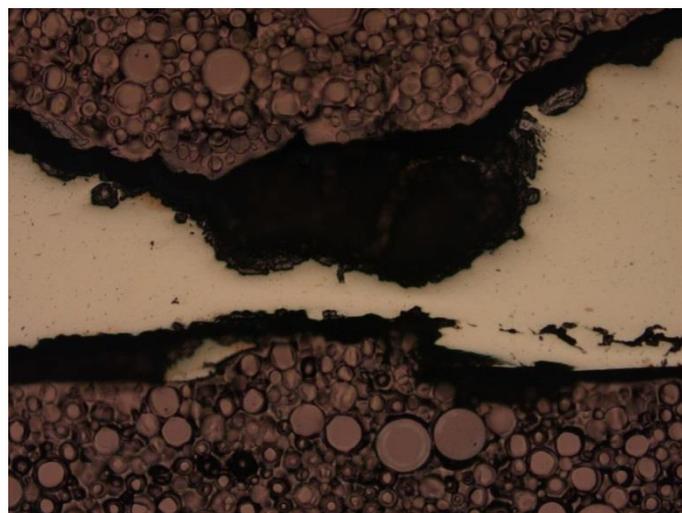
Figure 5 Metallographic section of area circled in Figure 4. Approximate magnification $\times 100$

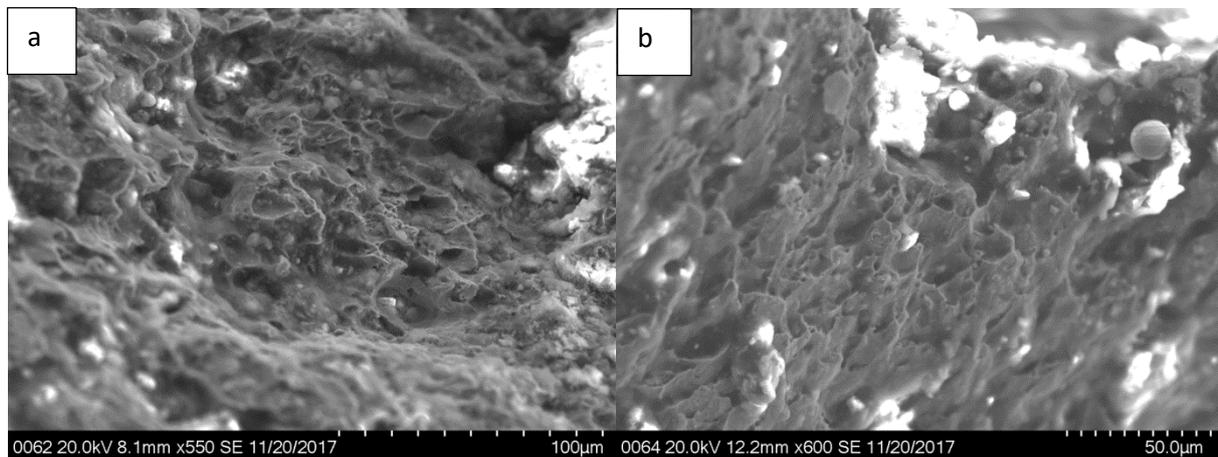
Approximately 200mm of the fracture was cut from the ruptured area. This sample was then cut into three pieces and was examined in the scanning electron microscope (SEM). Although the fracture surface was corroded, areas of micro-void coalescence and elongated micro-void coalescence, Figure 6, were visible indicating that the failure mode was ductile tensile overload and ductile shear.

Figure 6 Micro-void coalescence on fractured pipe wall (a) and elongated micro-void coalescence on fractured pipe wall (b)

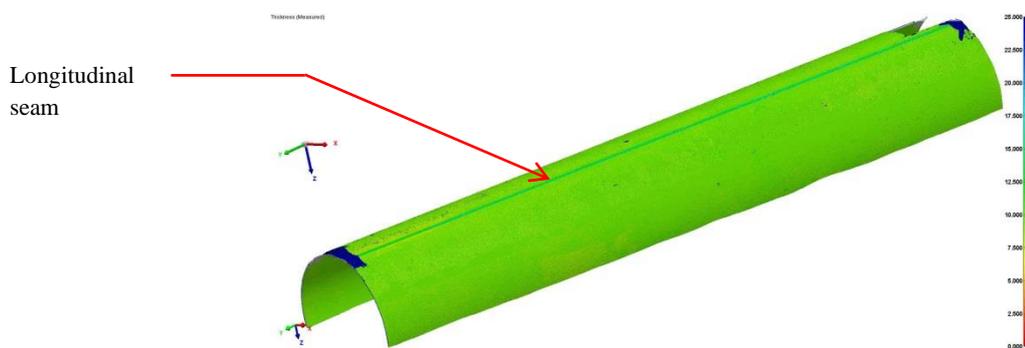
The colour profile maps clearly show that significant external thinning of the pipe wall had occurred at the 4 to 8 o'clock positions with the greatest wall thinning to less than 2.5 mm at the 5 to 7 o'clock positions. The line scans show significant external wall thinning to less than 2 mm away from the burst. In the vicinity of the burst, the scans indicate that thinning to less than 1 mm had occurred. On one of the longitudinal line scans, adjacent to the burst, an area of wall thinning was measured and found to be 0.4 mm, which corresponds to the approximate location of the pin holes observed.

Figure 7 Laser scan colour profile map of topside of pipe showing longitudinal seam and uniform thickness

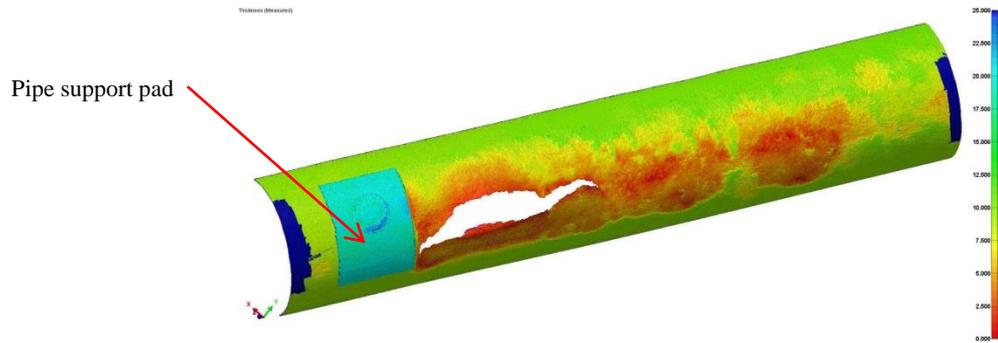
Figure 8 Laser scan colour profile map of underside of pipe showing thinning in yellow, orange and red

The pipe appeared to have had an original wall thickness of approximately 10 mm. Laser scanning revealed large areas of significant external wall thinning on the underside of the pipe between the 4 and 8 o'clock positions. The greatest wall thinning, below 2.5 mm, was evident at the 5 to 7 o'clock positions. Examination of the pipe in-situ and examination of the sample retrieved showed that the pipe was largely un-painted, or rather that the original paint layer had weathered and corroded away.

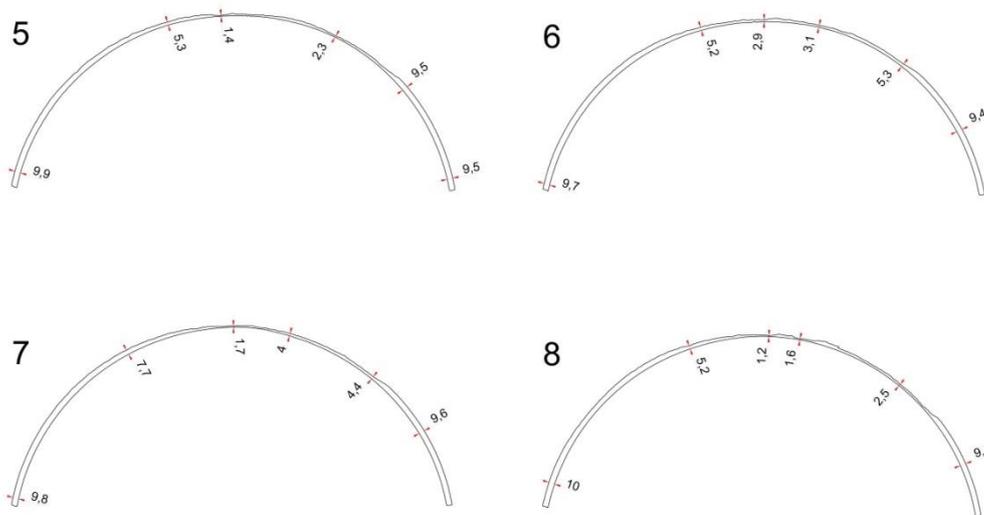
Figure 9 Example of laser line scans of lower half of pipe away from burst
