## Caribbean Petroleum VCE Case History

Q.A. Baker, J.K. Thomas, D.R. Malik and M.T. Edal, Baker Engineering and Risk Consultants, Inc., 3330 Oakwell Court, Suite 100, San Antonio, TX 78218-3024 USA

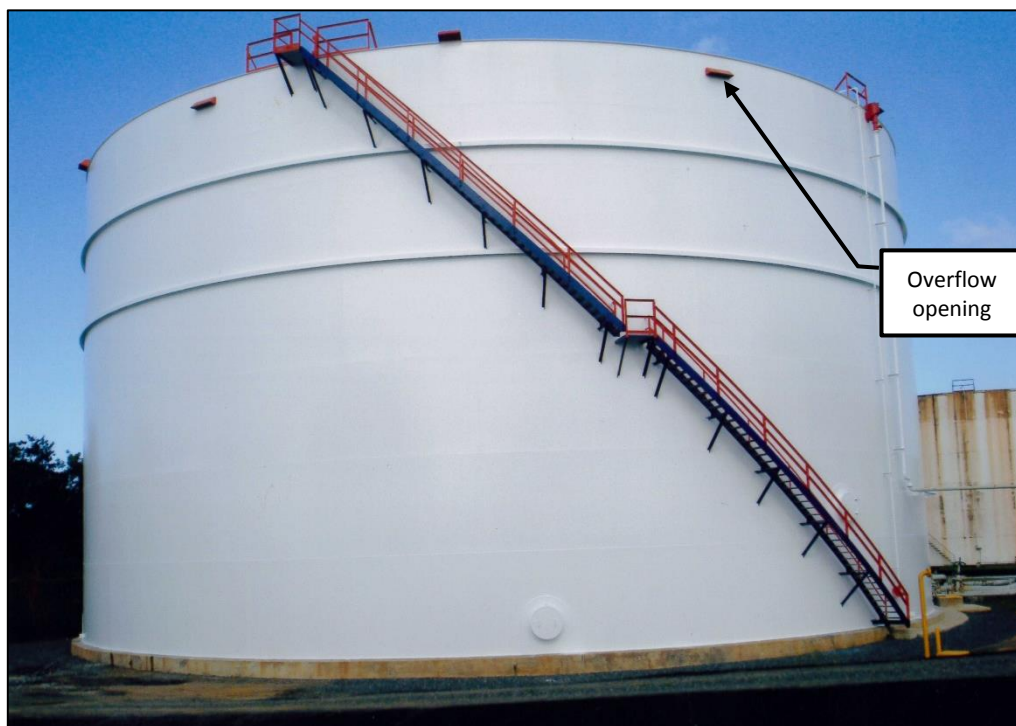
Figure 4. Tank 409 Photograph

Tank 409 was one of the newer tanks at the CAPECO facility. It was built in 2006, three years before the accident. The tank was 120 ft diameter and 63 ft high with a nominal capacity of 120,000 bbls. The tank had an internal floating roof. Figure 4 is a photograph of the tank taken at completion of construction. Visible in the photograph are two of the six overflow openings, each of which was 3 ft wide by 9 inches high.

Gasoline overflowed from the six overflow outlets arranged around the shell of Tank 409 about 60 ft (18.3 m) above grade (see Figure 4). The tank also had two wind girders that protruded 8 inches (20 cm) from the shell, fabricated from 8 inch × 6 inch (20 cm x 15 cm) angle steel with the open side of the angle facing down.

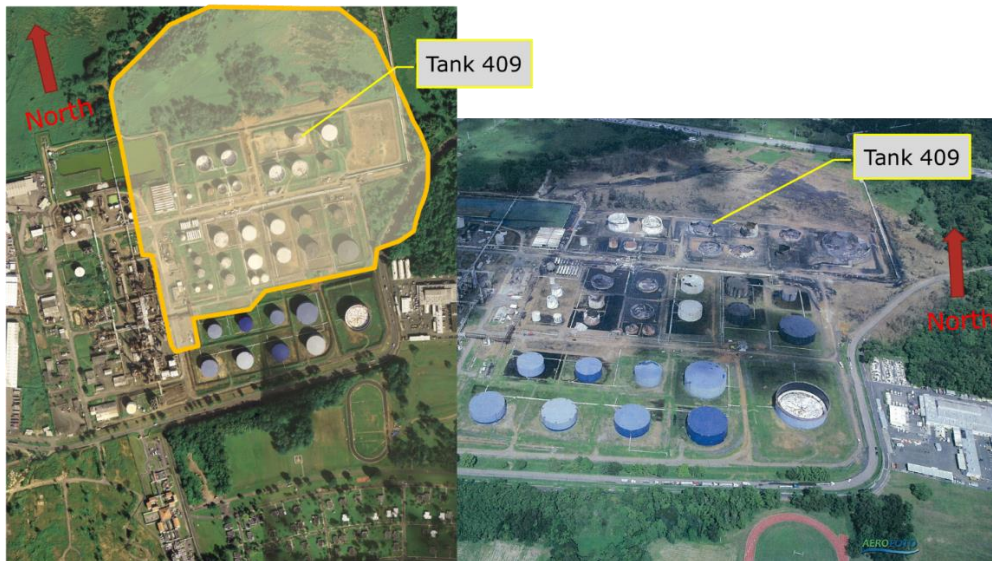
Figure 5. Flammable Cloud Overlaid on Before Photograph and Compared to After Photograph

The flammable cloud formed by a combination of gasoline vaporization and mist formation from falling gasoline impacting surfaces (i.e., tank wind girders, ground, etc.) and atomizing in air. The momentum of the vapors and mist carried the cloud outside of the dike. In the calm wind condition, the denser-than-air cloud spread in all directions from the tank, generally following the topography downhill.

The flammable cloud was about 1,000 ft (330 m) in diameter, and generally centered on Tank 409. Based on observed damage to vegetation and analysis of surveillance videos, the flammable cloud area was roughly 3 million ft<sup>2</sup> (70 acres, 0.3 km<sup>2</sup>).

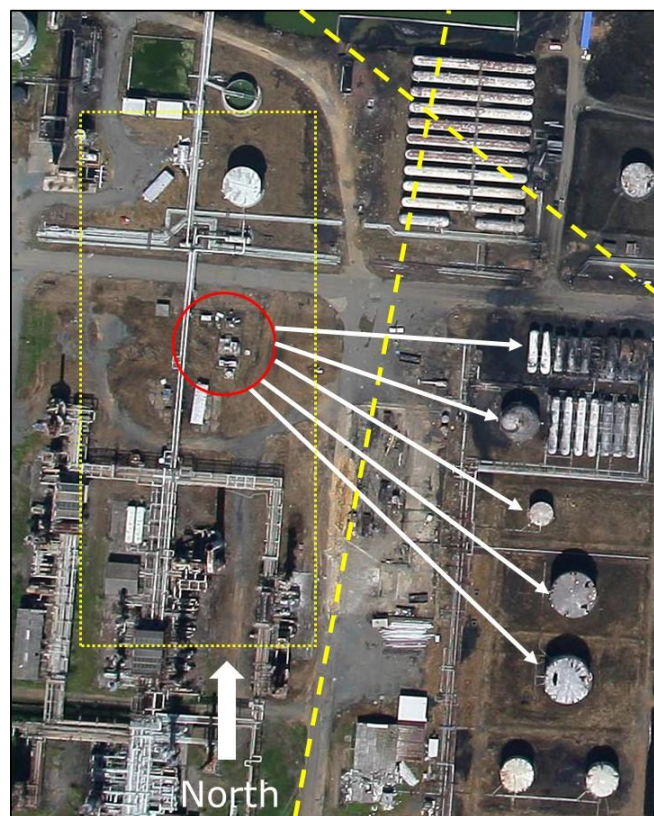
Figure 6. Location of Ignition Source

Ignition occurred about 34 minutes after Tank 409 began overflowing. The initial ignition source was on the western fringe of the flammable cloud, as depicted in Figure 5. CCTV cameras were located at northwest corner of the site (rotating) and on a column in the refinery (fixed). The ignition of the vapor cloud was not captured directly by either CCTV camera. However, the general location of the ignition source was deduced by examining CCTV footage and noting the object (e.g., tanks, vessels, etc.) surfaces that were first illuminated. This allowed the general area of the ignition source to be isolated to the dotted rectangle shown in Figure 6; the edges of the site lines for each CCTV camera are denoted as yellow lines in this figure. The most likely ignition area based on the reflections is shown as a red circle in Figure 6. The only identified potential ignition source within this circled area is an electrical equipment enclosure that housed pump switch gear, which is shown Figure 7. The white arrows in Figure 7 show the direction of illumination of the tanks from ignition at the electrical equipment enclosure. The metal panel siding for the enclosure was blown off the enclosure frame, consistent with flammable vapors entering the enclosure and being ignited within.

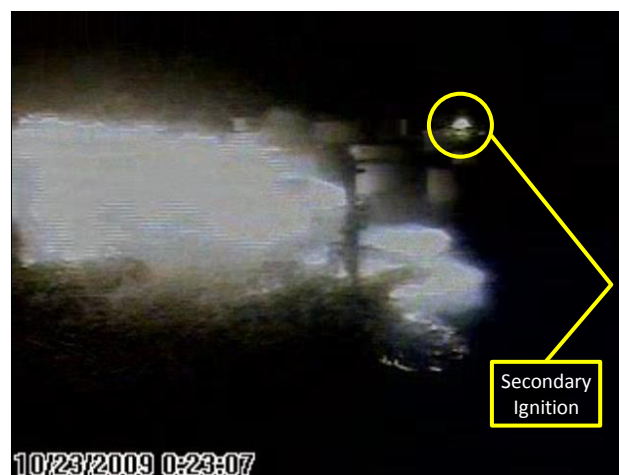
Figure 8. Frame from CCTV Showing Secondary Ignition

A secondary ignition is evident in the CCTV video roughly to the southwest of Tank 107 (i.e., flame appears in this area ahead of the main flame front), as shown in Figure 8. The hypothesis that this secondary ignition was a flame propagating through a sewer and jetting from a sewer opening southwest of Tank 107 was investigated in cooperation with the CSB. However, the only nearby storm sewer opening was a sump that always had standing water controlled by a level switch to keep a submersible pump submerged. In order to have reached this opening, the flame had to have been forced to propagate in the upstream direction through a check valve and the flooded pump. Inspection of this equipment did not indicate damage consistent with internal flame propagation. Process sewer pipes were also investigated and found to be liquid filled with no indications of internal blast pressure loading. The hypothesis of a flame jet originating from a sewer was therefore not borne out. Also, careful triangulation of the video placed this secondary ignition in line with an electrical equipment enclosure, not a sewer opening. The electrical equipment enclosure is shown in Figure 9. The panels forming the enclosure were all displaced in a manner consistent with internal pressurization; the circled items in Figure 9 are sections of this enclosure.
