## Evangelos Florakis Naval Base explosion

Roger Stokes, BakerRisk Europe Ltd, UK

## Summary

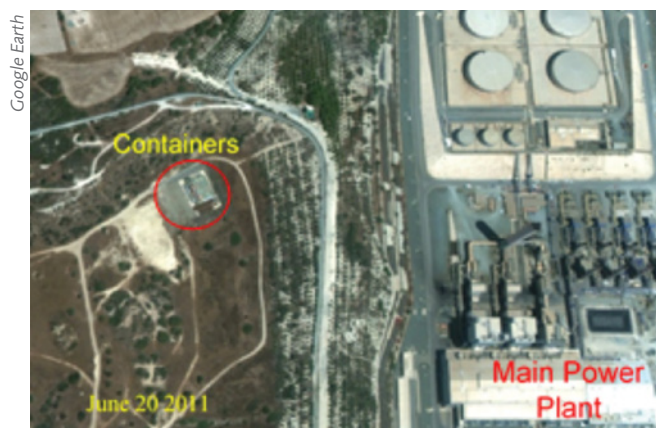
In total, 98 shipping containers were removed and stored in the open, towards the north-west corner of the naval base, piled three high. They were located some 300 metres from the main building at the adjacent power plant (see Figures 3 and 4).

Figure 3– Aerial close-up showing containers

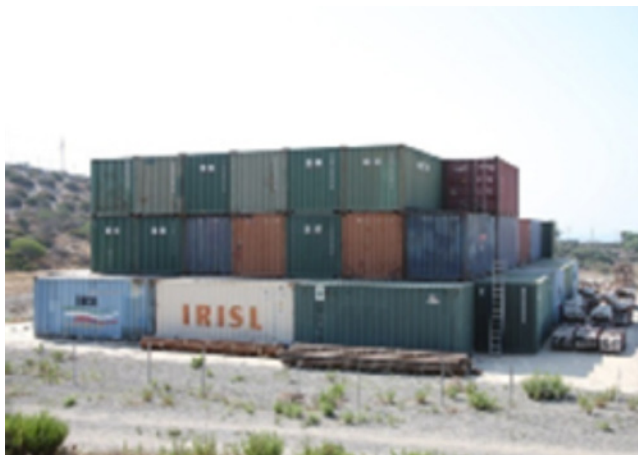
Figure 4 – Close-up showing containers

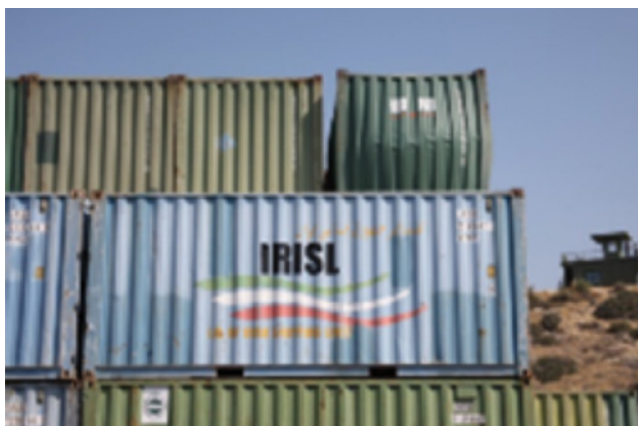
one of the 98 containers, located at the top south-east corner, was deformed. This was reported to the base Commander and the Ministry of Defence who held a meeting on 5 July 2011. On 6 July 2011, a group inspection of the containers took place and photographs were taken (see Figures 5 and 6).

Figure 5 – Deformed container 5 July 2011

Perhaps the most significant factor with this case study is that it was known that the material was explosive and required careful handling. The issue had been raised several times but was not dealt with for over 2½ years. The "inflated" container that was noted and inspected a week before the incident was a clear precursor to the main event.

On 7 July 2011, the Chief Expert prepared a safety report, with recommendations including the destruction of the explosives.

On 8 July 2011, the containers were drenched with water from a firefighting vehicle.

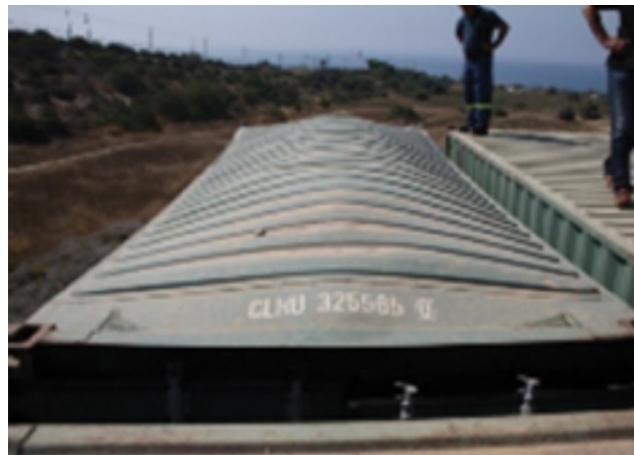
Figure 6 – Deformed container 5 July 2011

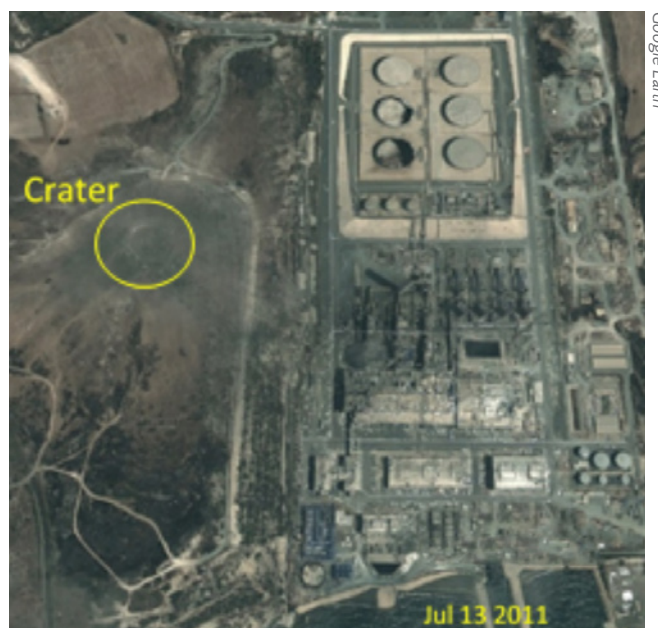
The adjacent Vassilikos Power Plant was severely damaged due to the blast wave and the debris from the containers and the munitions that rained down on the facility. The plant immediately shut down, causing rolling power blackouts across the island for many weeks.

A large crater shows where the containers were located (see Figure 7) and the damage to the power station, oil storage tanks and infrastructure can be seen from the historic Google Earth satellite imagery.

Figure 7 – Aerial photo 2 days after incident

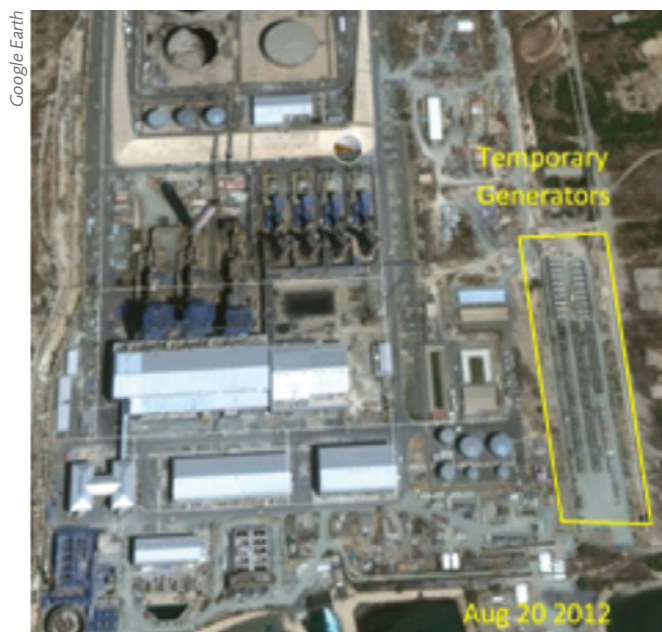
The rolling blackouts continued for several weeks until Greece provided portable generating capacity of 70 MW via a package of 129 heavy containers<sup>2</sup>. These were transported by the end of July and a temporary generating farm was installed to supplement the nation's supplies whilst repairs to the power

Figure 8 – Temporary Generators

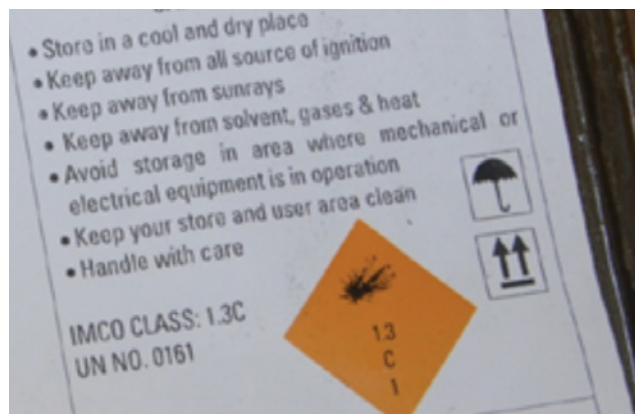
A hazard label from one of the containers inspected (see Figure 9), shows that a particular item was a class 1.3 explosive, which does not have a mass explosion hazard; however, it is understood that the cargo did not undergo a full survey. Furthermore, any deterioration of the explosives, which most probably occurred due to the inadequate storage arrangements, would tend to decrease its stability as was clearly demonstrated by the deformation of one of the containers. Whilst this issue was recognised and samples were eventually taken, analysis was not conducted.

Figure 9 – Hazard label on one of the items
