Incident

Series of mass explosions in a fireworks plant

Fausta Delli Quadri, ISPRA, Italy

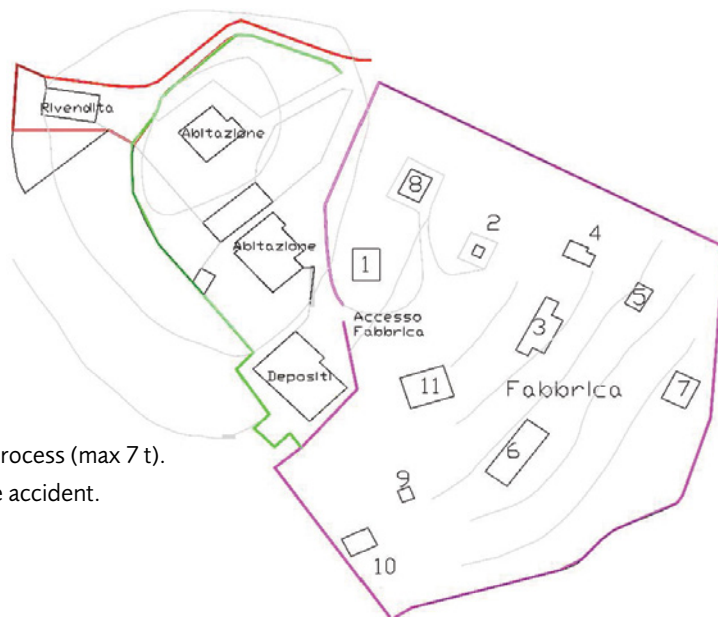
Figure 1 – Layout of the plant

1. Unclassified products storage (products that do not fall under the Italian regulation on explosives storage and production)
2. Black powder storage (max 500 kg)
3. Fireworks laboratory
4. Products storage (max 4 t)
5. Products storage (max 9.6 t)
6. Mixing
7. Colours and various material storage
8. Products storage (max 9.6 t)
9. Engines installation
10. Coal crushing
11. Semi-finished products storage under authorization process (max 7 t).
This building was not yet authorised at the time of the accident.

in the plant was involved. Seven of the eleven buildings were destroyed (buildings no. 2, 3, 4, 5, 6, 7, 8). The other buildings were partly damaged (buildings 1, 9, 10 and 11). Figures 2 and 3 shows some of the damage.

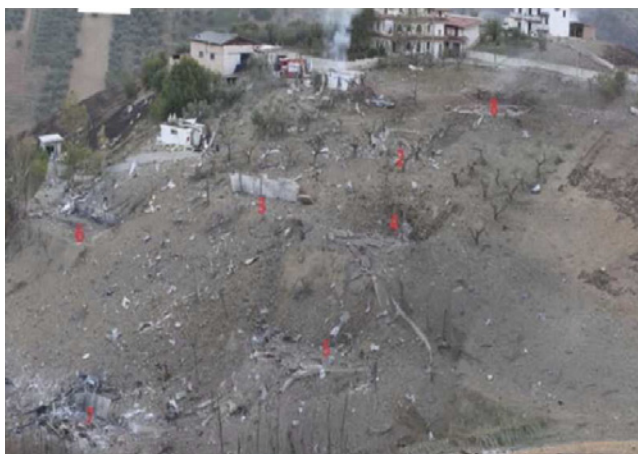
Figure 2 – The remains of the plant after the accident

hampered firefighters' efforts. The inappropriate location of the watchman's and operator's family houses in the immediate vicinity should also be noted (visible in Figures 2 and 9), with both buildings suffering substantial damage.

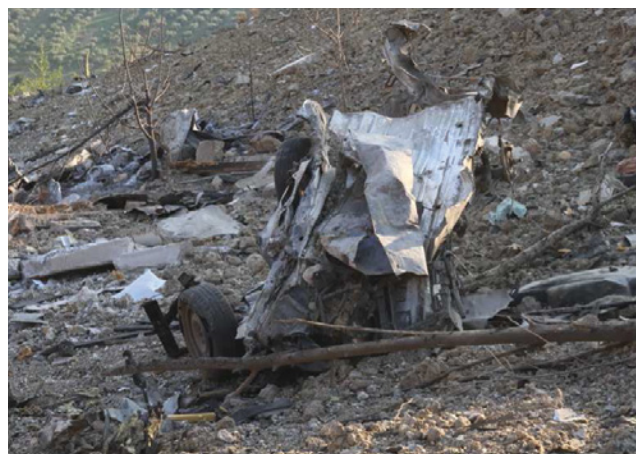
Figure 3 – The remains of the pick-up truck

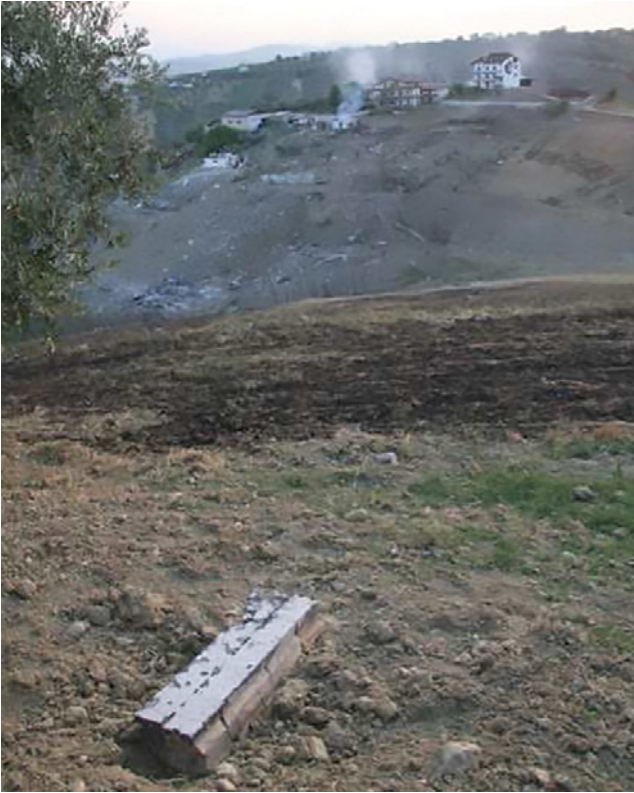
Figure 4 – Piece of concrete found more than 900 m away from the plant

almost the entire establishment. The blast waves caused damage to several buildings (houses, church, factories,...) within a 500 m radius. Debris was projected up to a radius of 1 km (Figure 4). In total, the accident caused an estimated financial loss of 1.5 million euros.

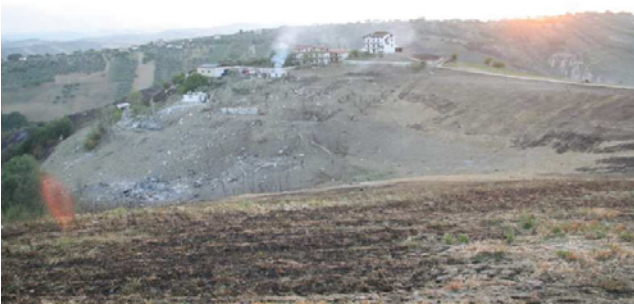
The accident generated a sequence of fires in the rural/natural area surrounding the plant (in a 500 m radius) (Figure 5), and a large cloud of gaseous products (including toxic substances) was observed after the explosions (Figure 6).

Figure 5 – Fires in the area around the plant

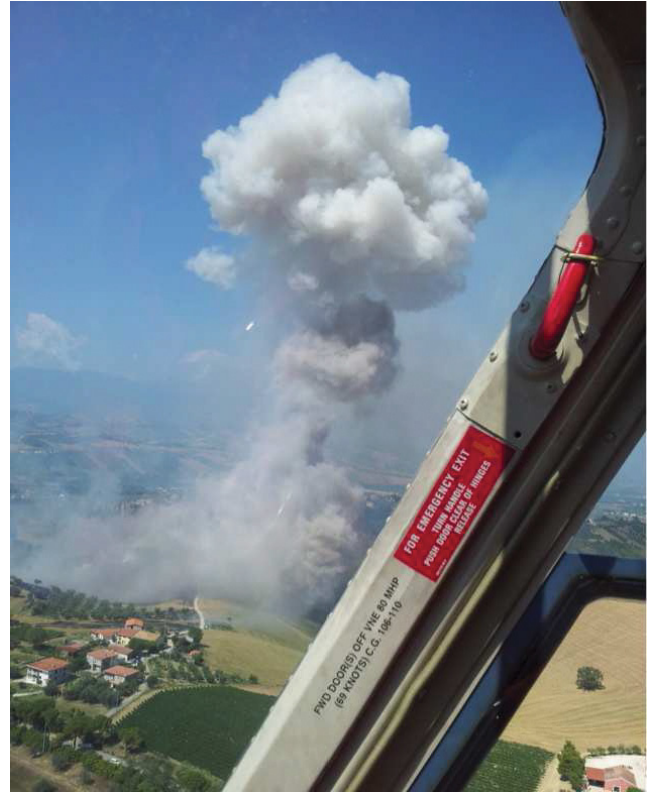
Figure 6 – Toxic cloud emitted to the atmosphere

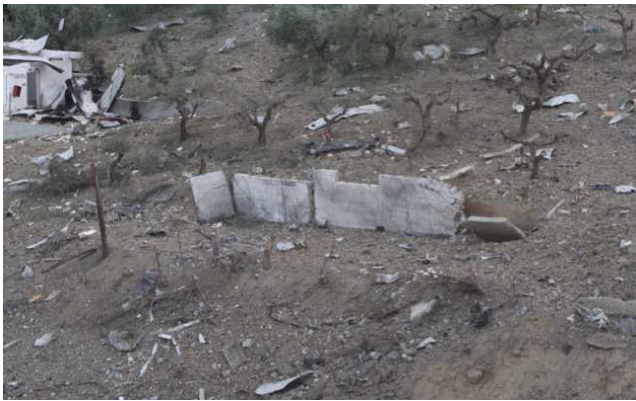
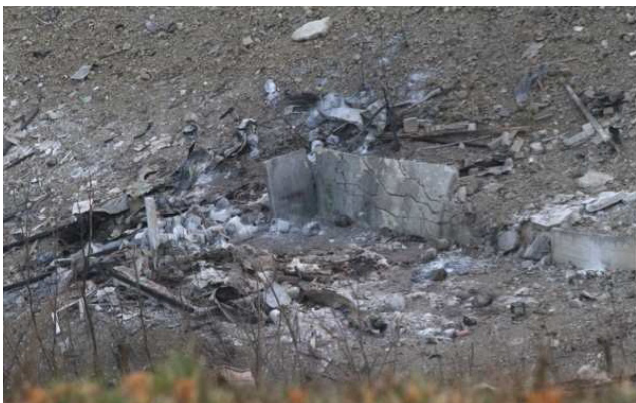
Figures 7 and 8 – Damage caused to the buildings and their protection walls

Last but not least, it would appear that the construction of the roofs of the depots was unsuitable, with debris from the roofs leading to a fatality.

- **Use of adequate construction materials (for example for the roofs of the buildings), in order to avoid increased human consequences in case of an accident.** Construction of the roofs of depots for explosive materials should be such that to avoid any subsequent injuries or domino effects. Where the whole construction is not blast proof, it is common practice to have roofs made of light materials which are then anchored by chains. The roof is not permanently bonded with the walls and in the event of an explosion the lifting of the roof acts as a pressure relief.

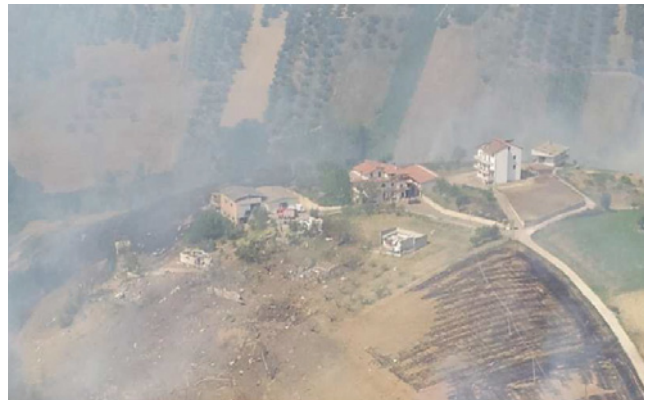
Moreover, a domino effect occurred in building no. 8 40 minutes after the first explosions. As shown in Figure 9, building no. 8 had already been damaged by the first blast wave. The

occurrence of a domino effect leads to the conclusion that there might have been more quantities and different qualities of explosives stored in the plant. Furthermore, 20 days after the accident, an additional amount of black powder (0.2 t) was discovered in a small disused building located outside the establishment, next to the south part of the fence.

Figure 9 – View of the plant after the first series of explosions
