Incident

Lessons for the Seveso Directive from Longford Australia

G D Kenney, M Boulton, R M Pitblado, DNV, London, UK

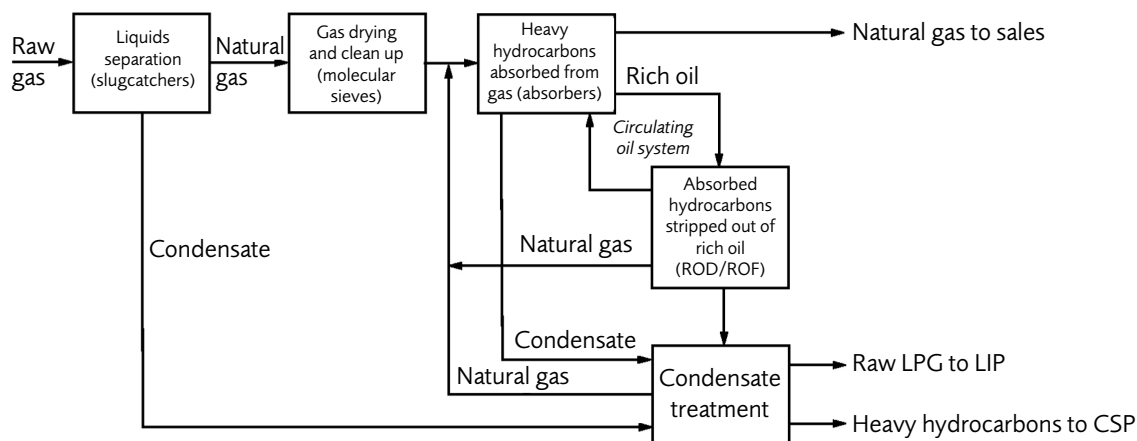
Figure 1: An overview of the GP1 unit

A simplified overview of the GP1 Unit is given in the block diagram in Figure 1. The event occurred within the Circulating Oil System in this figure.

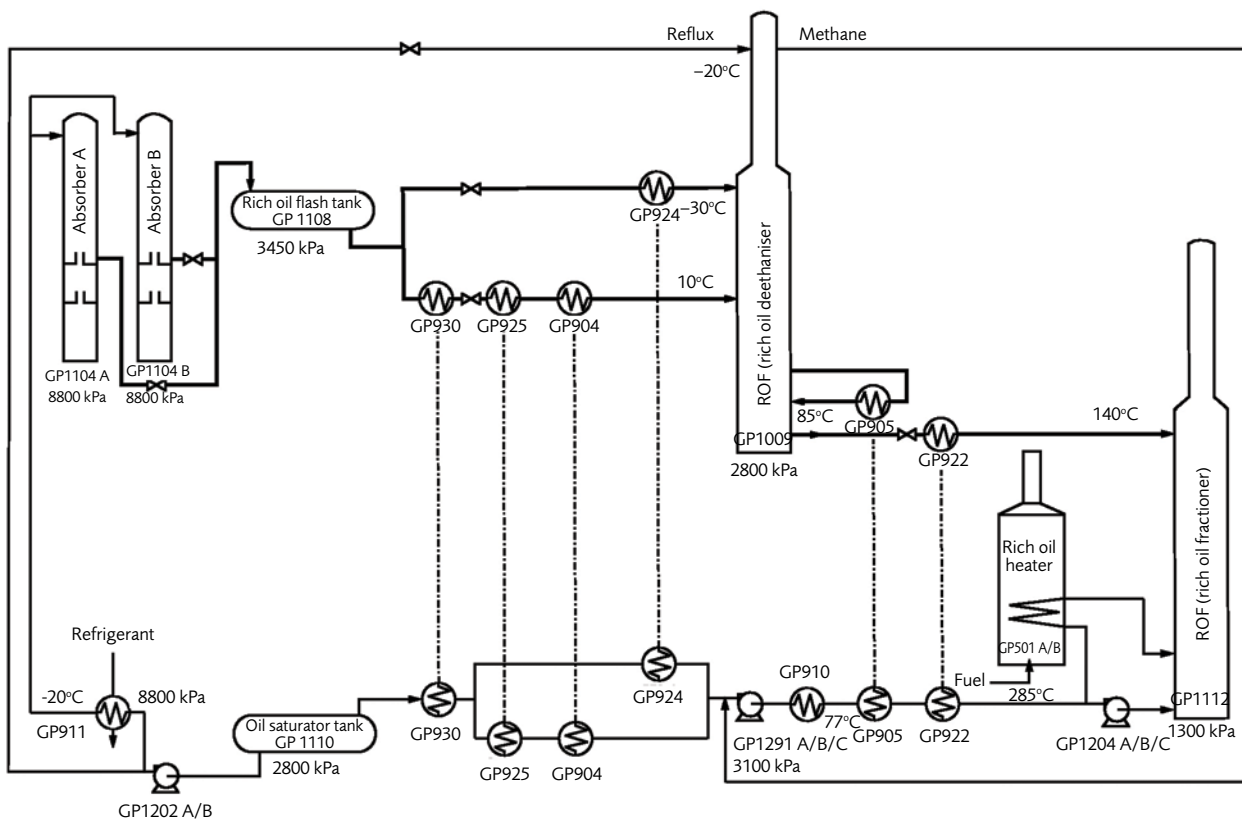
Figure 2: Process flow diagram of absorber oil recirculation loop

One of the vessels involved was GP905. The reduction in temperature of that vessel caused the embrittlement of its steel shell. When hot lean oil was re-introduced into the vessel it ruptured by way of brittle fracture at its eastern end, releasing a volume of hydrocarbon vapour which travelled towards the area of the fired heaters where it ignited, causing an explosion and fire.

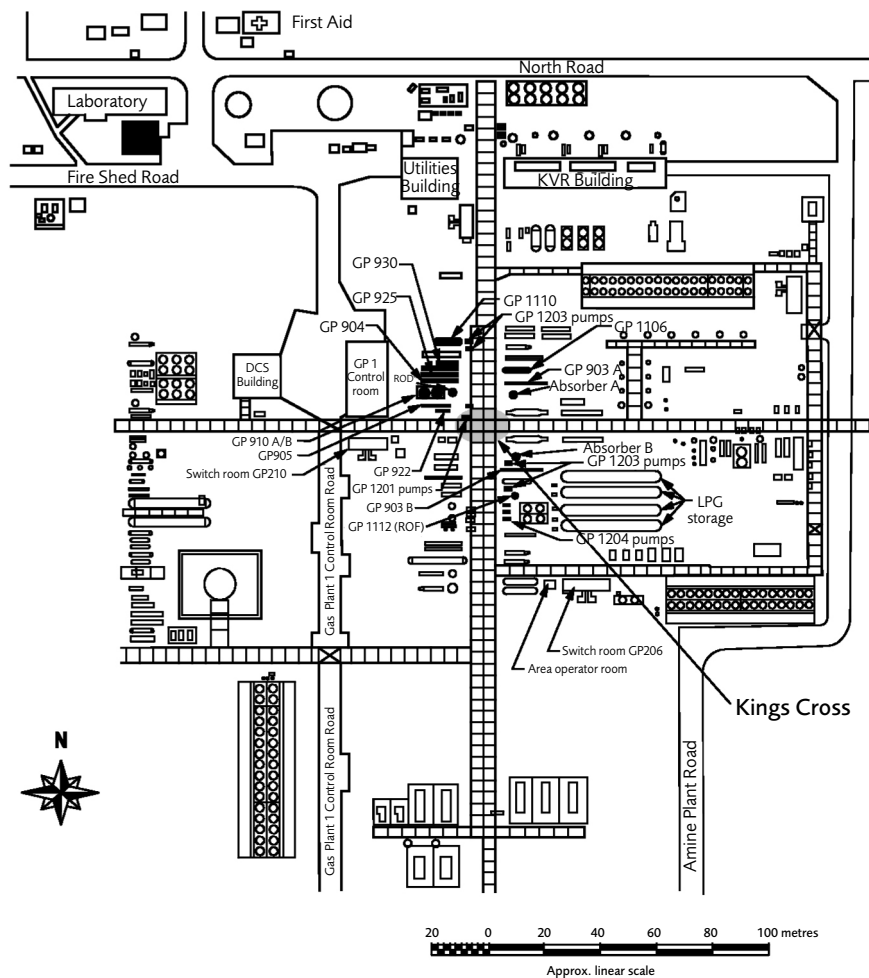
Figure 3: Plot plan around GP905 and King's Cross junction

The south-south easterly drift of the vapour cloud from the ROD/ROF area was towards the general direction of the gas-fired heaters, located approximately 170 metres away at the southern boundary of the plant. It would have taken in the order of 30-60 seconds for the cloud to drift this distance.

A major problem for the Esso operating staff was to isolate the many pipes passing through this critical junction of pipe racks. The GP905 exchanger was 5-10m from this junction (see Figure 3). The total isolation of the pipes feeding the fire required nearly 2½ days. This was due to major interconnections between the three gas plants. The Commission reported ... *Geoff Evans, a (Country Fire Authority) operations manager, was concerned about the ad hoc nature of the isolation of fuel sources. At 2.30 pm on Saturday 26 September, he had a discussion with Mick Brack, an Esso acting operations superintendent. He asked Brack for a detailed plan of the plant's pipework to assist the IMT in identifying which valves should be isolated to stop the flow of fuel to the fires. Brack said that he did not have a plan available and that in any event, the Longford plant was a hybrid, having had its original design modified on a number of occasions, so that a plan, even if one could be located, might not have been of much assistance.*
