# Seven minutes to failure — the Tosco hydrocracker runaway

Ramin Abhari, P.E. & H. Lynn Tomlinson, P.E., USA

## Summary

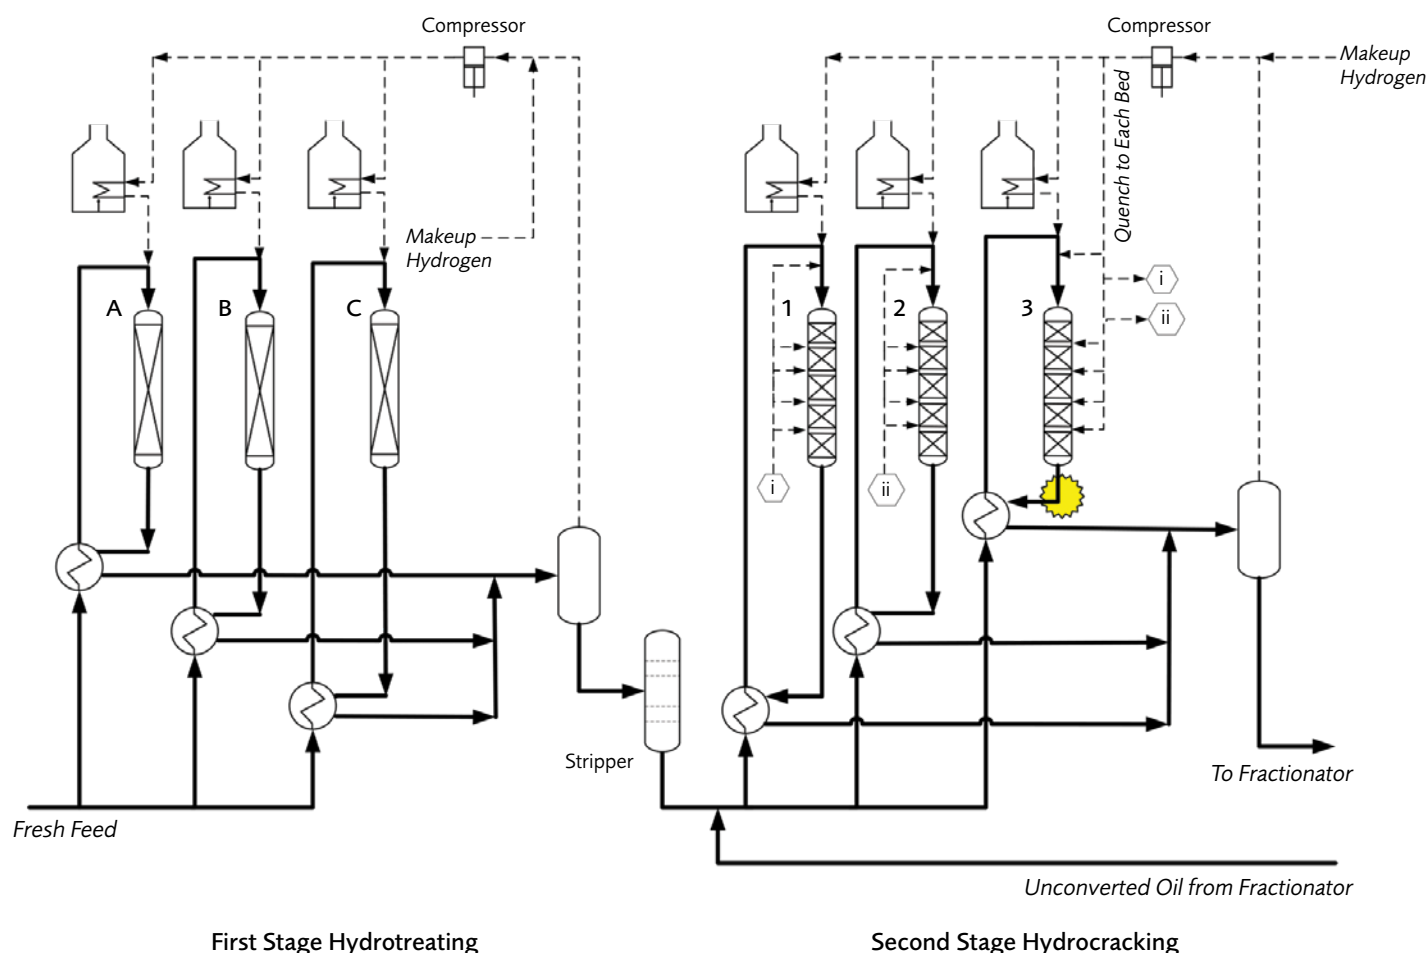
Figure 1 – Simplified process flow diagram for the Tosco hydrocracker with the location of the pipe rupture highlighted.

At 7:41, the 12" outlet pipe on Reactor 3 ruptured. The explosion that immediately followed killed the operator who was sent there to read the temperature.

First, EDS needs to be automated as an Independent Protection Layer with all the requirements an IPL entails. It took only seven minutes from the time the temperature started to rise (from what was thought to be a deactivated catalyst state) until the explosion. This is too short of a response time for reliable operator action.

During a reactor temperature excursion, no one should be around the reactor. All instrumentation for monitoring the reactor needs to be placed a distance away, preferably in a blast proof control room.
