Incident

Explosion at a hazardous waste site caused by contaminated nitric acid

Ivan Vince ASK Consultants, UK

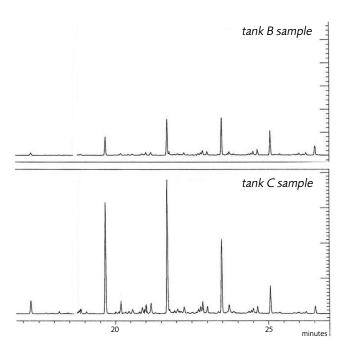
The tank B and tank C samples both had a distinct odour of white spirit. However, GCMS headspace analysis revealed important differences. The concentration of volatile organics was far higher in the tank C liquid than in tank B. More significantly, there was a shift in the distribution of individual components in the 'white spirit' in going from tank B to tank C, such that tank C contained a more volatile liquid than tank B (see Figure 1).

Figure 1: GCMS analysis of hydrocarbon components of organic layers from tanks B and C, showing 'centre of gravity' of peaks further to the left (increasing volatility) in the latter.
