Blast furnace no. 5 incident, Corus, Port Talbot, 08 November 2001

J Hodges and S Curry
Health and Safety Laboratory, Buxton, UK

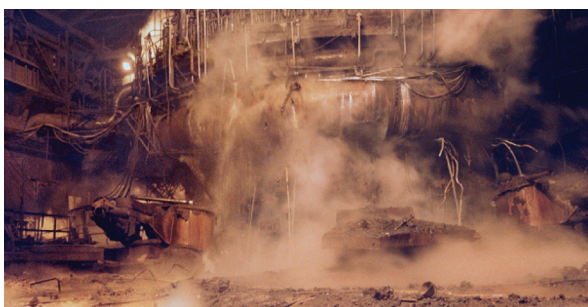
Figure 1: Blast Furnace No. 5 Picture taken from the cast house floor shortly after the incident

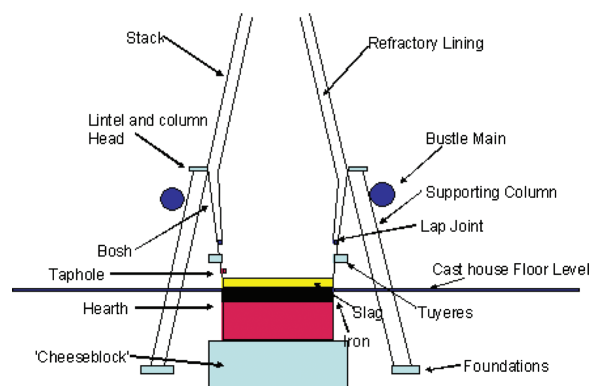
Figure 4: Furnace No. 5 main structural features

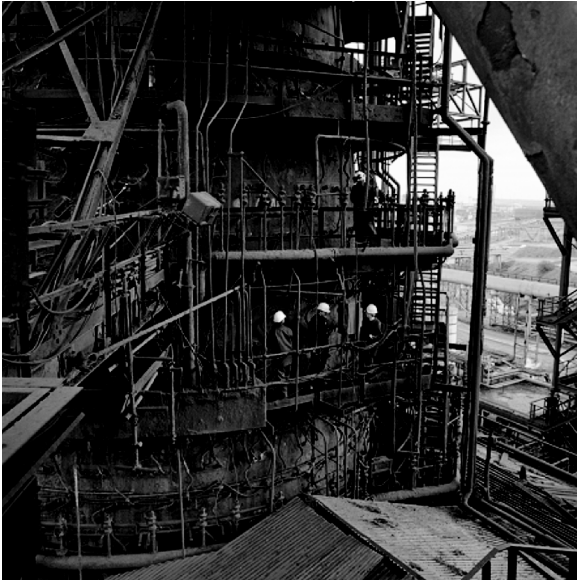
Figure 5: External view of the furnace cooling system

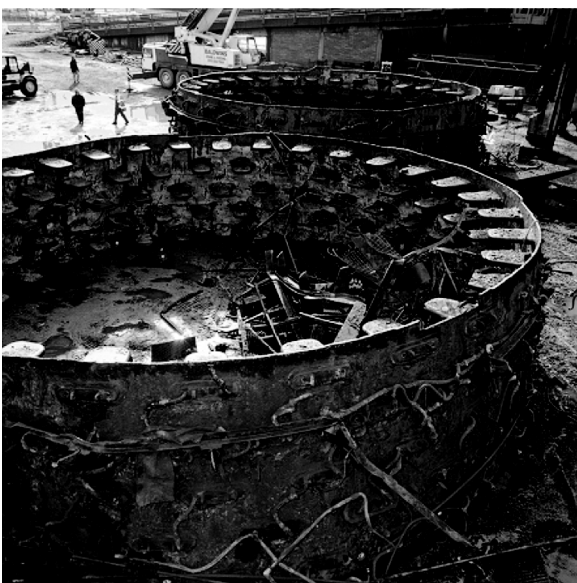
Figure 6: Sections of Furnace showing coolers (refractory removed)

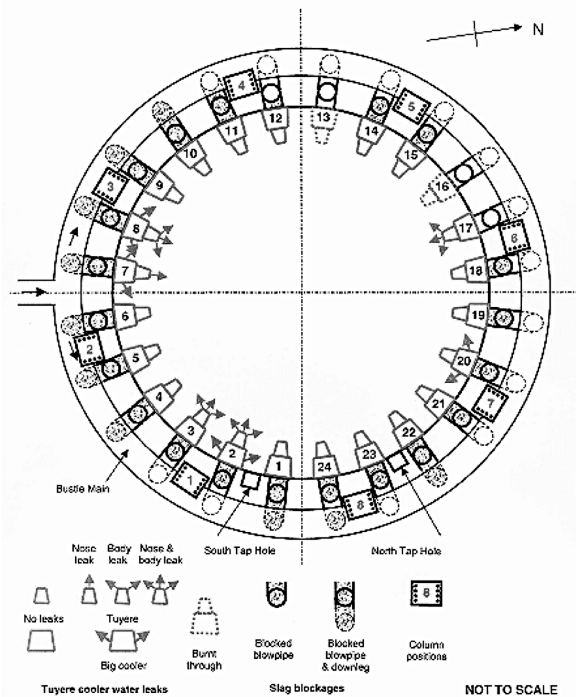
Figure 7: Tuyère blockages and water leaks

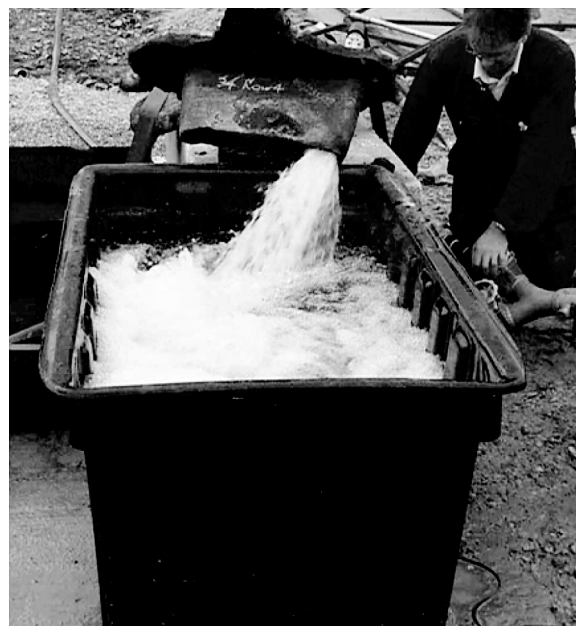
Figure 8: Determination of leakage rate through flat cooler

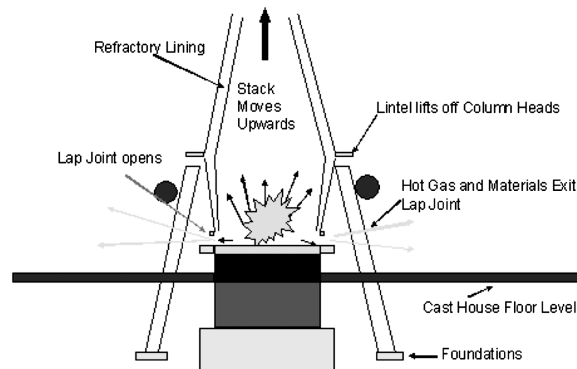
Figure 9: Main structural features during event
