Case Study - The Fire at Hickson & Welch Ltd, Castleford, UK

Dr K J Patterson

Health, Safety and Security Manager, Hickson & Welch Ltd

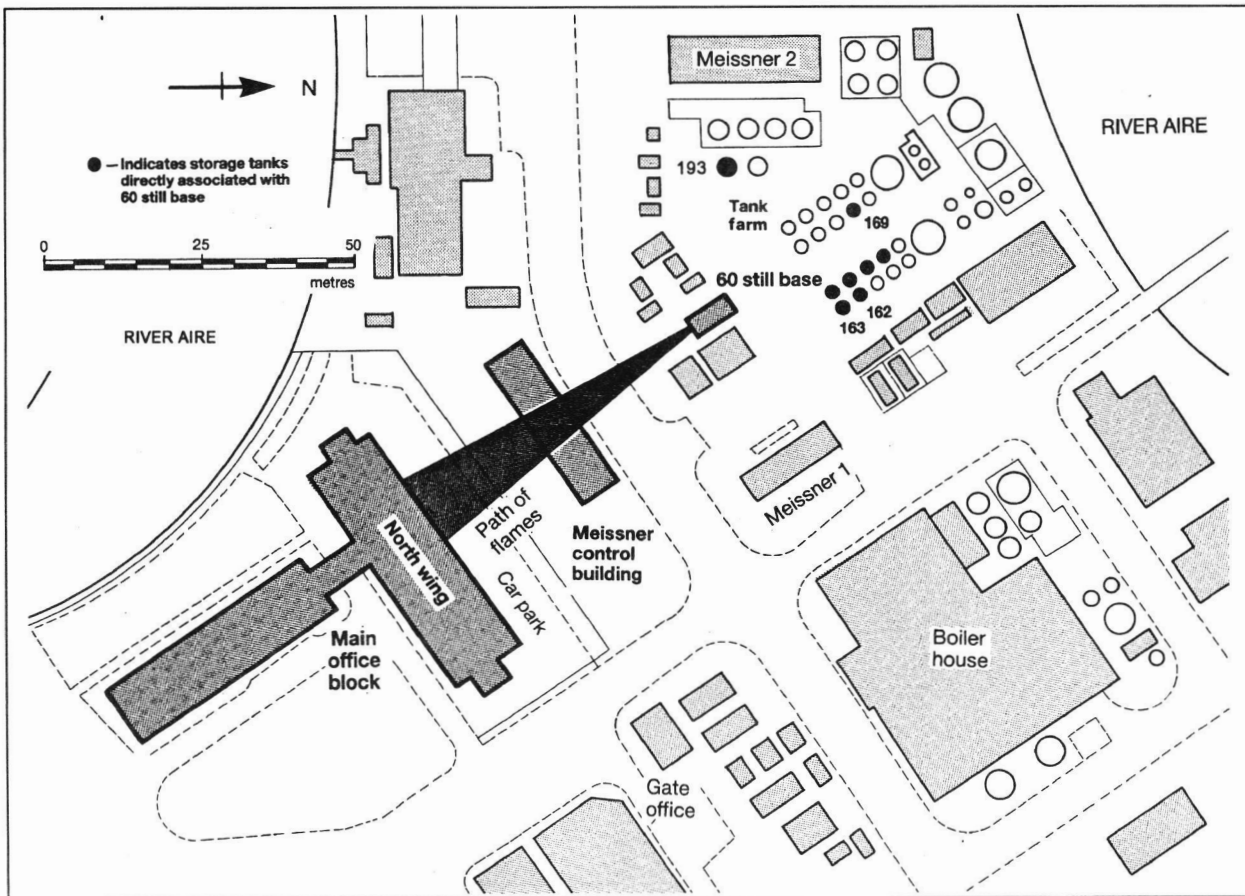
Figure 1: Plan of area around 60 still base showing path of flame

3.2 The flame then struck the main, four storey office block some 55 metres from the vessel. At the point of impact windows in the building shattered, brickwork spalled and window frames melted. A number of offices were set alight. At the time there were 63 people in the building. One employee was overcome by smoke on the second floor and died later in hospital. A plan of the area around 60 still base is shown as figure 1.

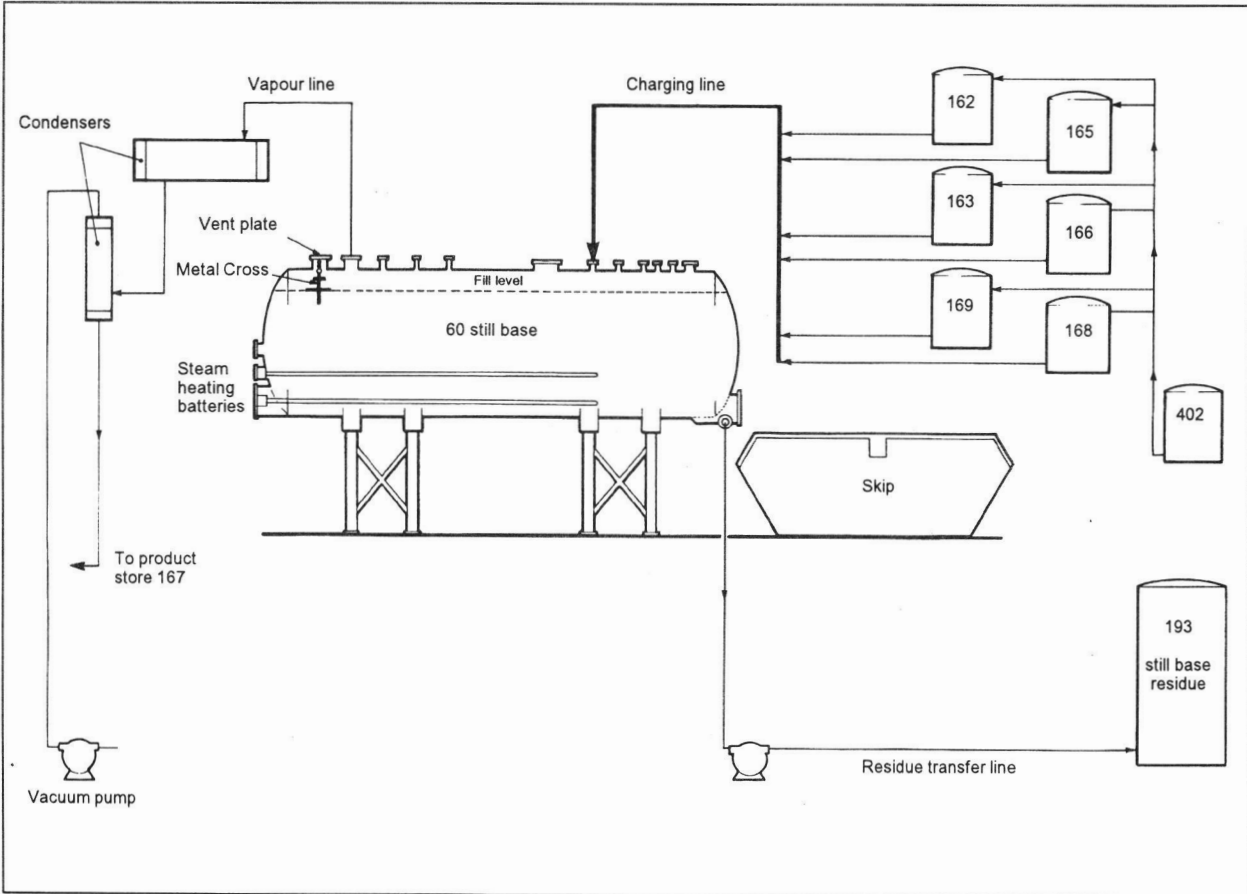
Figure 4: Schematic diagram of 60 still base and associated plant

5.3 As can be seen from figure 4, 60 still base could be fed from a number of storages. These storages could be used for other isomer streams as production demanded and so were occasionally required to be cleaned out. The final residue from 60 still base was pumped to a dedicated storage, 193 store, from where it was taken off site for final disposal.
