Process safety practice

It's OK, we have a back-up

Roger Stokes, BakerRisk, UK

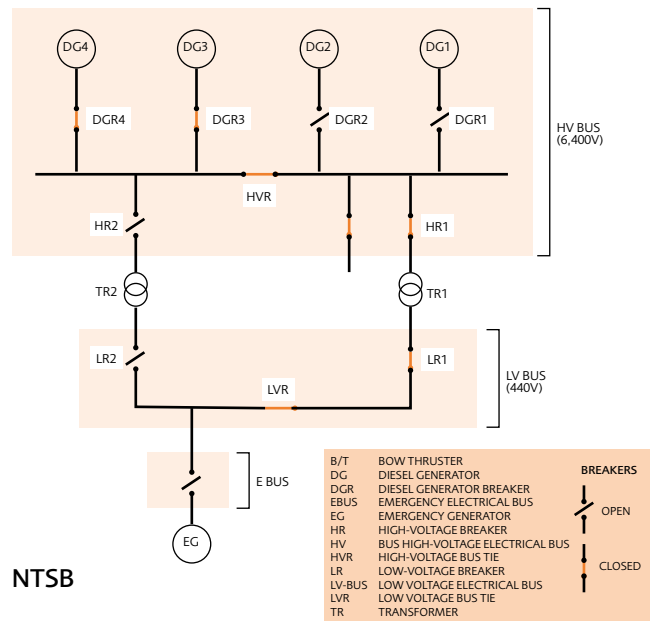
Figure 2 – Simplified single line electrical drawing⁴

The MV *Dali* is a 289-metre-long container ship (see Figure 1), propelled by a single 41,480 kW low-speed diesel engine driving the propeller at between 27 rpm (dead slow) and 80 rpm (full). The engine is started by compressed air and since there is no gearbox, it has to be stopped and started in the reverse direction to allow the vessel to go astern. High voltage (HV) electrical power is provided at 6.6kV to the HV bus by up to four diesel generators (DG), with two operating (DG3 and DG4) at the time of the incident and DG2 on automatic standby (see Figure 2). The voltage is stepped down to low voltage (LV) bus 440V by two (100% redundant) transformers. The engine oil lubricating pump and bow thruster is driven by a HV motor, and the engine water cooling pump and hydraulic steering gear pumps are powered by the LV system. An automatically starting emergency generator is provided on the LV system.

Although timing details were not available from the preliminary report, the emergency generator (EG) started, providing LV power to critical systems. This should have restored power for the emergency lighting, emergency steering pump, and engine cooling, but by this time, the main engine had tripped and would have required restarting. The crew manually closed HR1 and LR1, but shortly afterwards, the HV switchgear DGR4 and DGR3 tripped out, causing a second blackout to the HV system. Although the standby main generator DG2 had started automatically, providing power to the HV and LV bus via switchgear DGR2, there was no time to restart the main engine.

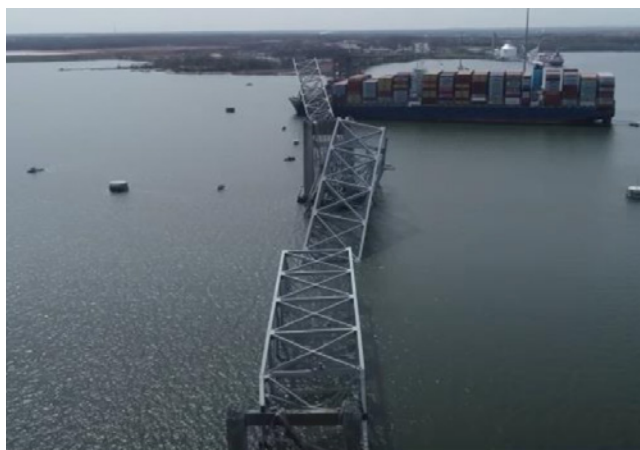
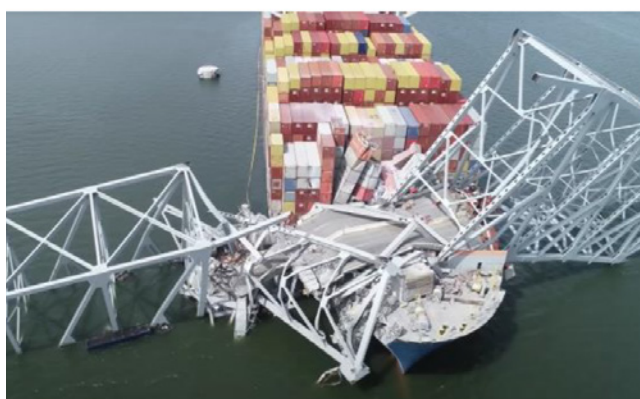
Figure 4 – Photographs of the Dali and Francis Scott Key Bridge after the incident

Approximately two minutes after the first power trip, at 0127:01, the pilot ordered an anchor dropped, but this did not prove effective. At 0127:23, the pilot ordered rudder hard to port, but at 0129:10, just four minutes after the first electrical trip, the *Dali* struck pier number 17 at about 6.5 knots causing six spans to collapse into the water and across the bow. This led to six fatalities and major damage to the *Dali* and its cargo containers (See Figure 4).

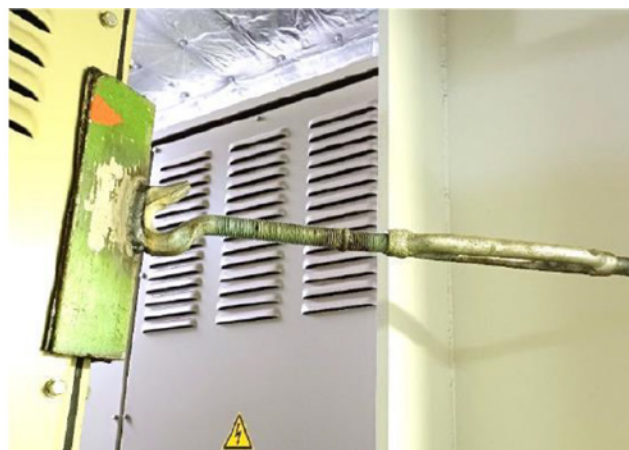
Figure 5 – Photograph of anti-vibration measures

Another potential casual factor is detailed in a civil claim filed by the US government on 18 September 2024⁷ that refers to a known problem of excessive vibration on the vessel. It would appear that a relatively crude measure was taken to try to reduce the effect of these vibrations on No.1 transformer. This involved a steel cargo chain turnbuckle that was found welded to a steel beam and wedged onto the frame of the electrical cabinet. (See Figure 5.)

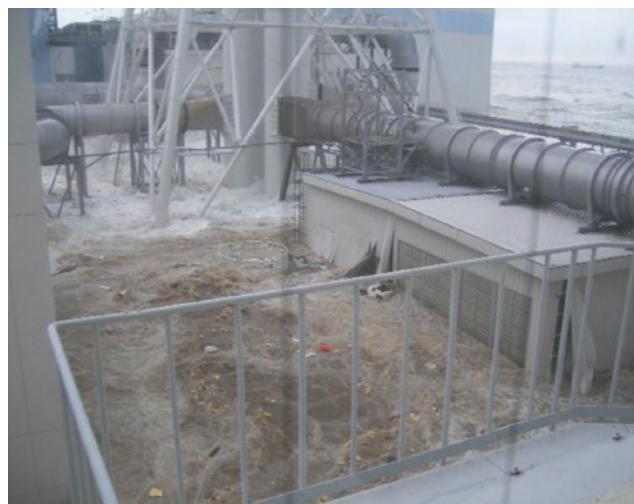
Figure 6 – Water inundation at Fukushima Daiichi⁹

The Japanese earthquake of 11 March 2011, occurred at 1446 hrs. Its initial impact on the Fukushima Daiichi power station caused a loss of external power supplies, and the three operating nuclear reactors tripped due to the seismic activity. The emergency diesel generators powered up and ran until shortly after 1541 hrs when the tsunami struck the facility and inundated the generator rooms, which were located at/below ground level. Despite heroic efforts from the operating team, the loss of power from the emergency generators led to loss of both control systems and reactor cooling, a subsequent meltdown, and hydrogen explosions that followed over the next three days.

Learning that was specific to back-up supplies included a failure to consider the common cause failure of power supplies following an earthquake and tsunami, despite previous evidence that the sea wall was not high enough to handle such an event.
