Boksburg LPG tanker blast — a detailed analysis of the tragic chain of events and safety insights

Princess Diana Dube, University of Johannesburg, South Africa

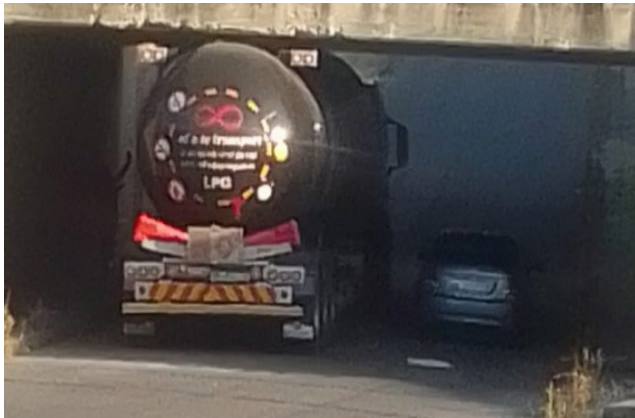
At approximately 06:15am, the truck got stuck under the bridge, causing damage to the gas tanker and releasing liquefied petroleum gas. Upon hearing a metal scraping sound, the driver stopped the vehicle and inspected it, he found that the tanker's cap had been scraped off². The driver immediately contacted his ISS (Innovative Staffing Solutions) controller and the fire department to report the incident and the gas leak². He quickly cordoned off the area and warned the public, motorists, and passersby to evacuate. A security vehicle soon arrived to assist, and together they secured the scene with safety tape.

The investigation revealed that the driver had seven years of experience transporting LPG gas and had adhered to all required safety and transit protocols. However, the explosion was caused by damage to the tank, which occurred when the vehicle attempted to pass under the bridge⁴. The driver had assessed the possibility of driving through the bridge; however, he overlooked the incline on the road under the bridge, which raised the trailer, pressing it onto the roof.

Figure 1 – a) LPG tanker stuck under bridge before explosion, b) during the explosion, c) the affected surrounding area, d) after the explosion

a) Image: Supplied⁵

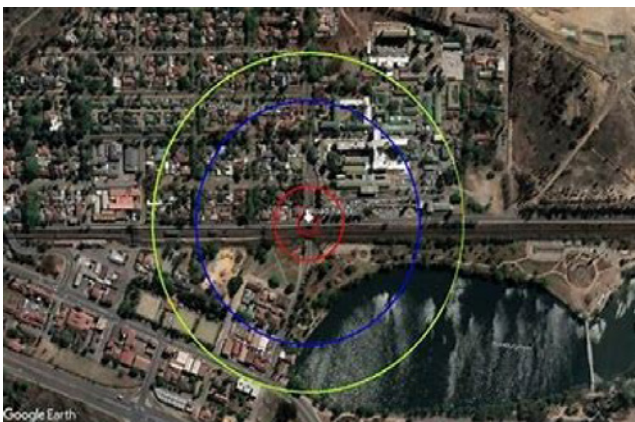
c) Estimation of thermal radiation effects due to Explosion.
Image: Google Earth

The explosion destroyed two nearby houses and several cars, including a fire vehicle that was attempting to extinguish the fire, and most properties in the sphere of influence were severely damaged⁵. The railway bridge underneath which the explosion occurred was also damaged, affecting the Germiston-Springs and the PRASA railway lines.
