Management and technical factors emerging from the inspection activity after a major accident

Abstract

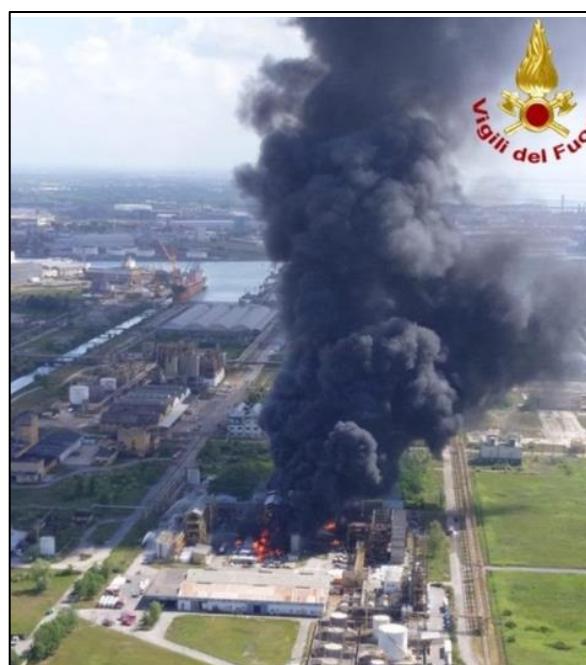
The trigger gave rise to the explosion and catastrophic rupture of the atmospheric tank, resulting in the release of flammable vapours and the formation of a vast fire. In other words, an internal domino effect was generated, which subsequently affected all the units and plants of the establishment, in a succession of fires and explosions (see Fig. 2 in Appendix).

Fig. 2. Destruction of the establishment

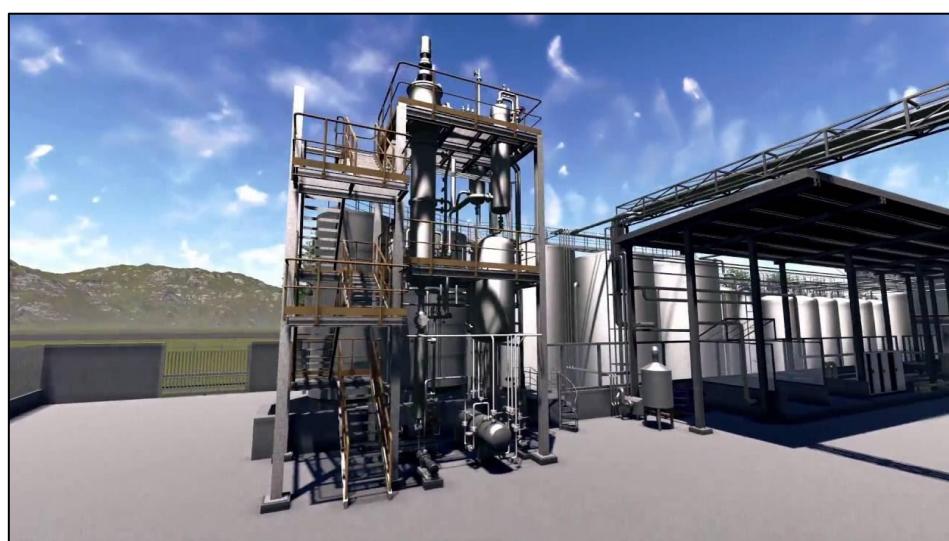
Based on past laboratory analyses, tank TK 2.2 was likely to have been holding wastewater containing the following hazardous substances: xylene, acetone, methyl acetate, ethanol, ethylbenzene, o-xylene and hexyl acid (see Fig. 3 in Appendix).

Fig. 3. Scheme of the plant involved

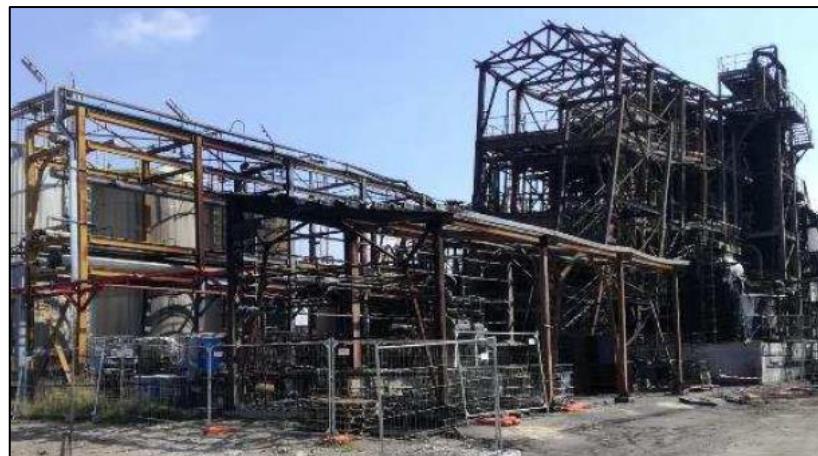
The fire affected all production areas (see Fig. 4, Fig. 5, Fig. 6, Fig. 7 in Appendix), directly and by heat radiation, as well as part of the laboratory building, the control room adjacent to the production units and the cooling tower area. The assets were destroyed and are now no longer usable (apart from 15 metal tanks).

Fig. 4. Consequences on equipment and structures: Plant Unit #3

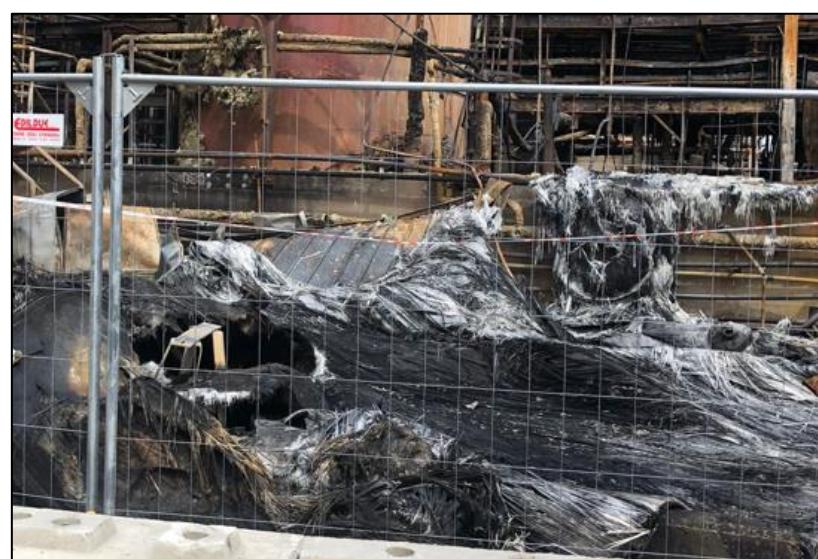
Fig. 5. Consequences on equipment and structures: Collapsed Fiberglass tank

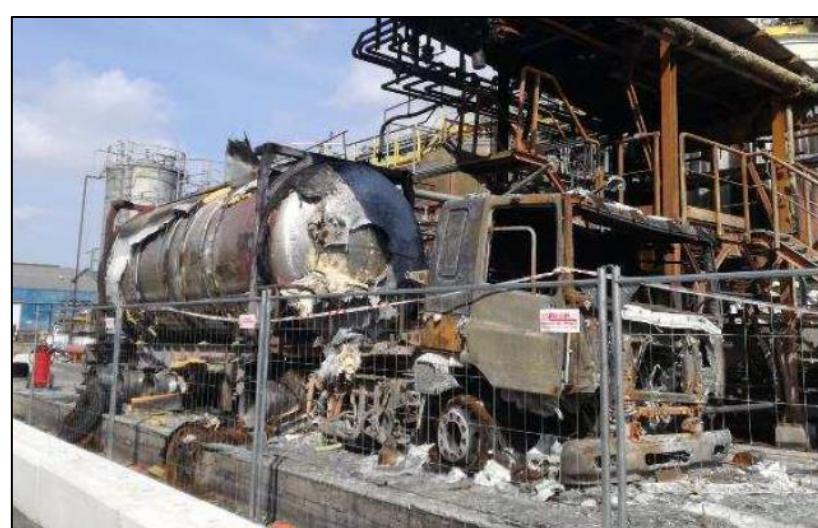
Fig. 6. Consequences on equipment and structures: Tanker Truck

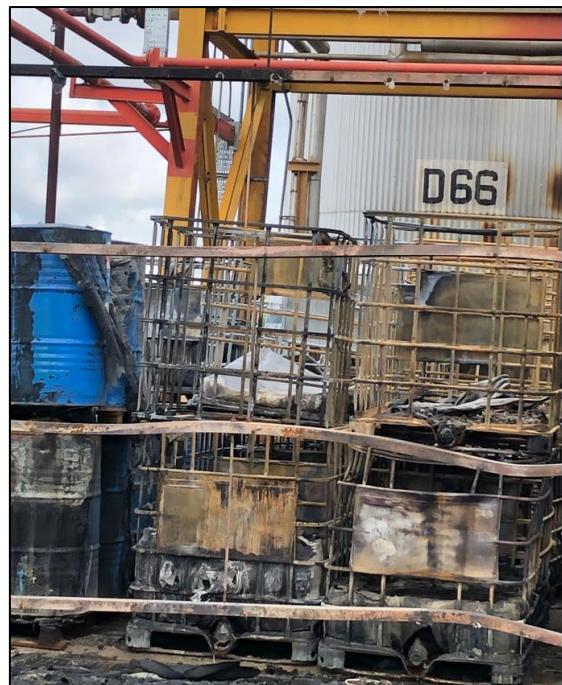
They include design of plants/systems/equipment: the presence of hazardous substances stored on the forecourt were not adequately protected by fire prevention systems.

Fig. 6. Consequences on equipment and structures: IBC and DRUMS

- Follow the procedures for the correct positioning of stores of hazardous substances and mixtures on the forecourt (e.g. tanks, drums, IBCs, etc.), including related fire protection systems and equipment, as a result of an appropriate risk analysis.

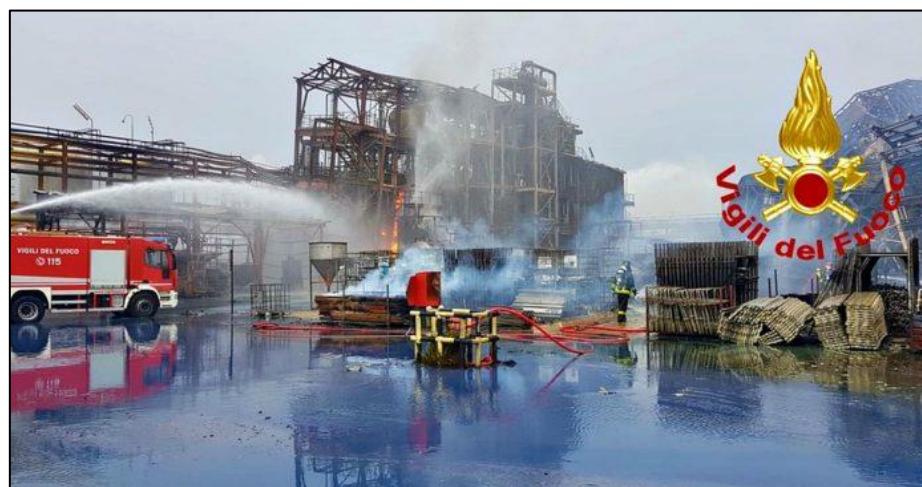
The External Emergency Plan (EEP) was then activated by the Prefect's Office, following notification from the fire brigade. Following intervention by the off-site external emergency services, the fire was brought under control at approx. 14:00, and the emergency was declared over at approx. 17:00. Approximately 30 fire brigade vehicles attended with 90 firefighters, including from neighbouring stations (see Fig. 8 in Appendix).

Fig. 8. Intervention of the fire brigade
