Crane failure results in dropping of a heavy load

*Geoff Gill
BNFL Business Group*

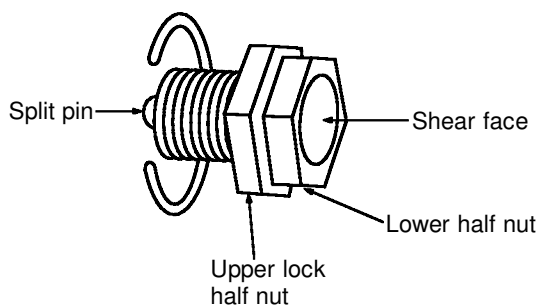
It was evident that the crane failed due to the fracture of a rope terminal securing one of the load-bearing wire

ropes—in the threaded section immediately below where it is attached to the load equalizing beam. It was secured by means of two half nuts (see Figure 1). The threads immediately above the failure point were distorted due to wear and tear, and movement between contacting surfaces prior to failure. Metallurgical examination showed that failure initiated from cracking in the bolt threads.

The failed terminal was attached to one of four new ropes that had been supplied and fitted about two years before the incident. These had replaced the original ropes that had been in use for about five years. The replacement rope terminals were shorter and of smaller diameter than the originals and to accommodate this, they were secured with two half nuts instead of two full ones. Calculations showed that this reduced the effective safe working load (SWL) by about 40–50% and meant that the crane had been operating at or above its effective SWL. This was concluded to be the prime root cause of the failure.

There was also some evidence of metal-to-metal contact between the load equalizing mechanism and the inside surfaces of the compensating beam (though this was more evident at the end which did not fail). This could have been a partial contributor to the failure of the terminal.

FIGURE 1: SHEARED SWAGED STUD ROPE TERMINAL

The main actions centred around the installation of different sized rope terminals about two years earlier. The crane concerned and all other similar ones on the site were surveyed to ensure that those with rope terminals of this type (studs 'swaged') were secured with at least one full nut, a lock nut and a split pin. Swaging is the process of reducing the cross-section of a metal rod or stud by forcing it through a tapered aperture.

The design of the rope terminal was reviewed and an improved arrangement implemented.
